11	18-44 Napoleon Street (CT39913/3, CT39913/4, CT39913/5) and Adjacent Foreshore and Area of the River Derwent, Battery Point - Partial Demolition, New Boatshed, Jetty Extension and Reclamation Works	
	Attachment G	PLN-19-237 - 18-44 NAPOLEON ST BATTERY POINT (CT39913/3, CT39913/4, CT39913/5) AND ADJACENT FORESHORE AND AREA OF THE RIVER DERWENT - CPC Supporting Documents2

Statement of Historical Archaeological Potential and
Archaeological Impact Assessment

Portion of the Ross Patent Slip &
Portion of the Battery Point Shipping Activity Areas
Napoleon Street, BATTERY POINT, TASMANIA

Brad Williams
Historical & Maritime Archaeologist

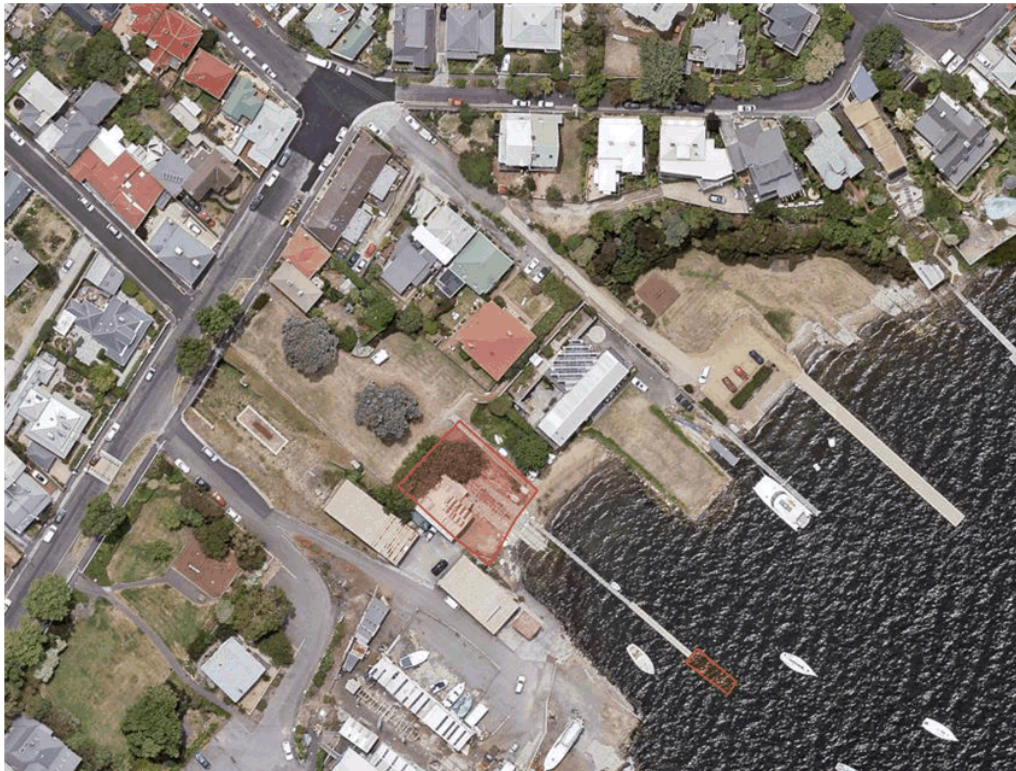
Figure 1.1 – A recent aerial image of the study area. Adapted from www.thelist.tas.gov.au

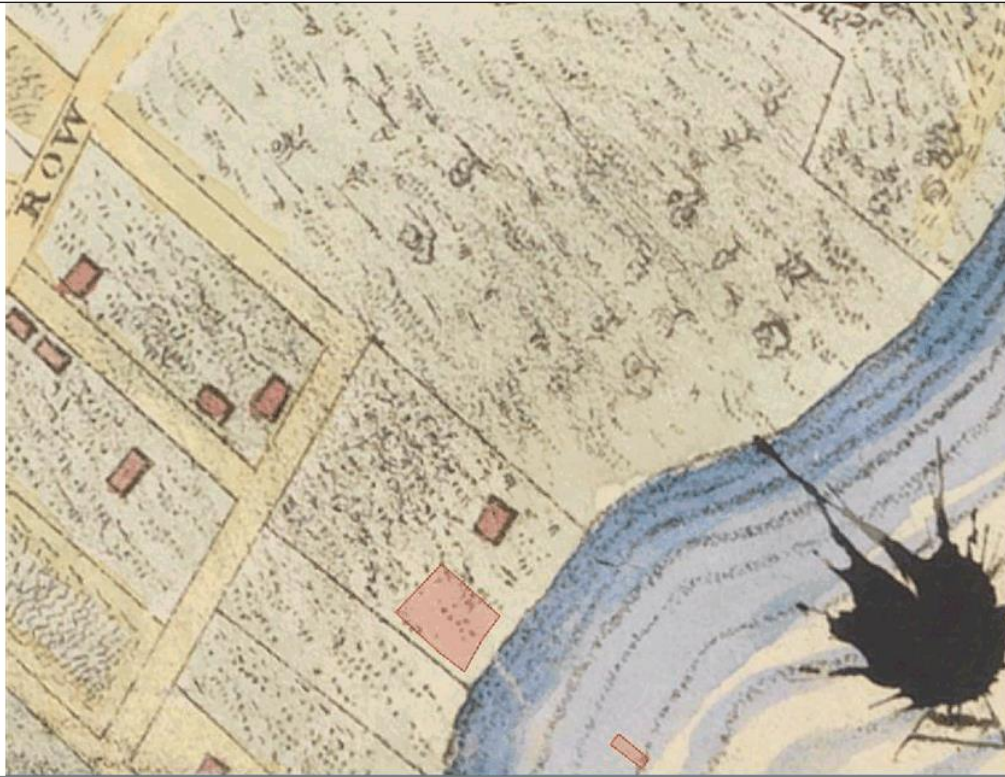
Figure 3.1 - 1839 Frankland survey, State Library of Tasmania, Allport Stack 912.94661MAP

Frankland's 1839 map of Hobart and surrounds (State Library of Tasmania, Allport Stack 912.94661MAP) shows the study area as part of a larger site with a single building – the allotment running from what is now Napoleon Street to the water. Whilst this plan is known to not have a high level of accuracy, it does suggest that the study area was not the site of any development at that time. Shipbuilding and maritime activities in Battery Point had not commenced in any major way at that time, therefore it is likely that the study area was merely part of the waterfront yardspace of that building.

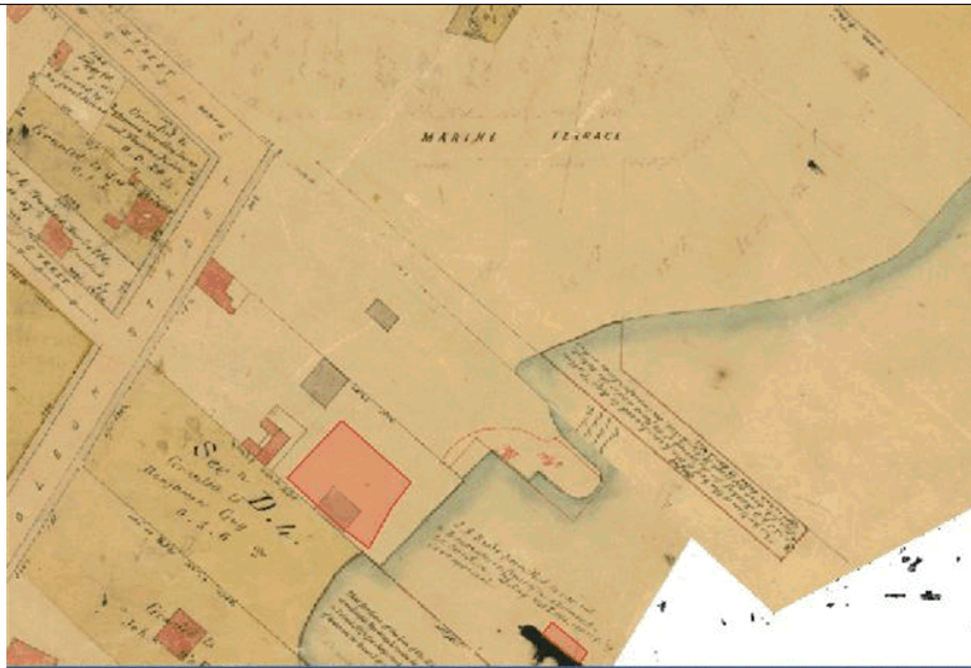
Figure 3.2 - 1845 Sprent survey, Libraries Tasmania

Sprent's 1845 map of Hobart and surrounds (www.thelist.tas.gov.au) is considered to be one of the most accurate depictions of the layout of early Hobart buildings and the street grid, although it is limited to buildings (and parts of buildings) which were visible from public vantage points. Nonetheless, this survey shows the subdivision of the larger allotments in the earlier surveys and an intensification of development of what would later become the Ross Patent Slip. The wider site appears to have had two masonry buildings and two timber buildings constructed by that time – one of those timber buildings is within the subject site in the location of the current boatshed. This survey also indicates some formalisation of the shoreline suggesting the lead-up to the intensification of maritime activity and use of the land-river interface. The study area itself appears to have had no development at that time.

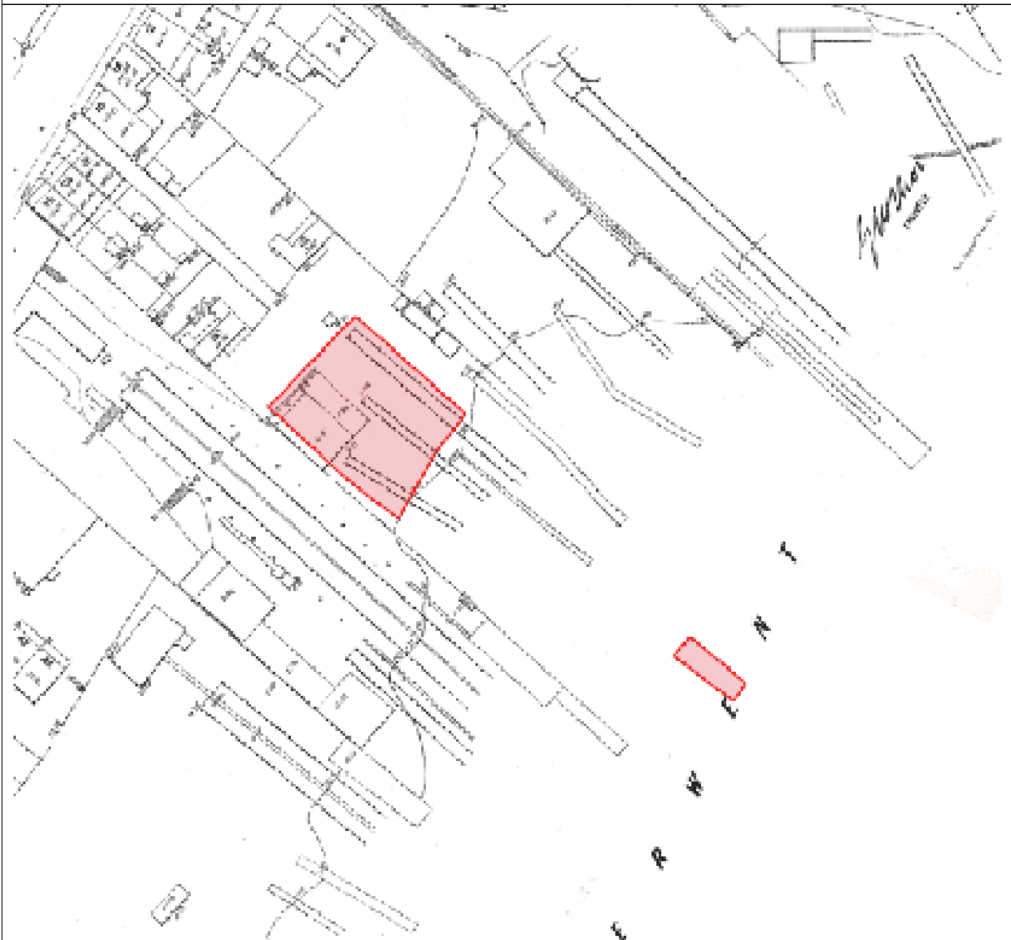
Figure 3.4 - 1908 Metropolitan Drainage Board maps (Sheet 35, Libraries Tasmania TL.MAP 881.11).

The 1908 Metropolitan Drainage Board survey of Hobart (State Library of Tasmania) shows that by that time three slips had been established within the study area and that two sheds are depicted in the location of the current shed (larger than that shown on the earlier Sprent survey). The central slip as shown on this map approximately corresponds to the existing slip on the site. This survey also shows a long jetty extending off the site in a similar position to that which still exists.

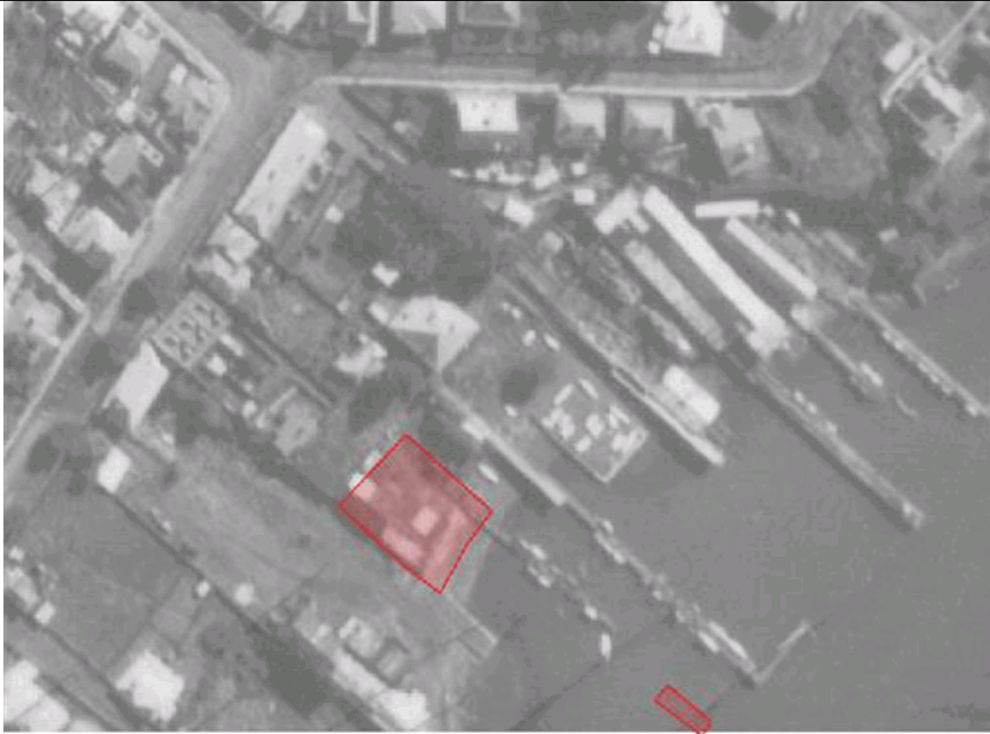
Figure 3.6 – 1946 aerial photograph survey, DPIPWE 1946 Hobart Run 1, 10893.

The 1946 aerial photograph of the area indicates that the three slips no longer remained, however the sheds and jetty were still extant at that time.

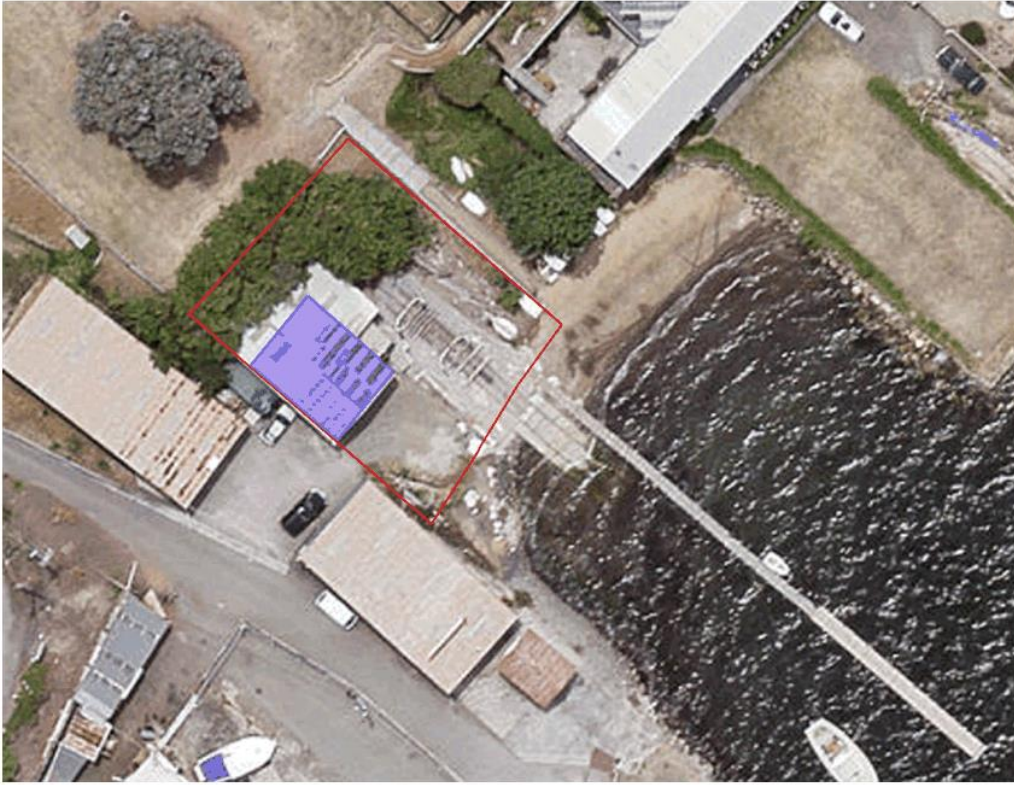
Figure 3.8 – Footprint of the building depicted on the Sprent survey in relation to current site features. Adapted from www.theliest.tas.gov.au

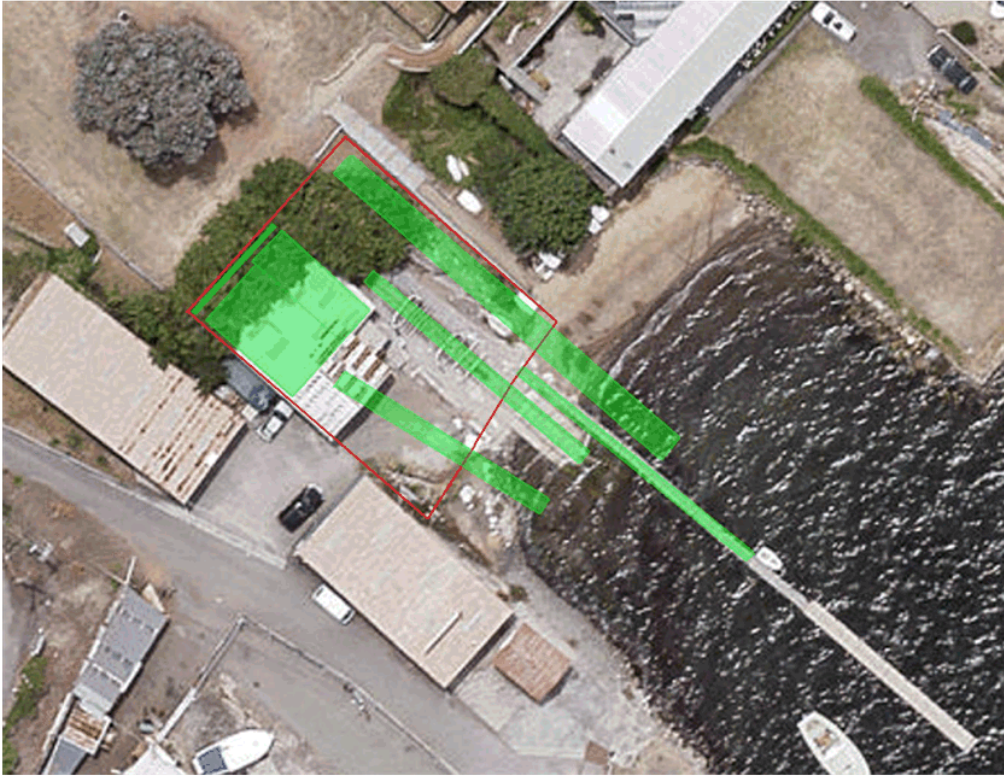
Figure 3.9 – Footprint of the features depicted on the 1908 Metropolitan Drainage Board survey and the 1922 Huon Railway survey in relation to current site features. Adapted from www.theliest.tas.gov.au

An inspection of the existing infrastructure on subject site reveals that the existing slip is built on the footprint of the earlier middle-slip, as seen on Figure 3.9. That current slip is surrounded by a concrete pad and powered by a winch at the top of the slip near the shed. None of this infrastructure appears to be historic and is certainly related to the slip deriving from the latter half of the c20th. Note that observations and description of the shed itself were not part of the brief for this project.

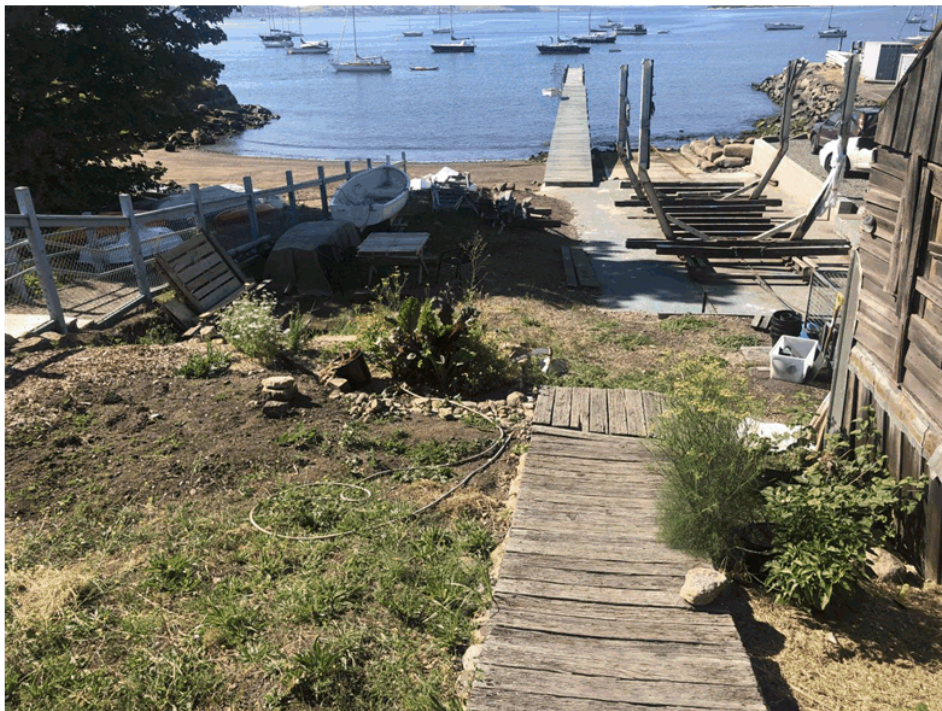
Figure 4.1 – View across the slip site from the top of the site.

Overall, site observations did not reveal any trace of the earlier slips at ground level or above.

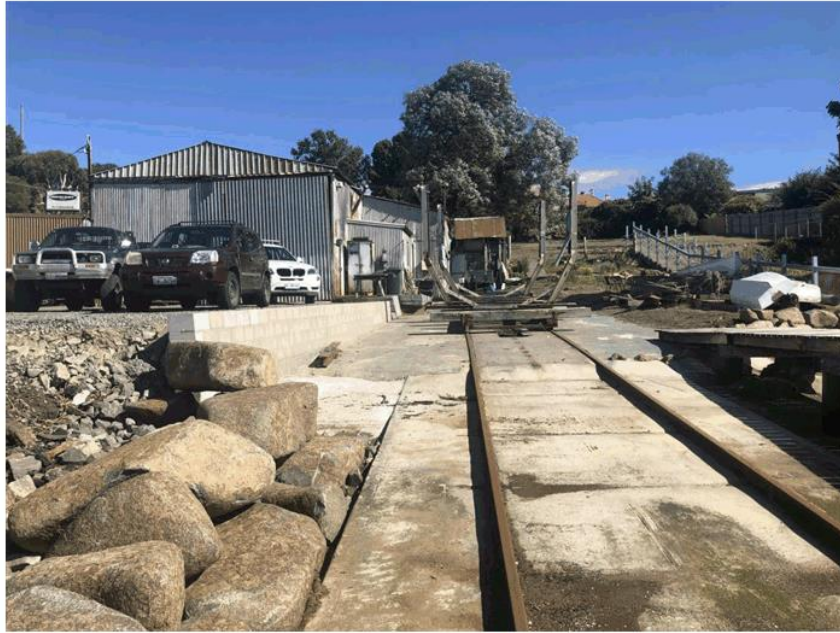
Figure 4.2 – View up the slip site from the top of the waterline.

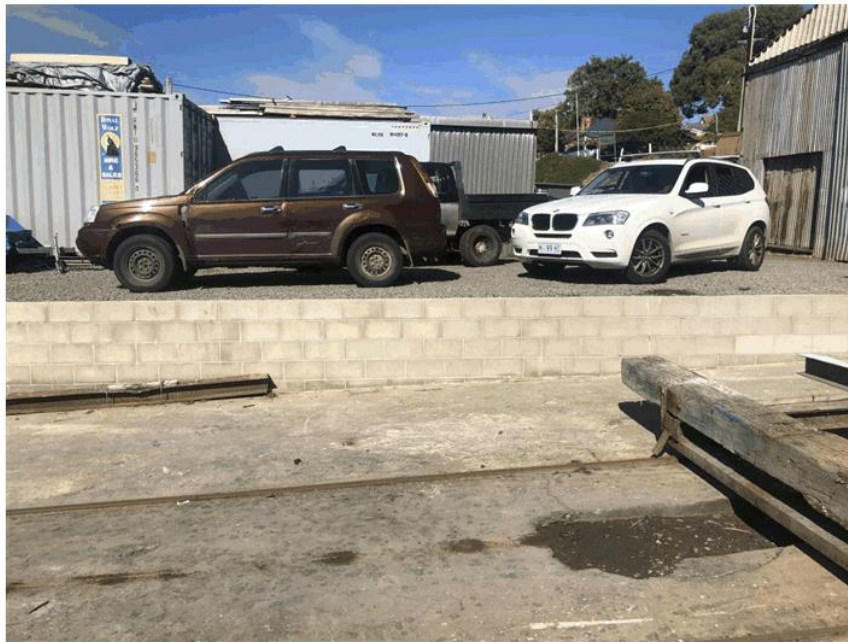
Figure 4.3 – Modern fill and retaining wall benching the shoreward portion of the western part of the site.

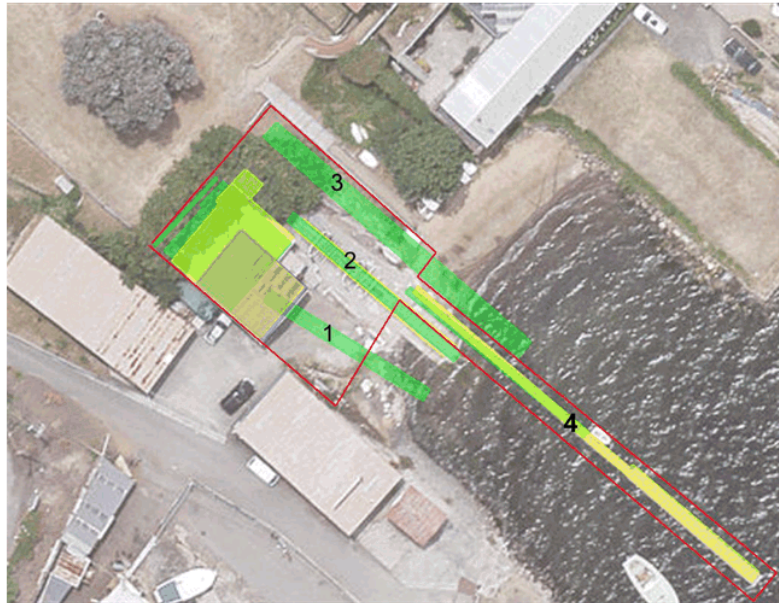
Figure 4.4 – The location of each of the historical slips as per below:

Slip	Likely disturbance/integrity	Likely archaeological potential
1	Unknown, however any remains of this slip are likely to have been buried by later filling and retaining activity.	Possibility of deeper (e.g. 800-1200mm) remains of this slip beneath modern fill.
2	Any remains of the earlier slip have probably been disturbed by the construction of the current slip.	This area probably has low or no archaeological potential given the likelihood of disturbance.
3	Apart from some apparent shallow cutting/benching/filling activity this area does not appear to have been subject to extensive disturbance.	This area probably has a higher archaeological potential given that disturbance is likely to have been shallow or minimal.

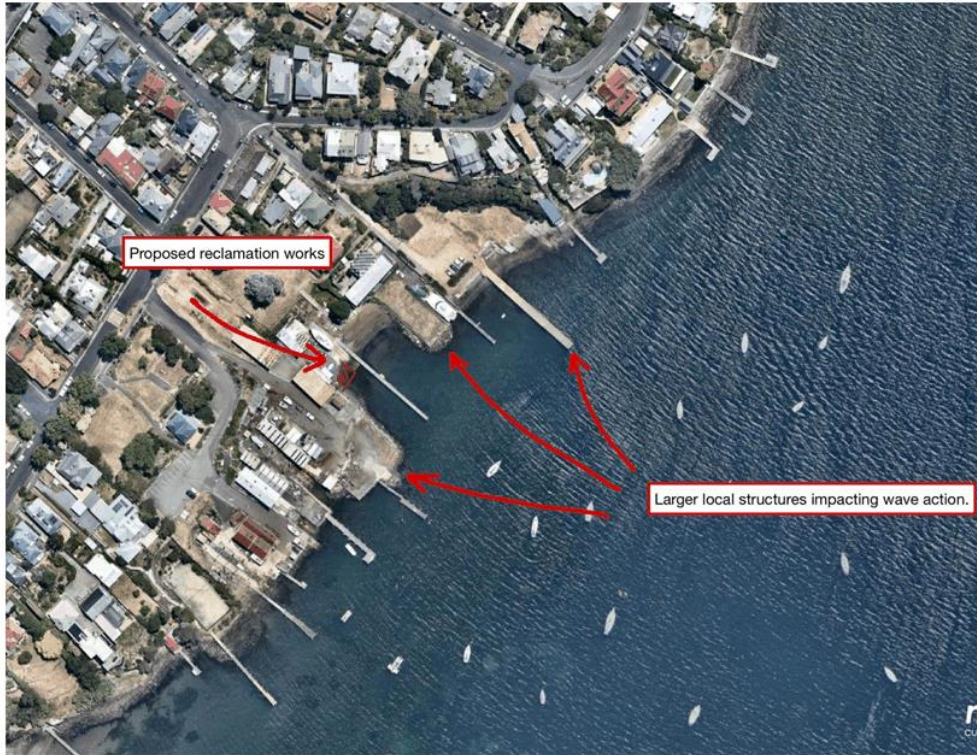
Figure 2: Wide view image showing wave action impacted by larger structures but not by modest size of proposed reclamation works
