CITY OF HOBART

**CITY PLANNING COMMITTEE MEETING**

13	179-191 Murray Street, Hobart, 62 Patrick Street, Hobart Adjacent Road Reserve - Demolition and New Building for General Retail and Hire, Bulky Goods Sales and 68 Multiple Dwellings
Attachment E	PLN-19-486 - 179-191 MURRAY STREET HOBART TAS 7000 - CPC Supporting Documents.....2

### Sewer & Water Servicing Concept for 62-64 Patrick Street, Hobart

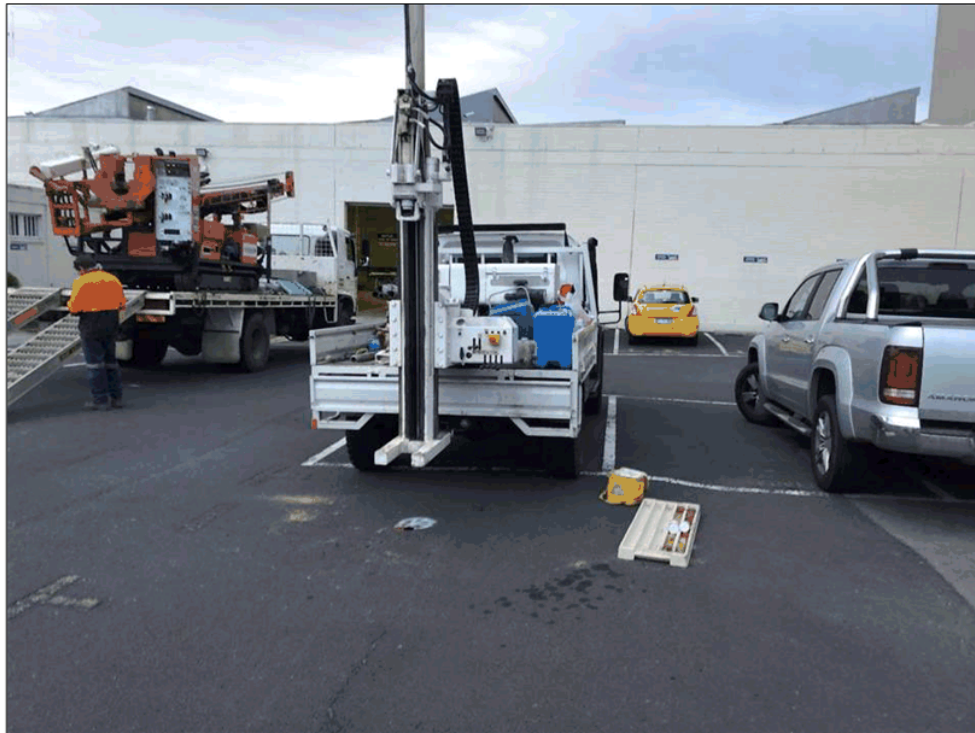
**Plate 10** Current Site conditions, view to the east and building at 62 Patrick Street.

A site walkover was completed by GES staff on the 28<sup>th</sup> June 2019. Images of the current site conditions are presented in Plate 10 and Plate 11; additional photographs are presented in Appendix 4. The surface of across the site is asphalt in the outside parking area and concrete inside the workshop both of which are in good condition.

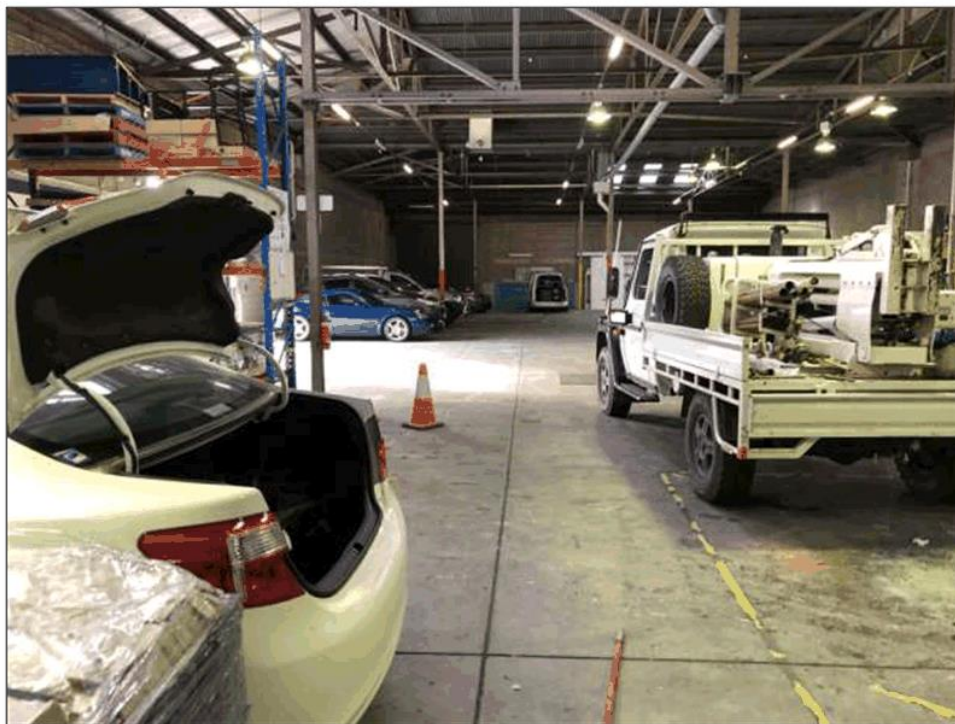
**Plate 11** Current Site conditions, view to the east inside the workshop building.

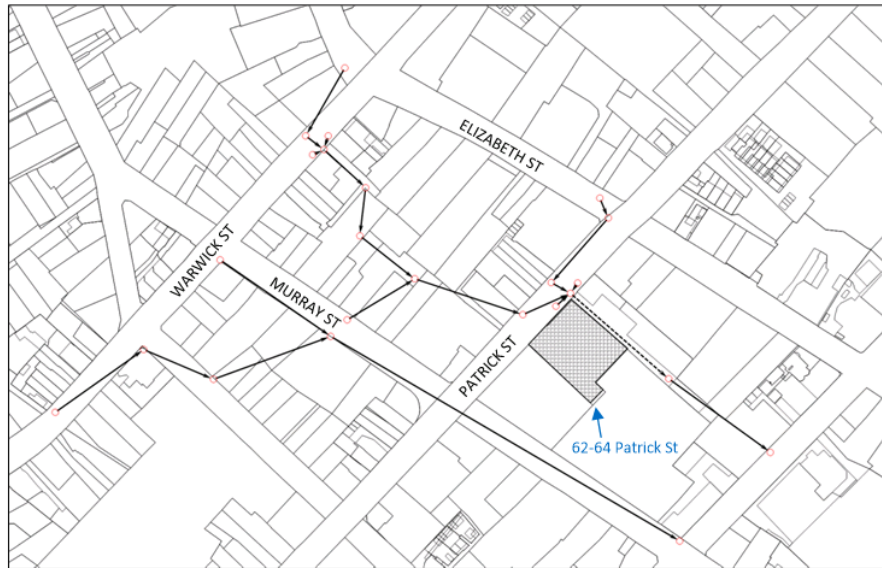
**Figure 5.** XPSTORM modelled underground pipe network.

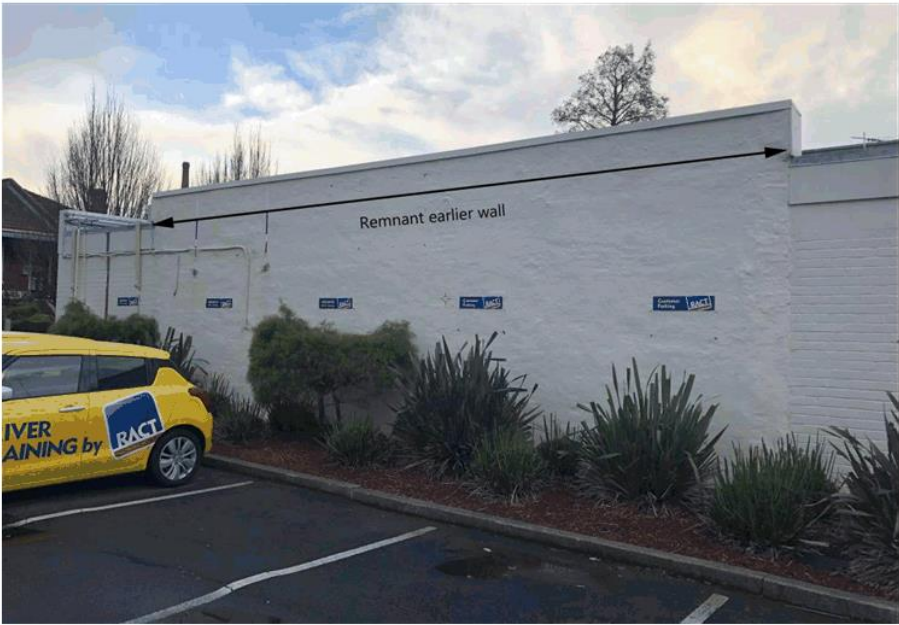
Figure 6.3 – Remnant wall of the c1890s houses incorporated into the 1960s building.

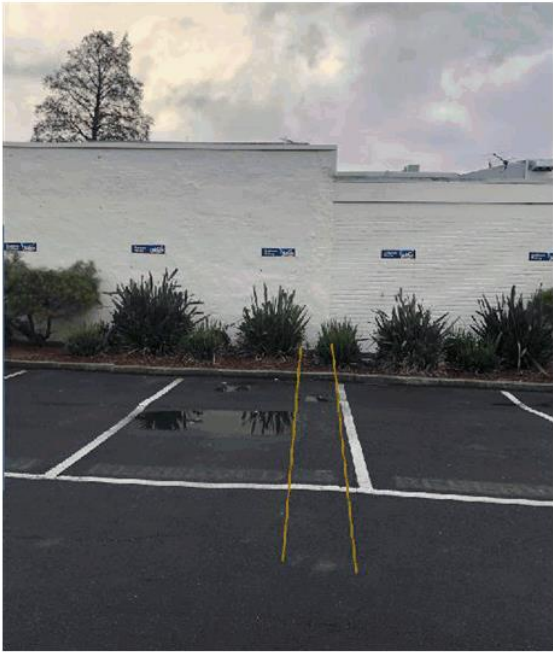
Figure 6.4 – Example of pavement cracking in-line with expected rear wall of the c1890s building.

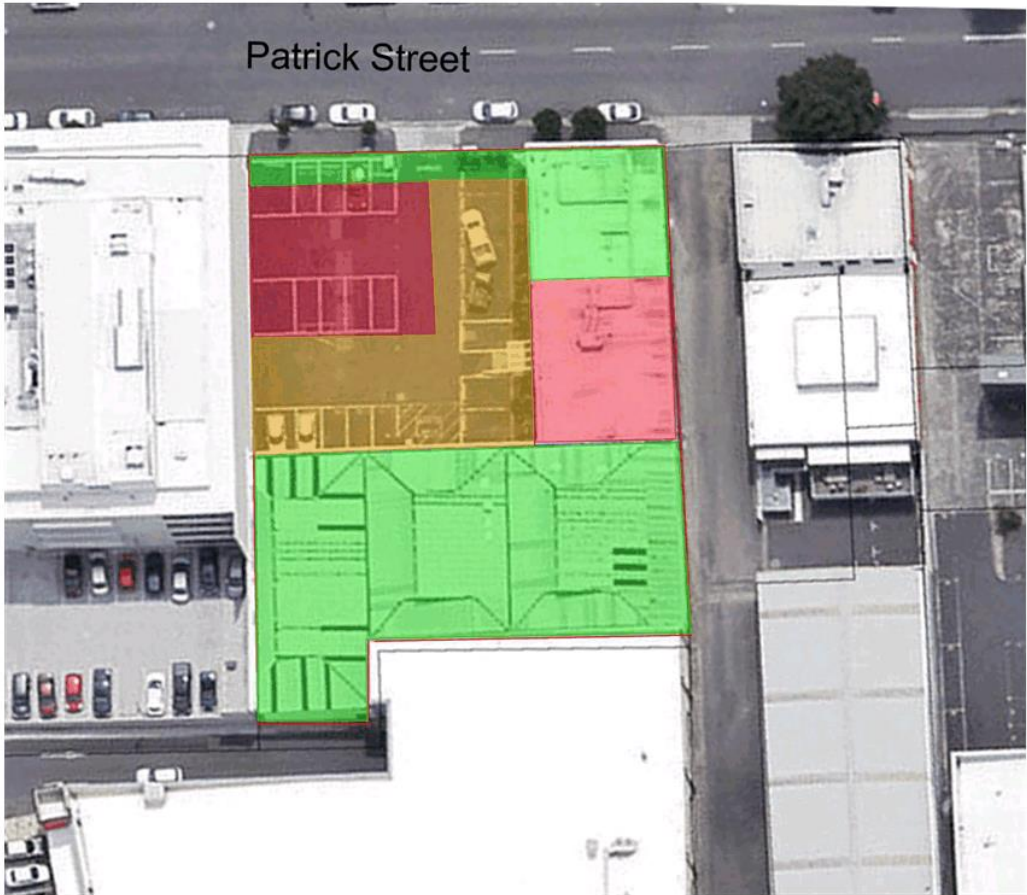
Figure 7.1 – Archaeological zoning plan for the subject site. Red denoting areas of high archaeological potential, orange depicting areas of medium archaeological potential and green depicting areas of low archaeological potential.

Based on the likely impacts, the construction plan, desire to 'test' and ground-truth archaeological theories, as well as a range of logistics, the approach to archaeology is proposed to follow the sequence in the table below, as per the areas of archaeological zoning plan on Figure 7.1:

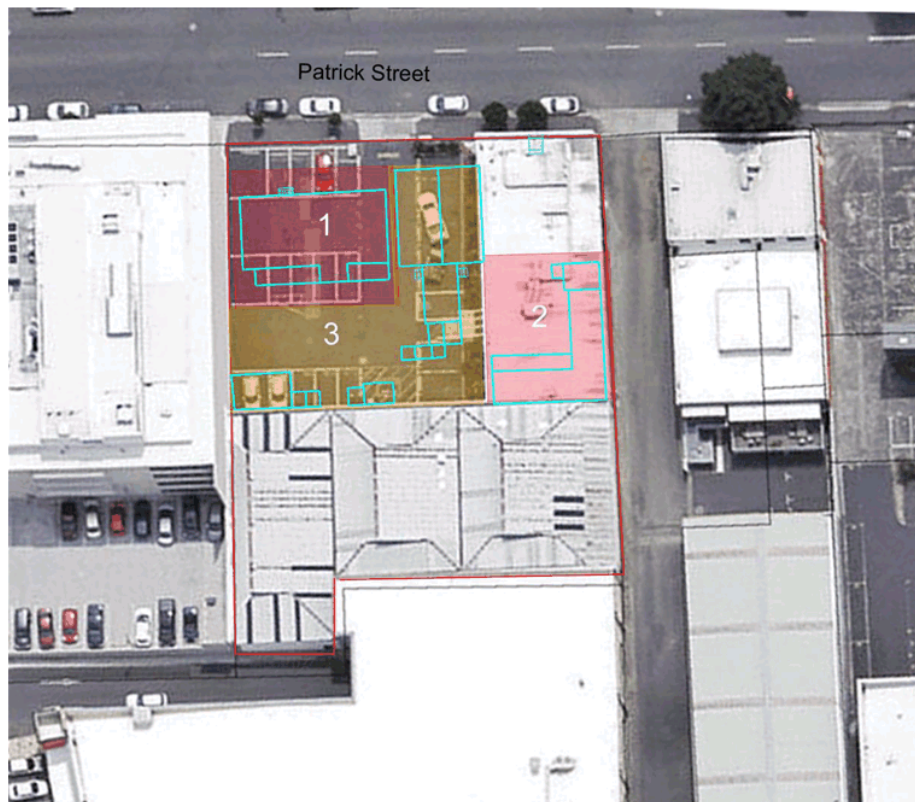
Figure 9.1 – Areas proposed for archaeological investigations, to be read in conjunction with the table below
