CITY OF HOBART

SPECIAL COUNCIL MEETING

2.1.1	100 Pinnacle Road, Mount Wellington and 30 McRobies Road, South Hobart and Adjacent Road Reserve	
Attachment J	PLN-19-345 - 100 PINNACLE ROAD MOUNT WELLINGTON TAS 7054 - Advertised Document - Review Report	4
Attachment K	PLN-19-345 - 100 PINNACLE ROAD MOUNT WELLINGTON TAS 7054 - Advertised Document - MWCC Masterplan	7
Attachment L	PLN-19-345 - 100 PINNACLE ROAD MOUNT WELLINGTON TAS 7054 - Advertised Document - Architectural Drawings.....	8
Attachment M	PLN-19-345 - 100 PINNACLE ROAD MOUNT WELLINGTON TAS 7054 - Advertised Document - Planning Assessments	24
Attachment N	PLN-19-345 - 100 PINNACLE ROAD MOUNT WELLINGTON TAS 7054 - Advertised Document - Engineering Drawings and Reports	196

100 PINNACLE ROAD MOUNT WELLINGTON TAS 7854

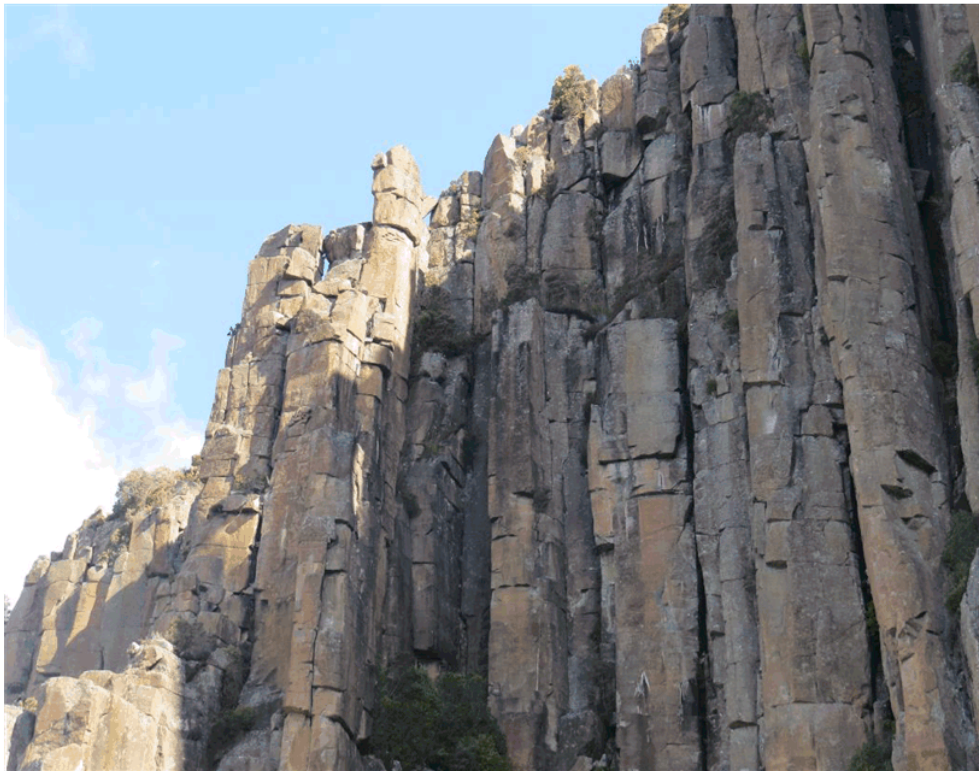
Figure 3-1 Dolerite Columns Exposed at the Organ Pipes, Mount Wellington

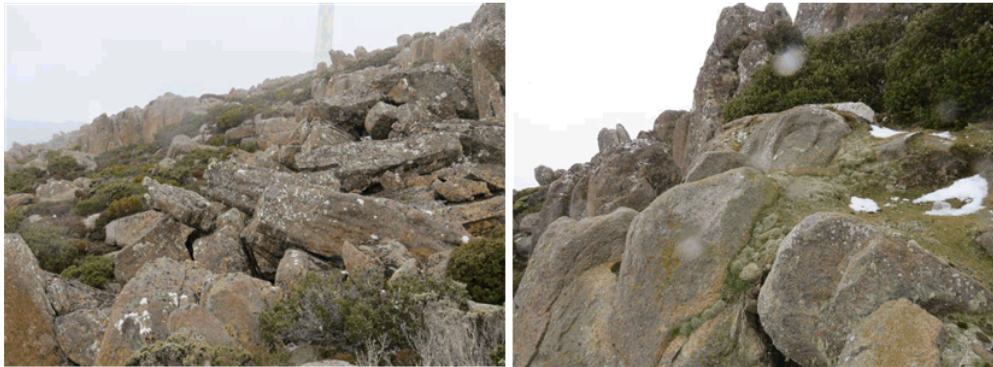
Figure 3-4 Typical slope comprising dolerite ridges and outcrop with boulder talus accumulations (left), interspersed with thin alpine peat soils and scrubby vegetation (right)

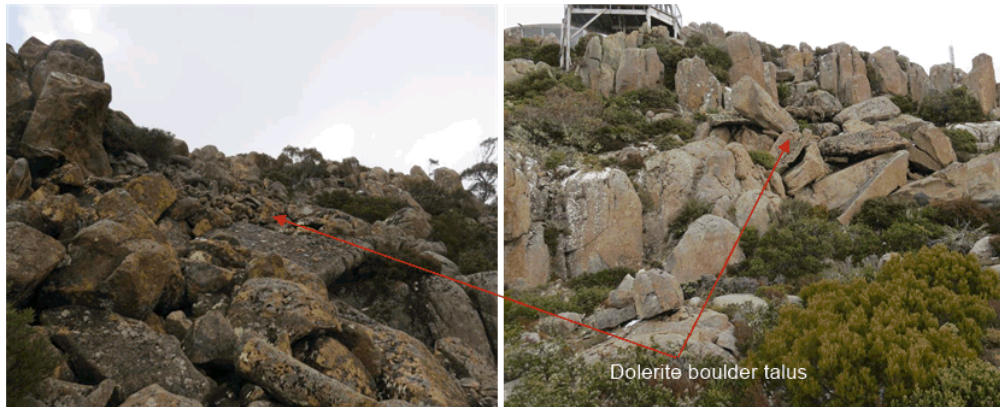
Figure 3-5 Dolerite field (left), typical boulder talus at toe of outcrop (right)

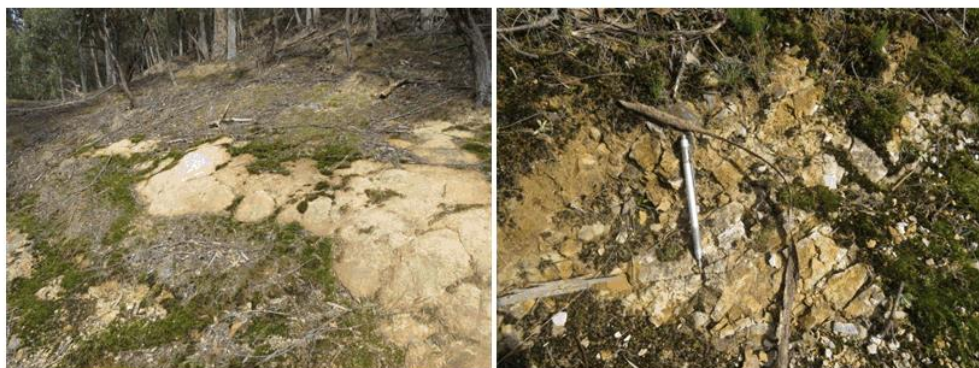
Figure 4-3 Extremely weathered sandstone outcrop up-slope from Base Site

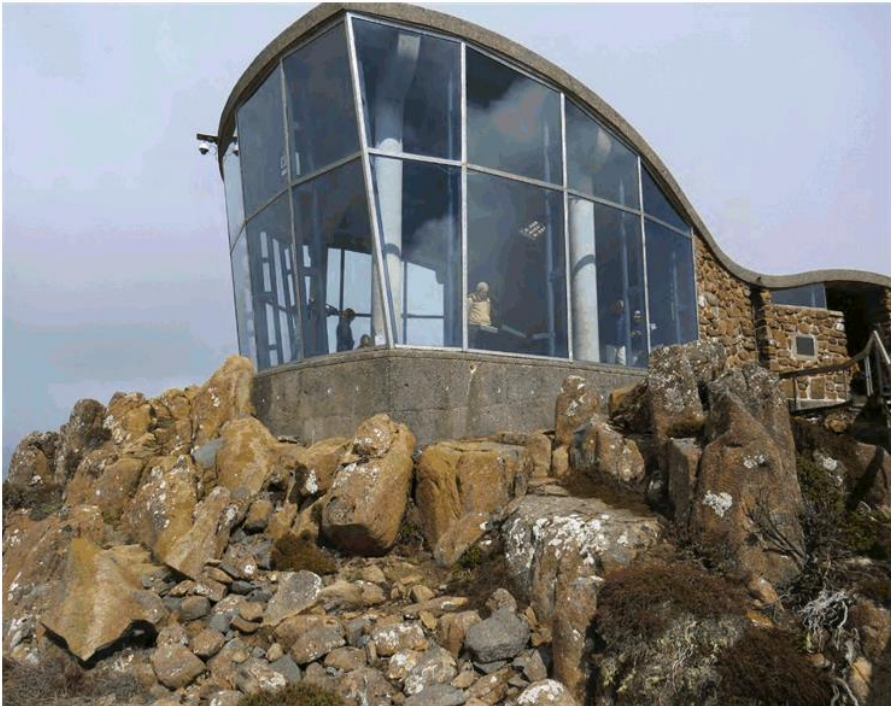
Photo 3 - Existing viewing shelter founded on Dolerite outcrop

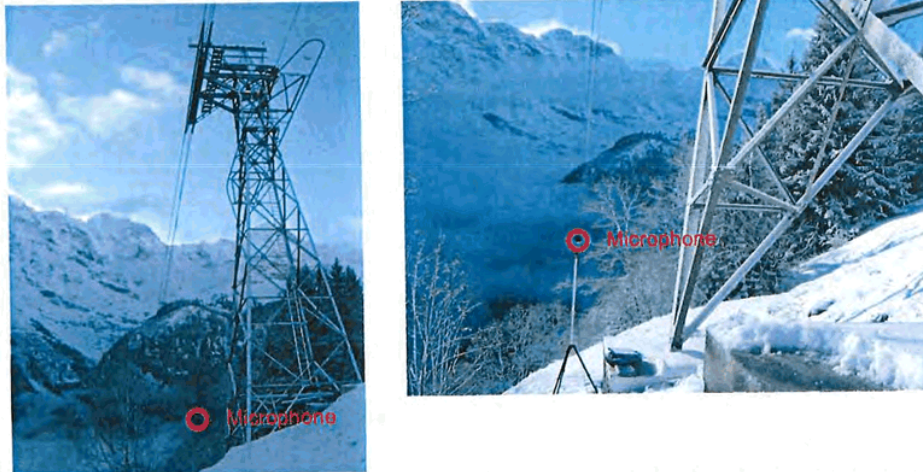
The distance between microphone and cable (bar) was measured with a laser-meter and was 26.95 m (measured in the middle of the bar). The microphone itself was at 2,1 m above terrain.

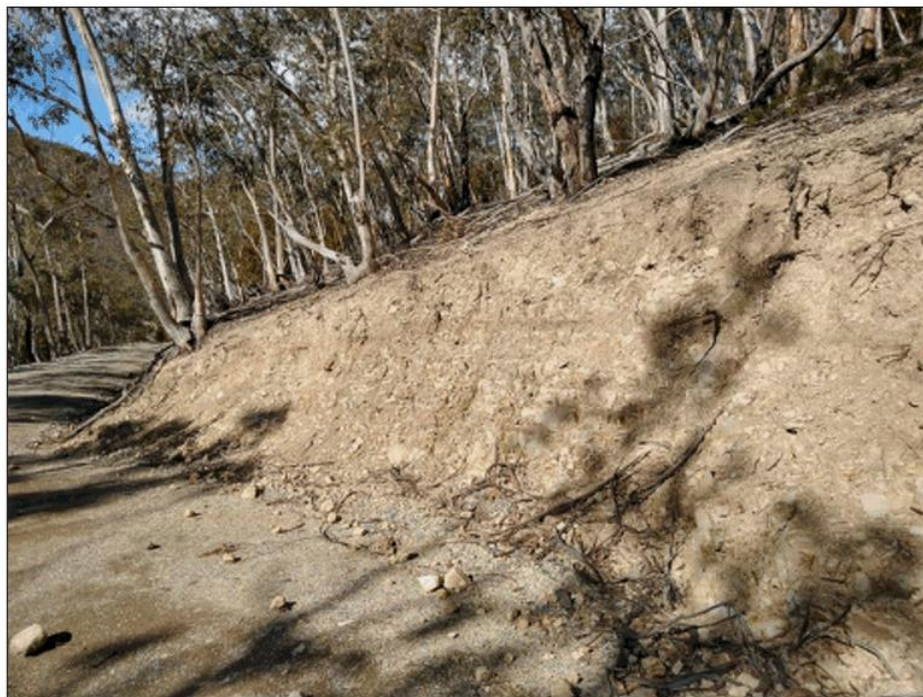
Plate 4 Current Site conditions, Permian sediments on the lower fire trail.
