CITY OF HOBART

City Planning Committee Meeting

Monday, 30 August 2021

7.1 APPLICATIONS UNDER THE HOBART INTERIM PLANNING SCHEME 2015	7
7.1.1 251 Macquarie Street and 245-247 Macquarie Street, Hobart - Three Multiple Dwellings (Two Existing, One New).....	7

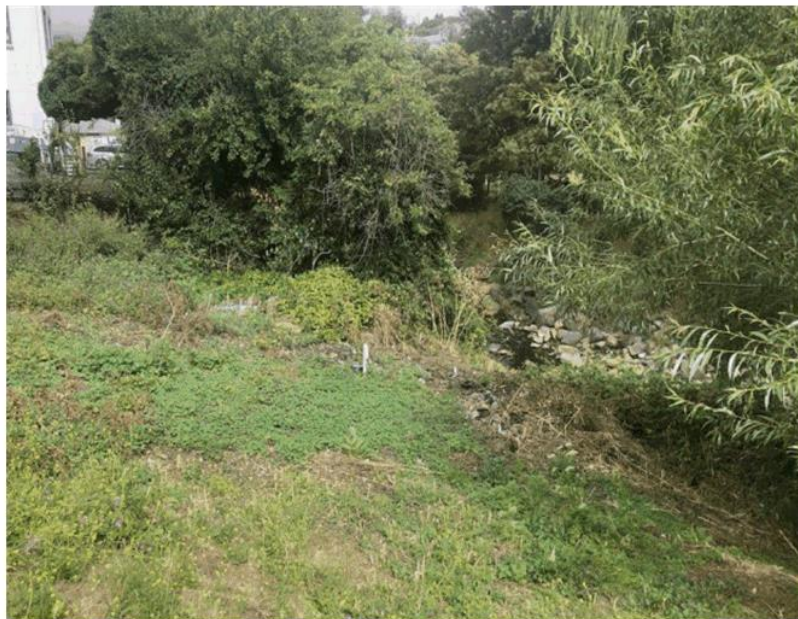
The land does not appear to have been modified with landscaping or plantings, and supports grass and weeds (refer to Images 2 and 3 below).

Image 2: Site near Hobart Rivulet boundary (taken from submitted archaeology report)

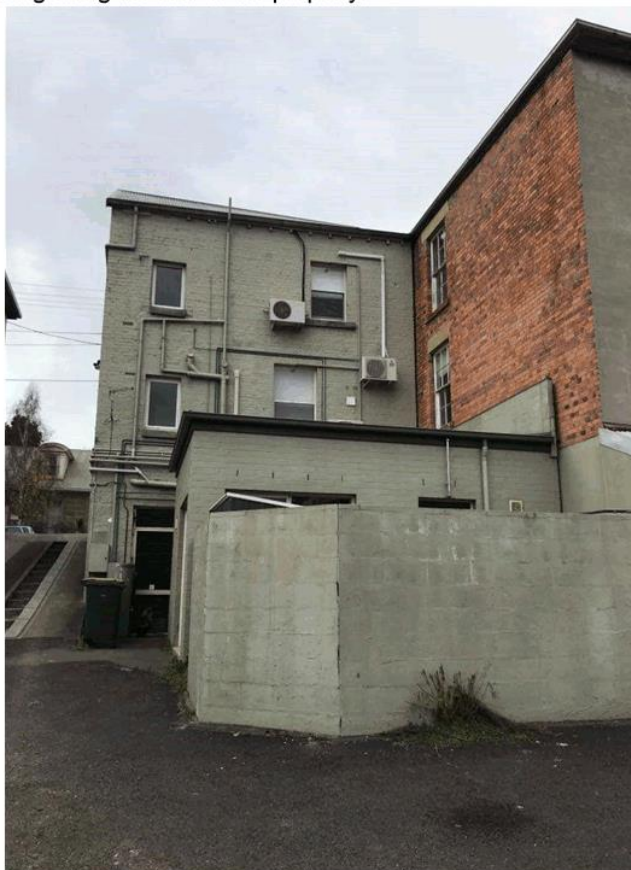
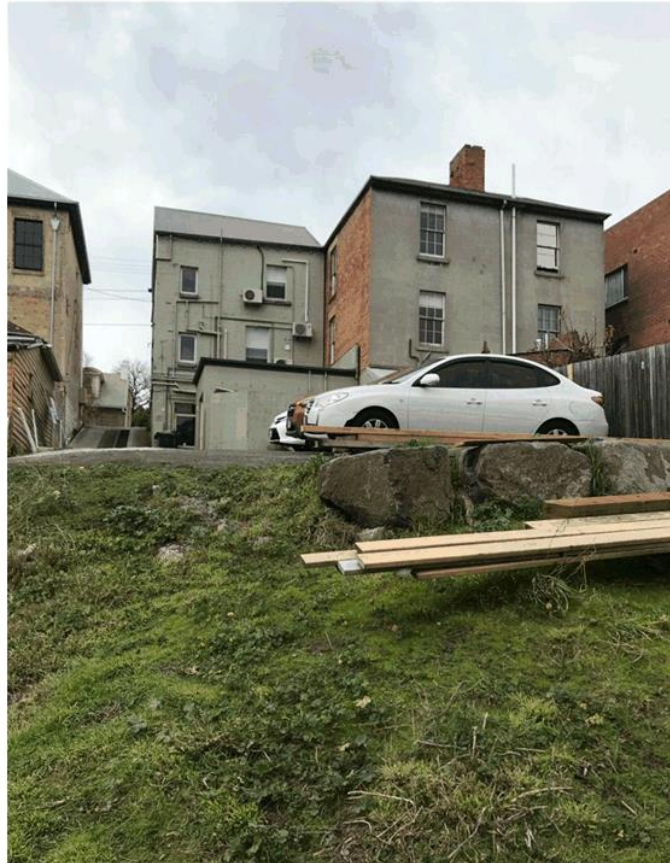
Rear of 251 Macquarie Street showing 1997 addition (Image taken by Heritage Officer July 19th 2021)

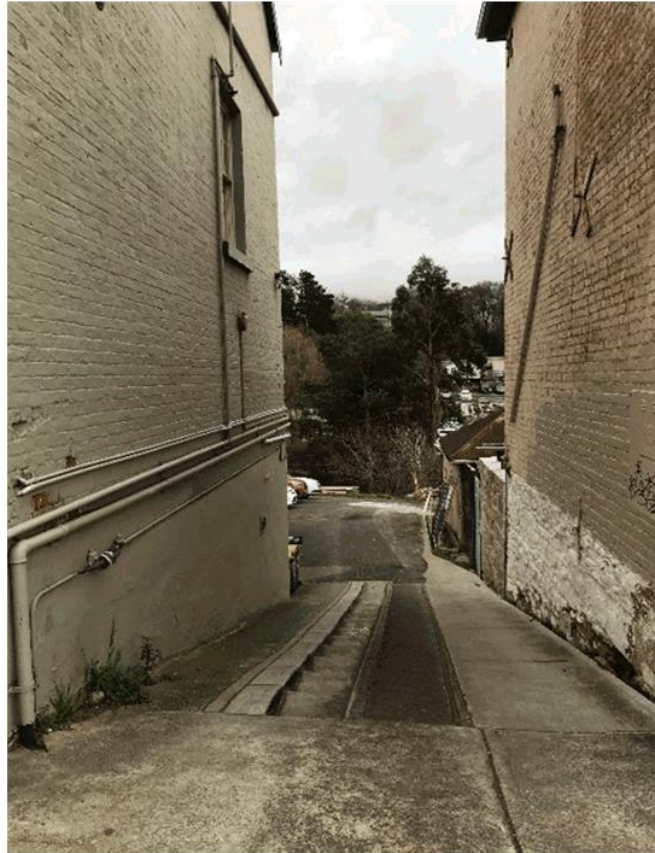
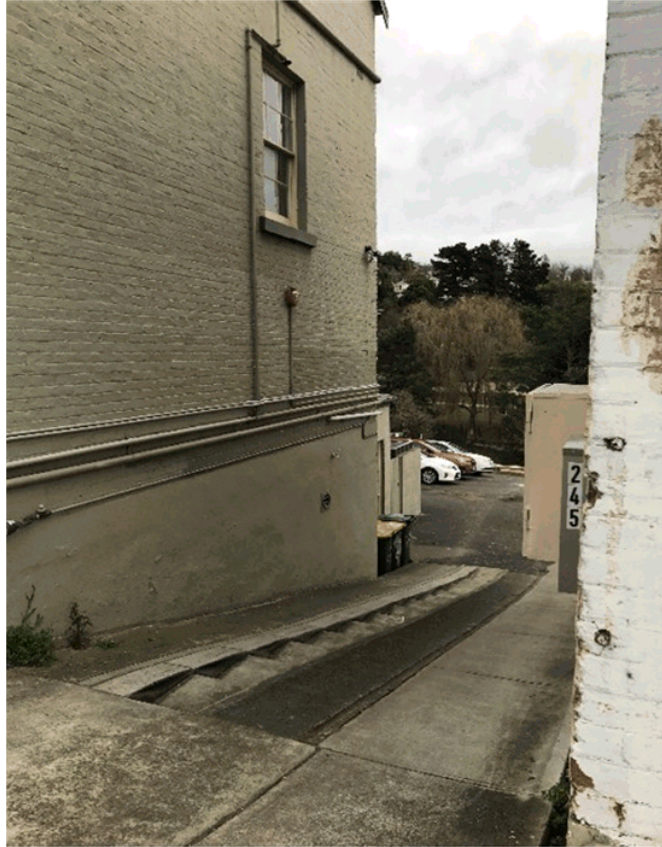
As discussed above the proposed dwelling is set back approximately 25m from the frontage of Macquarie Street, and while there will be views to the building through the shared driveway of 251 and 249 Macquarie Street it will not be prominent within the streetscape, or alter the way the

listed buildings are viewed or experienced from Macquarie Street.
Figures 2 & 3 below.

Figure 2 & 3 - Shared driveway between 251 and 247 Macquarie Street
(Image taken by Heritage Officer July 19th 2021)

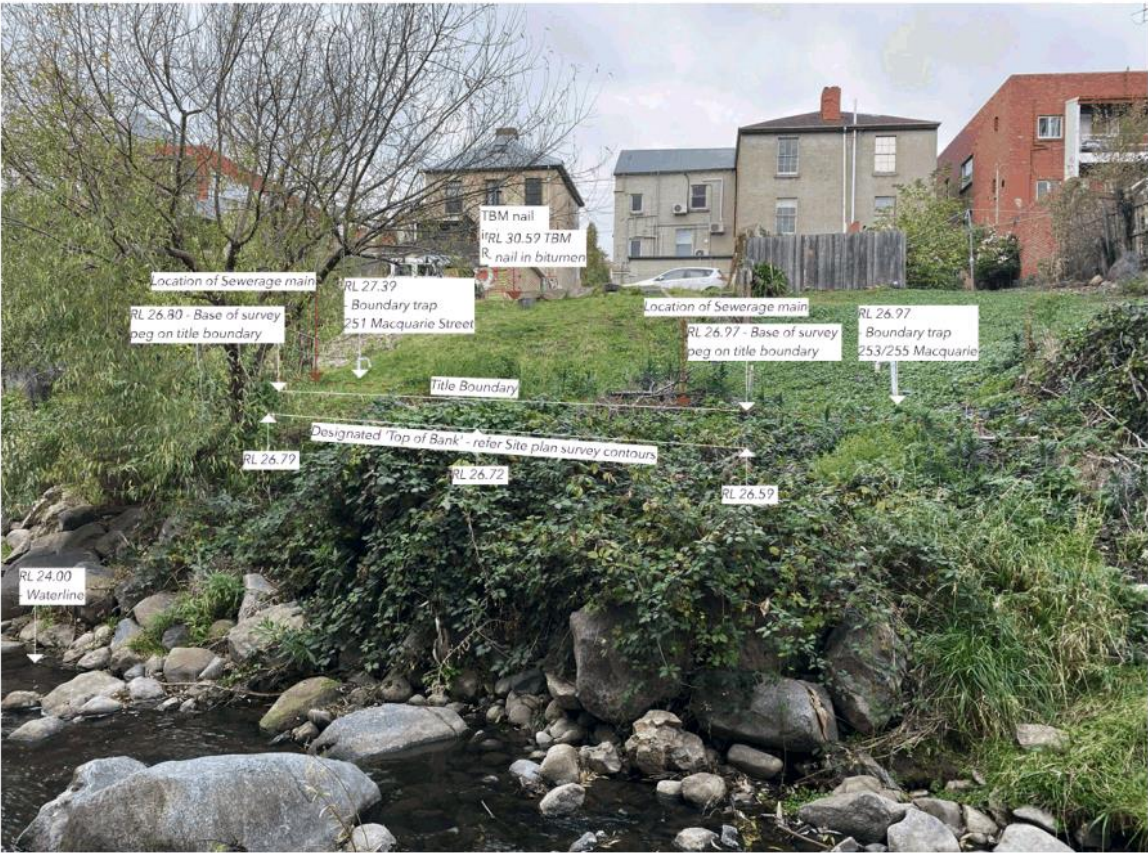
NTS Designated Top of Bank - 251 Maquarie - Hobart Rivulet

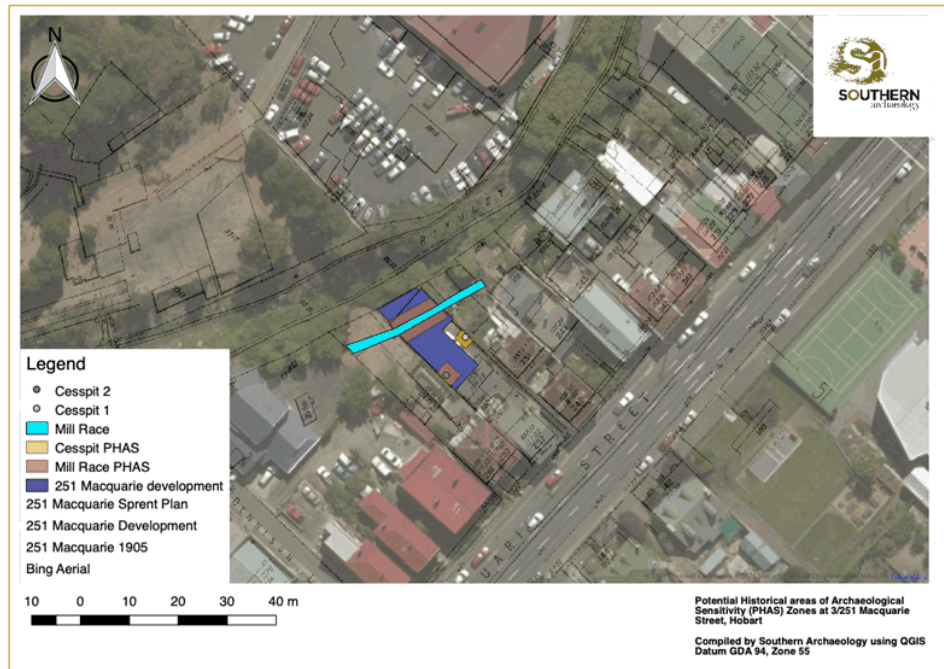
Figure 2: PHAS zones at the study area. Compiled by Darren Watton using QGIS 2021.

Three PHAS zones were identified:

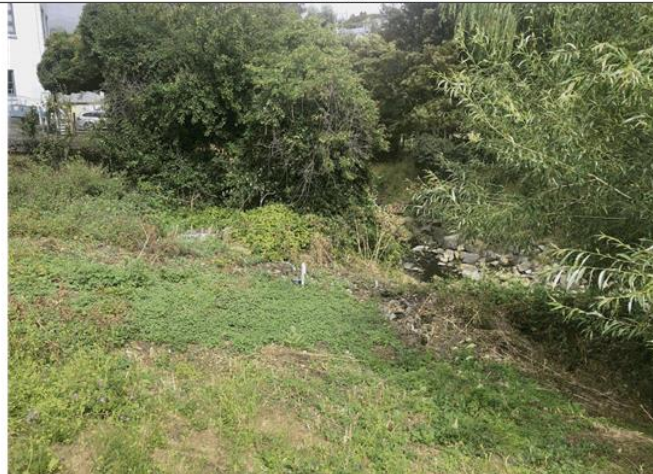
H) Location of sewerage line and Hobart Town Rivulet at the study area. This area is also where the original mill race was located.

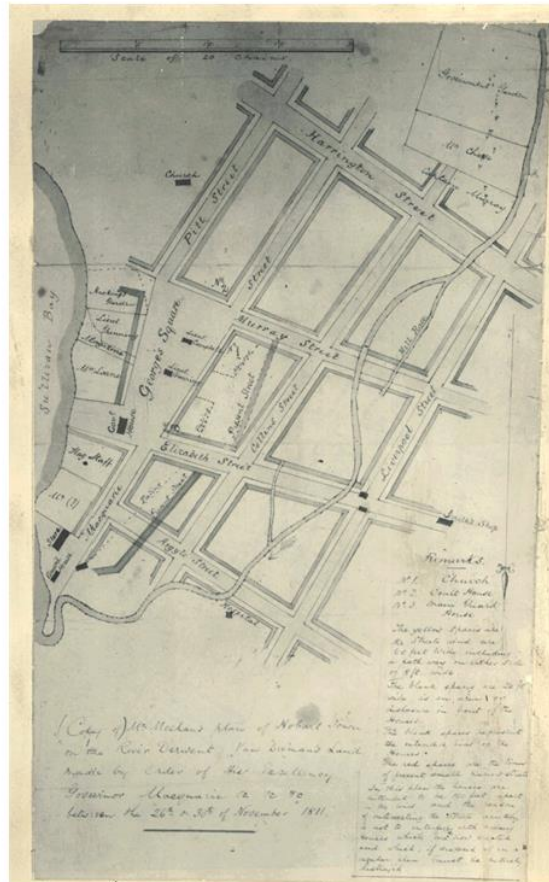
Figure 8: Copy of a plan from 1811 by Meehan showing the development around the port and the Hobart Town Rivulet.
Source: Solomon 1976:30 and Libraries Tasmania Ref: AF394-1-1 accessed 2021.

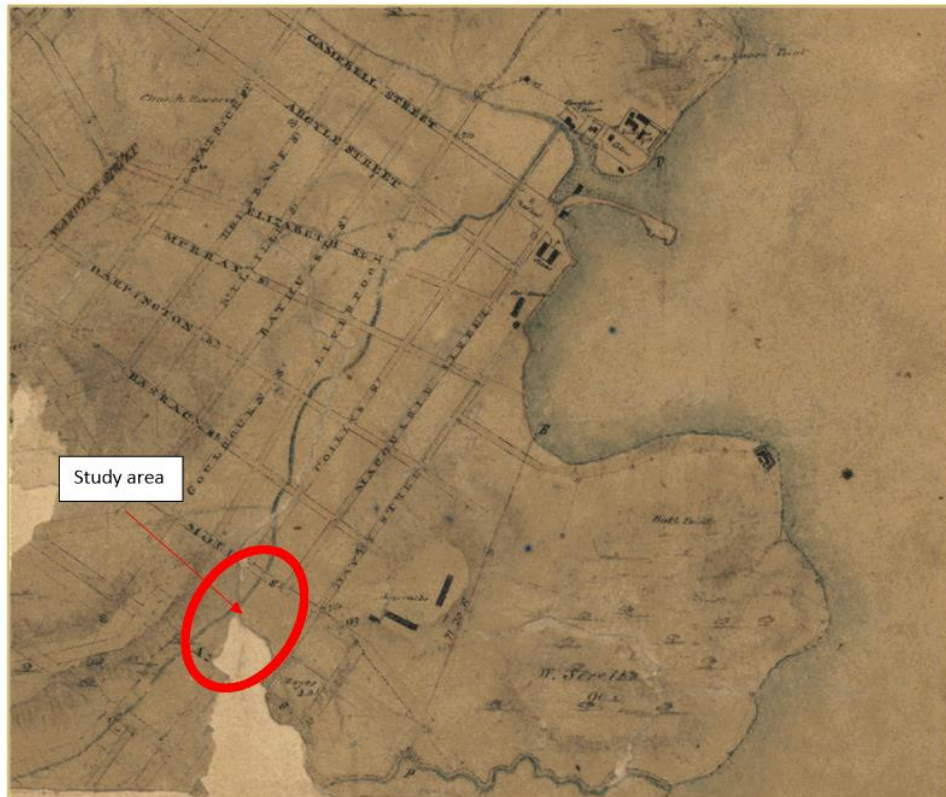
The plan below in **Figure 9** was completed by Sharland (based upon an earlier plan by Scott) and is dated to 1827. There is no development shown at the study area.

Figure 9: Section of Sharlands plan dated 1827 and based upon an earlier plan by Scott. Source: Libraries Tasmania Ref: Hobart No. 4 - AF394-1-4 accessed 2021.

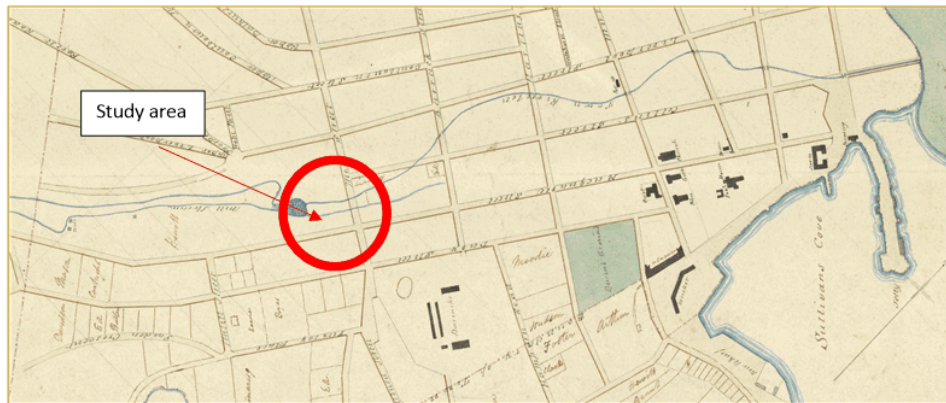
The plan in **Figure 12** is similar and is also dated 1829 but it is unclear who produced the plan. It also shows no development on the study area other than the race at this time.

Figure 12: Section of plan dated 1829. Source: Libraries Tasmania. Source: Libraries Tasmania Ref: AUTAS001136187713J2K accessed 2021.

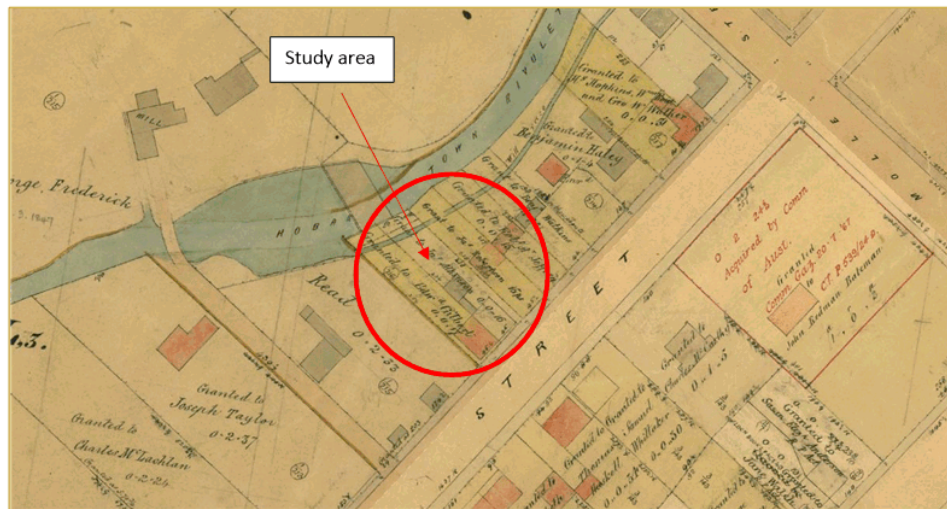
Figure 14: Section of Sprent c. 1843 plan. Source: LIST accessed 2021.

The boundaries of the earliest occupation of the site are clearly shown on Sprent's survey from c. 1843 and this plan shows the general position of the earliest timber structure on the block (**Figure 1**). Around 1853, Atkinson added 3 more tenements to the property. These are shown on the 1905 Hobart Drainage plans and documented in the Hobart Town Gazette from 1853 (see **Figure 21 in Section 6**).

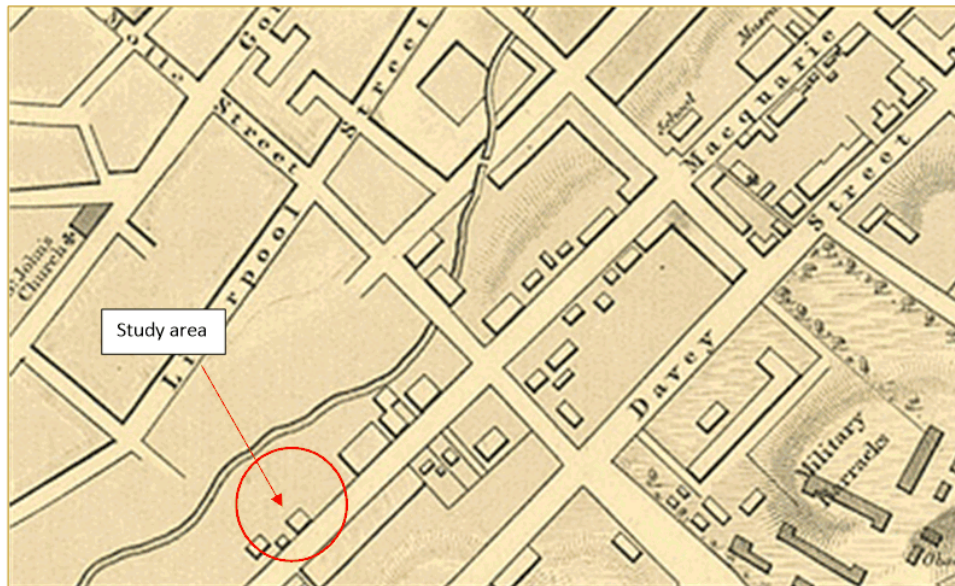
Figure 20: Section 1897 Hobart plan showing the study area. Source: Libraries Tasmania Ref: AUTAS001144581501 accessed 2021.

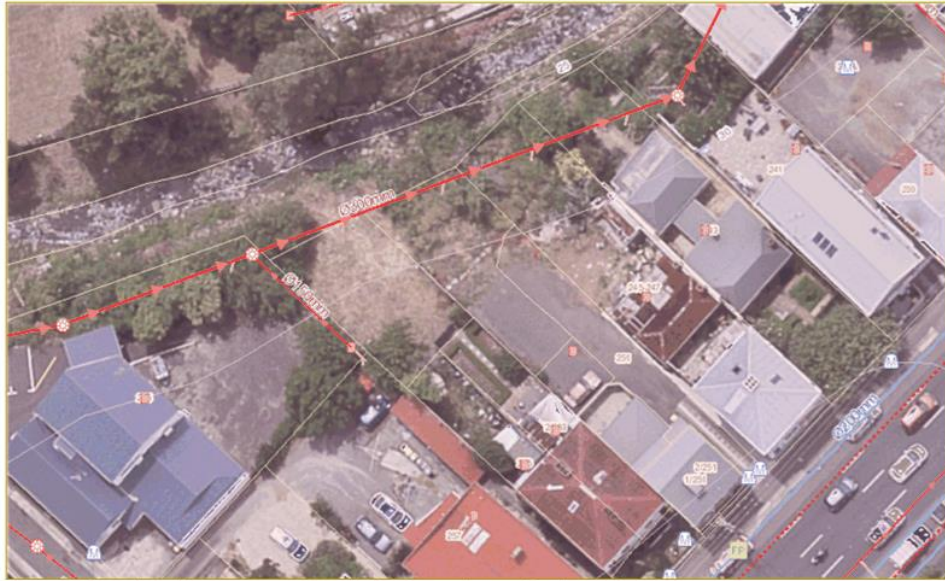
Figure 22: Sewer line alignment – constructed 1992. Source: Joanne Crawley 2021.

The property changes gradually over this time with some of the rear buildings demolished. The area of the proposed development becomes a vacant carpark. A sewer is installed alongside (and closer to the Hobart Town Rivulet) the alignment of the mill race in 1992 (**Figure 22**). Joanne Crawley becomes the owner, and a three-bedroom townhouse is proposed at the study area.

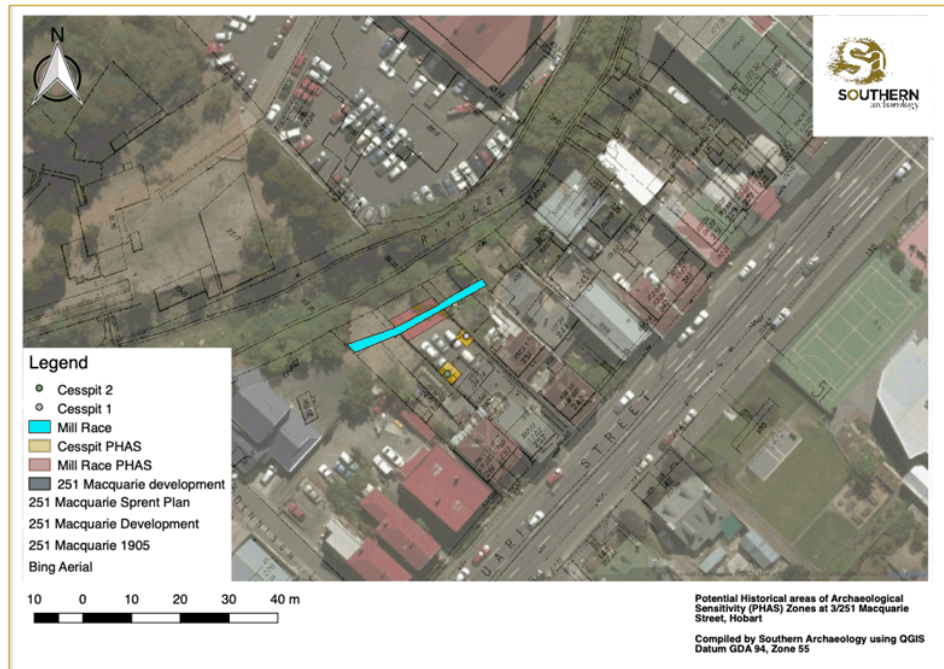
Figure 26 and Figure 27 below divide the study area into Potential Historical Archaeological Sensitivity (PHAS) Zones. These PHAS Zones have been developed to assist in understanding the main areas of where the development may impact archaeological remains and archaeological potential at the site. They also assist in focusing archaeological works at the site. The zones are as follows:

Figure 26: PHAS zones in relation to the 1905 Hobart Drainage Board plan. Compiled by Darren Watton using QGIS 2021.

- A copy of this SHAP and AMS will be sent to the proponent. The proponent should pass this on to the City of Hobart council for review and approval.
- Archaeological monitoring is to be undertaken, by a qualified archaeologist, during sub-surface works as detailed in this AMS (see **Section 11**) especially within the areas identified in the PHAS zones shown in **Figure 26 and Figure 27**. This is to be completed as follows:

The procedures for archaeological monitoring are outlined in this AMS report to satisfy the legislative requirements. The archaeological monitoring (supervised by an archaeologist) will establish if any archaeological remains are present in the development area. **Figure 26 and Figure 27** above detail the PHAS Zones within the area of the development and provide a guide as to where archaeological monitoring should be prioritised.

- A copy of this SHAP and AMS be supplied to the City of Hobart Council and the proponent for review and approval.
- A suitably qualified archaeologist supervise the archaeological monitoring works within areas of archaeological potential as set out in the Red and Orange PHAS Zones in **Figure 26 and Figure 27** above.

- A qualified archaeologist will supervise all archaeological works.
- The Red and Orange PHAS Zones in **Figure 26** and **Figure 27** set out the areas or zones where archaeological potential is possible. These PHAS Zones will guide and focus archaeological monitoring. Monitoring may extend beyond the areas if required by the archaeologist and/or if further archaeological features or materials are uncovered.

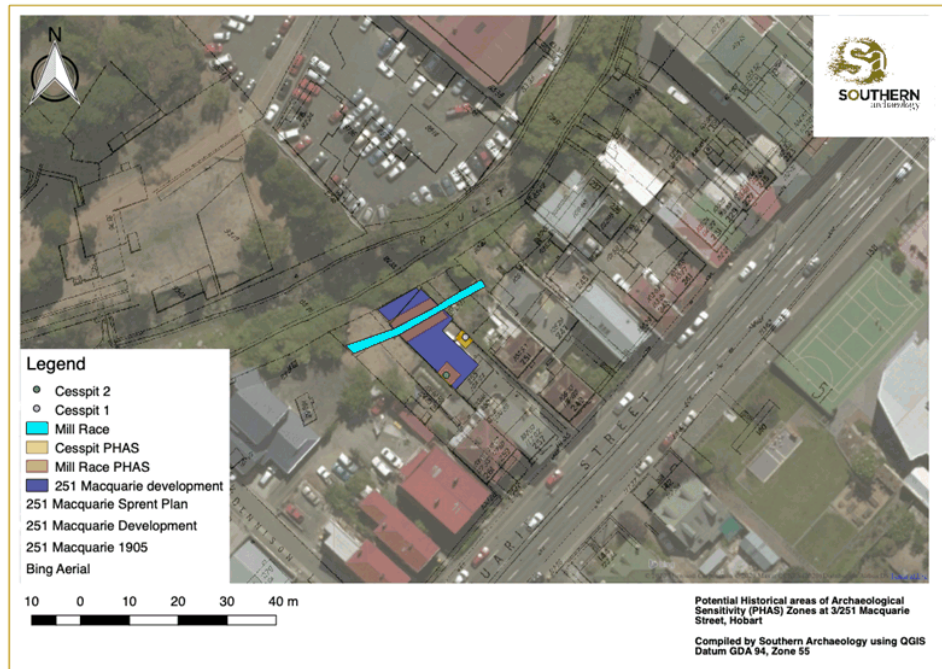
Figure 27: PHAS zones in relation to the proposed development at 3/251 Macquarie Street. Compiled by Darren Watton using QGIS 2021.

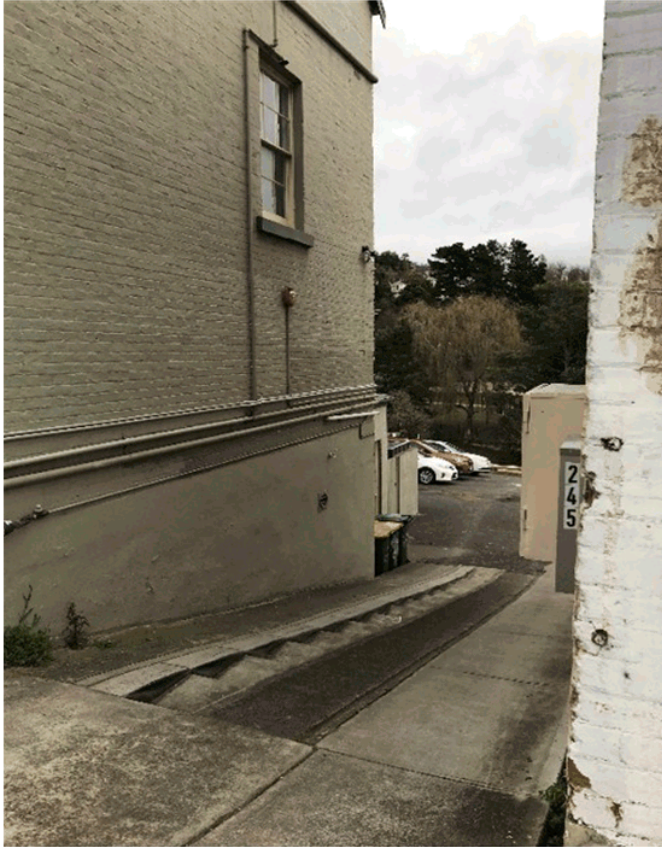
Figure 2 & 3 - Shared driveway between 251 and 247 Macquarie Street (Image taken by Heritage Officer July 19th 2021)

In regards to the siting with respect to buildings, structures and listed elements the proposed new dwelling is largely located behind the footprint and bulk of 251 Macquarie Street, the rear eastern section of the new dwelling is proposed to protrude beyond the eastern setbacks of the existing buildings on site, however this protrusion is less than 3 metres and approximately 33m from the Macquarie Street frontage, minimizing its impact upon the streetscape.

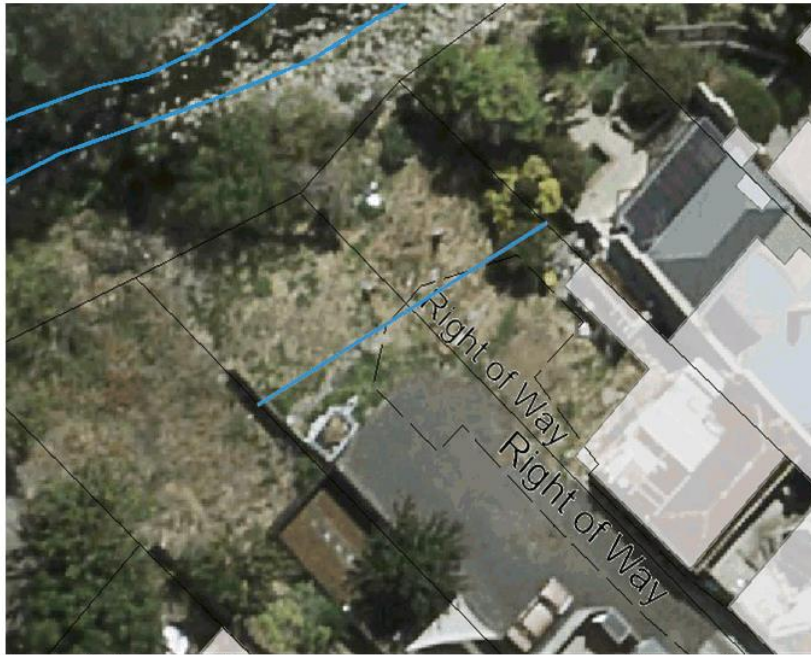
The Code applies because development is proposed within a waterway protection area. The extent of the WPA is 10m from the top of the bank of Hobart Rivulet (refer to Image 1 below).

Image 1: Approximate extent of waterway protection area (blue line)

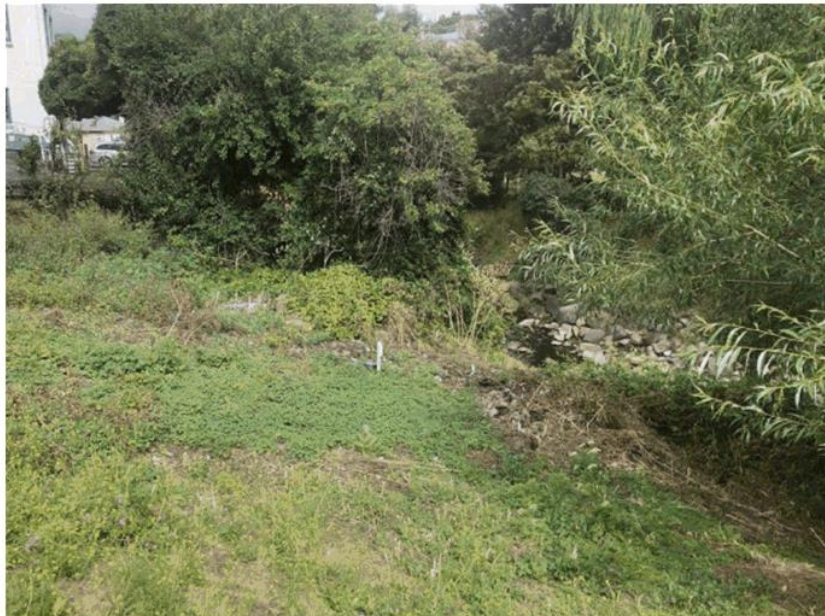
The land does not appear to have been modified with landscaping or plantings, and supports grass and weeds (refer to Images 2 and 3 below).

Image 2: Site near Hobart Rivulet boundary (taken from submitted archaeology report)

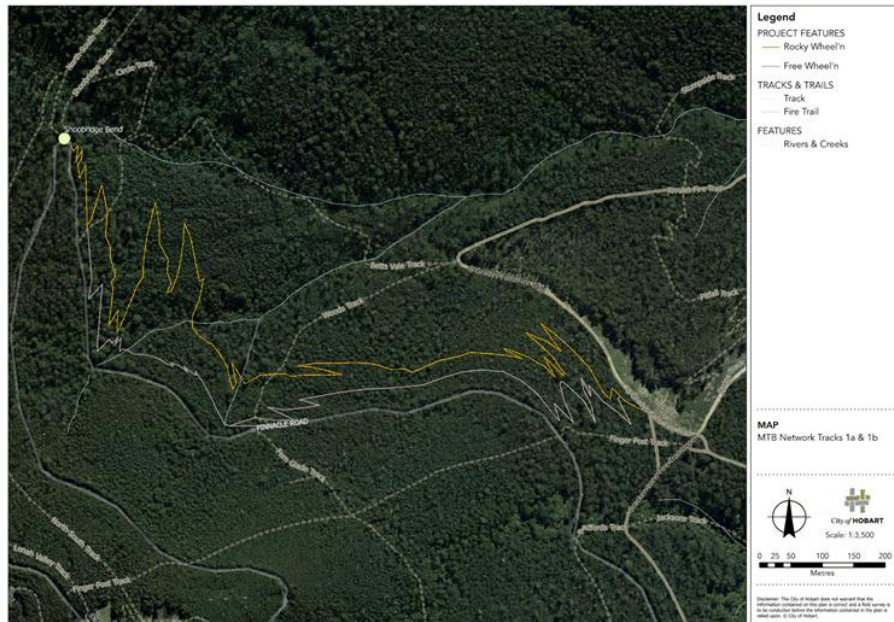
Figure 1: Excerpt from the submitted application showing the alignment of the proposed Rocky Wheel'n and Free Wheel'n trails amongst the existing trail network.

- Generally, construction activities of the tracks will include the removal of an approximate 1.5m wide strip of understorey and ground cover vegetation along the track alignment, which will avoid trees, large logs, and abrupt changes in topography. The track surface will be created by scraping away the surface mulch and debris down to a firm natural surface and benching where necessary.

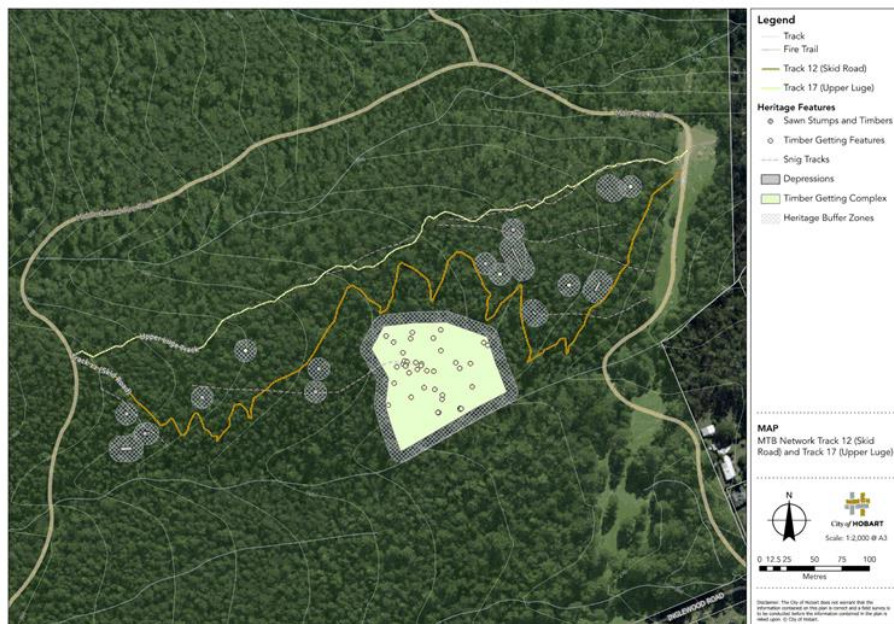
Figure 2: Excerpt from the submitted application showing the alignment of the proposed Skid Road trail and the formalised Upper luge trail amongst the existing trail network.

- Between the Main Fire Trail and the Middle Island Fire Trail (Figure 2), a newly proposed track - 'Skid Road' will provide a shared, dual direction for walkers and runners but uphill only for mountain bike trail, allowing access to the upper section of the Middle Island Fire Trail. An existing informal shared dual direction trail known as 'Upper Luge' is also proposed to be formalised as a mountain bike only, downhill only trail, utilising the current trail alignment. Both the new and formalised trails in this area are to be intermediate (Blue) standard, incorporating more features to challenge more experienced riders.

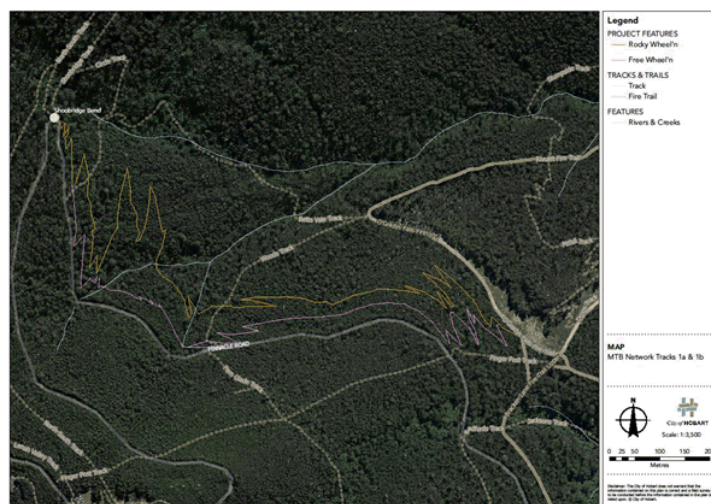
Map – Alignment of Tracks 1a (Rocky Wheel'n) & 1b (Free Wheel'n)

1a (Rocky Wheel'n) forms a connection between Bracken Lane Fire trail and Shoobridge Bend, allowing all track users access to North South Track from Fern Tree and South Hobart. The track traverses moderate to steep forested terrain, with the lower section considerably drier and more open than the top section. Overall the intention is that all users will be provided a means of climbing to Shoobridge Bend away from the road in a safe and pleasing natural environment. The main trail will be well formed, smooth and with some gentle climbs, average gradient of 4-5%, with a maximum of 15% for 10m; predictable with no surprises and suitable for beginner riders. The gentle gradient will make climbing the track achievable by most ages and fitness levels. Riders can develop balance and gear choice skills, and increase skill level on optional lines.

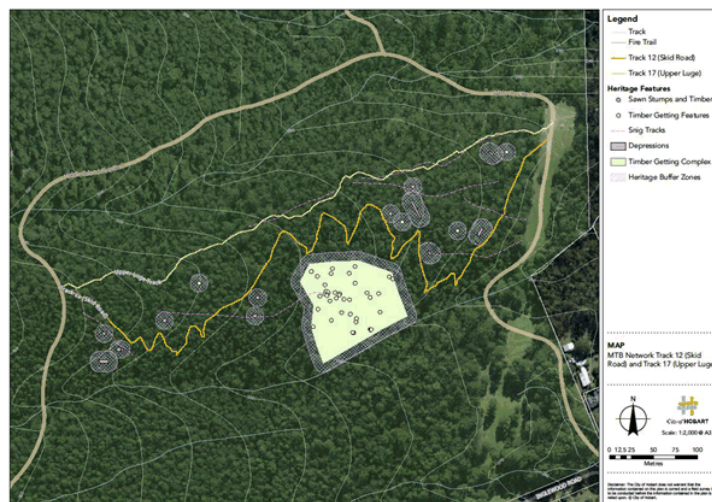
Map – Alignment of Tracks 1a (Rocky Wheel'n) & 1b (Free Wheel'n)

Track 12 (Skid Road) will form a connection between Main Fire Trail and Middle Island Fire Trail, allowing all track users to access the lower foothills of kunanyi /

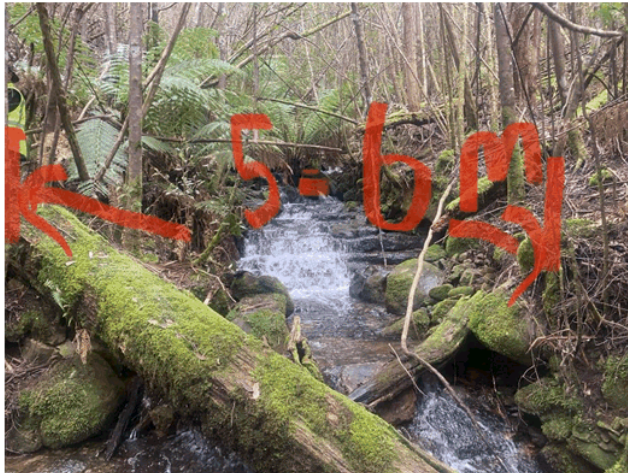
Photo 1: Hobart Rivulet / Rocky Wheel'n crossing (proposed 6m bridge):

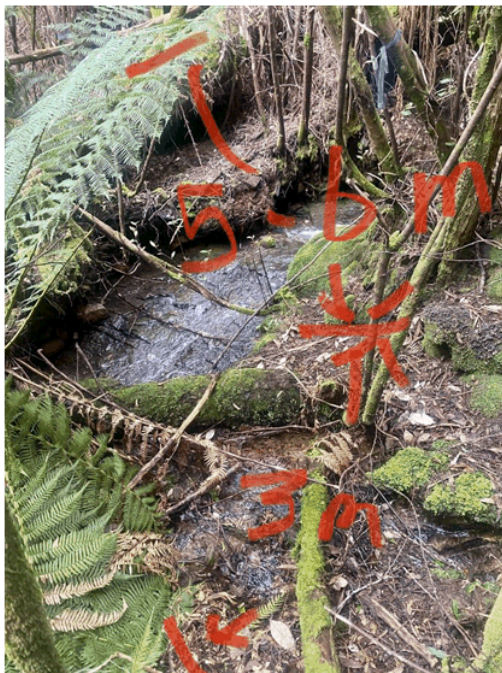
Photo 2: Hobart Rivulet / Free Wheel'n crossing (proposed 6m bridge + 3m bridge or causeway):

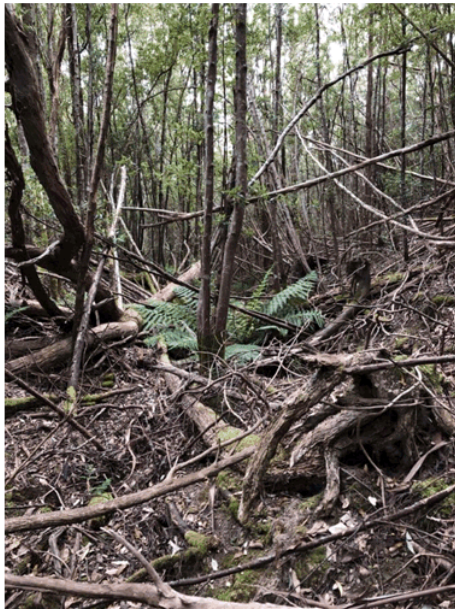
Photo 3: Hobart rivulet tributary lower crossing (proposed causeway)

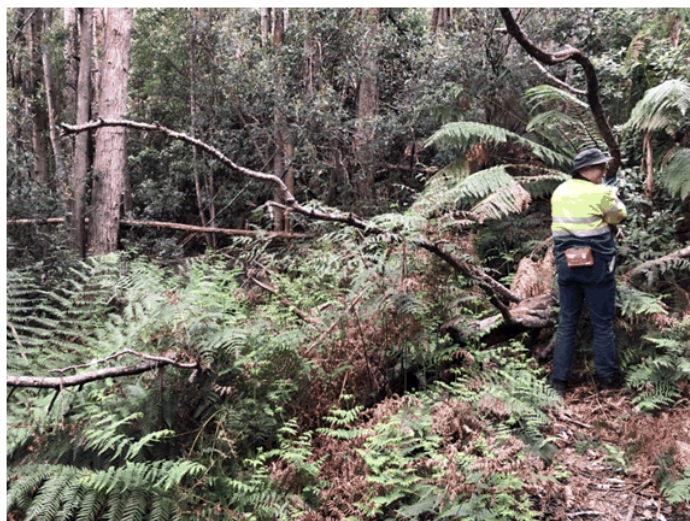
Photo 4: Hobart rivulet tributary upper crossing (proposed causeway)

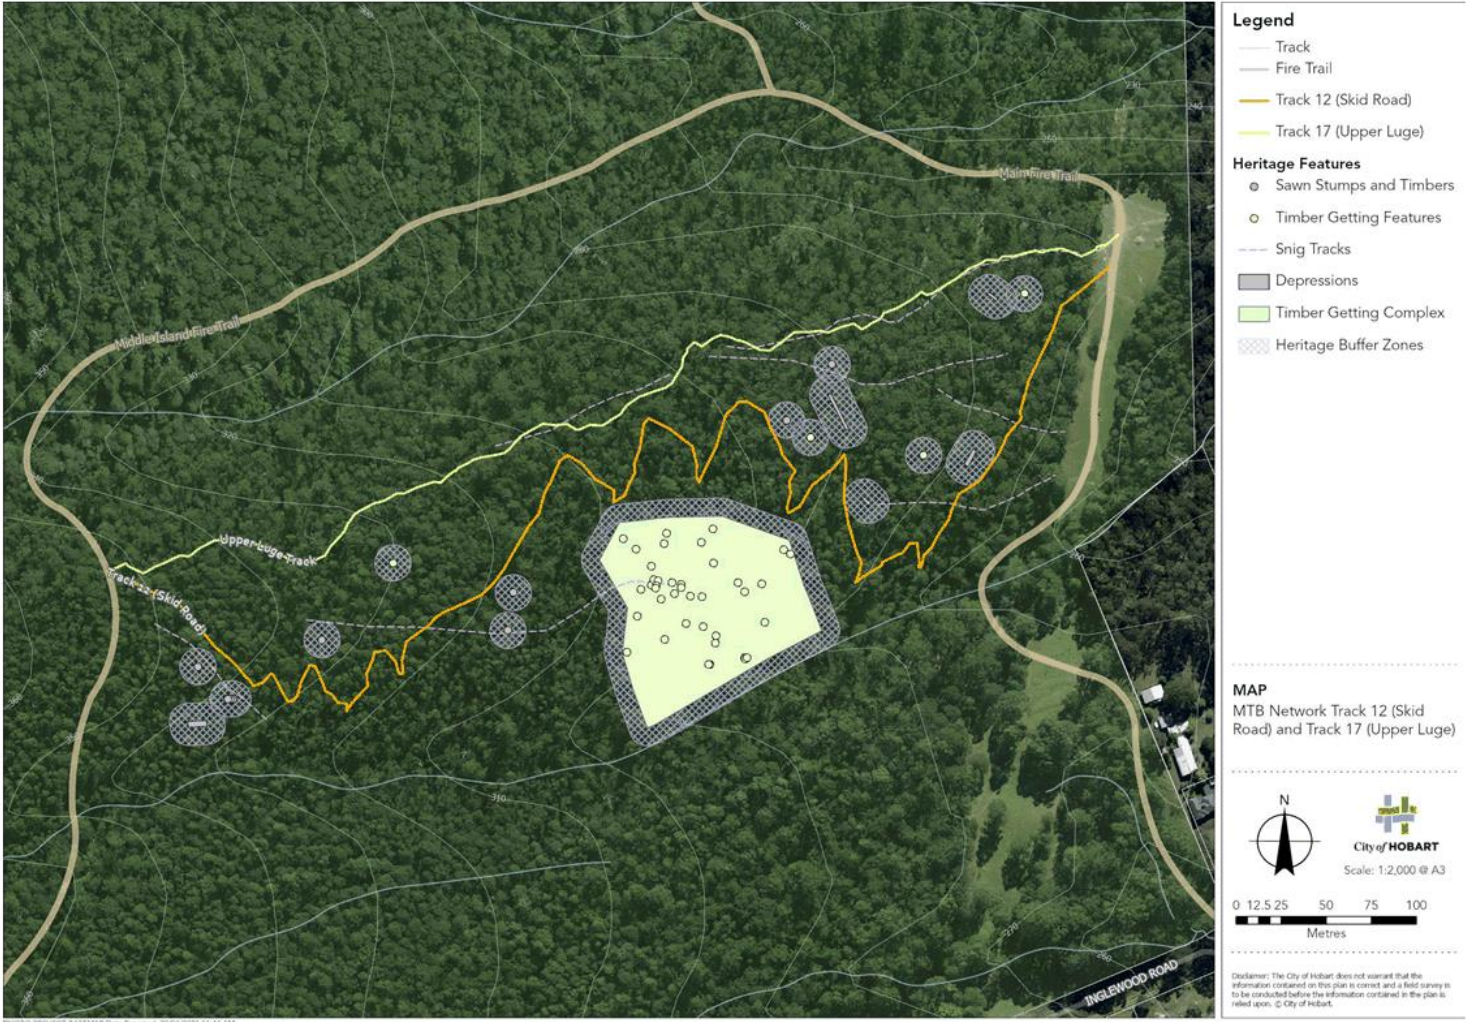
Appendix 1: Map 1 - MTB Network Track 12 and Track 17

MTB Project 20/21 Design Specification requirements

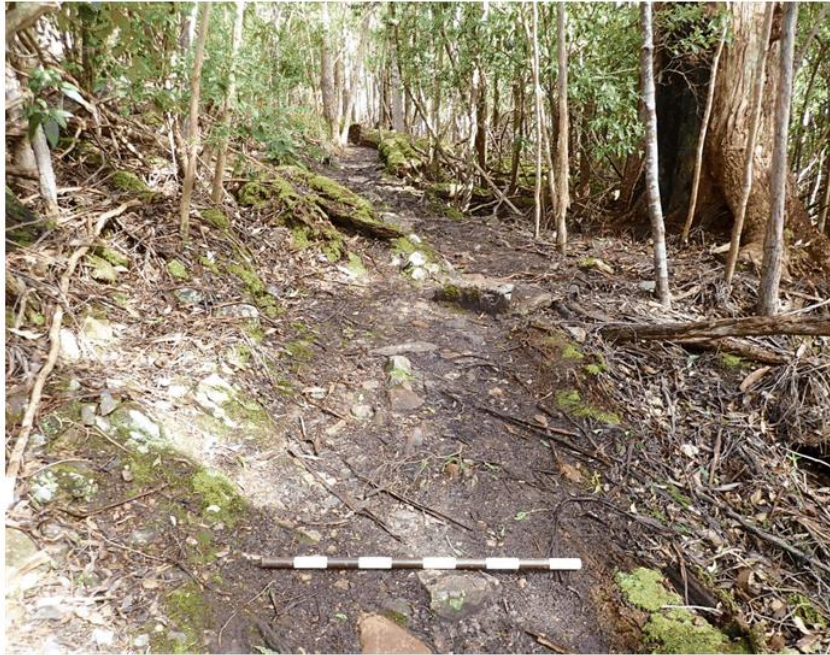
Figure 6.1.3 Looking to the south over a twentieth century track within Study Area One, showing its associated disturbance and exposure. The scale has 100mm marks (15 February 2021).

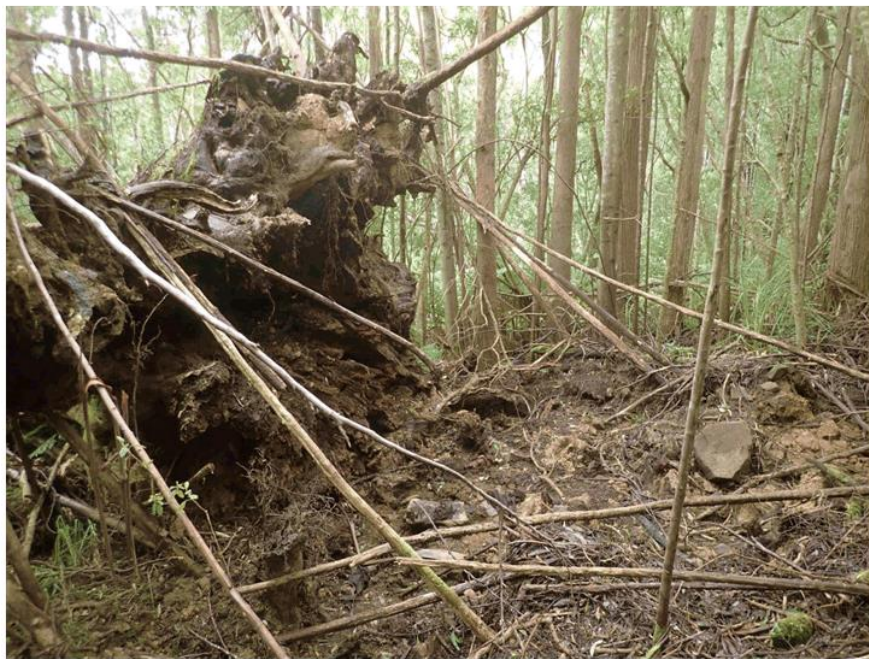
Figure 6.1.4 Looking to the east showing the soil turned up by a recently fallen tree. Clearly visible are the dolerite blocks and sandy clay soil common through this study area (15 February 2021).

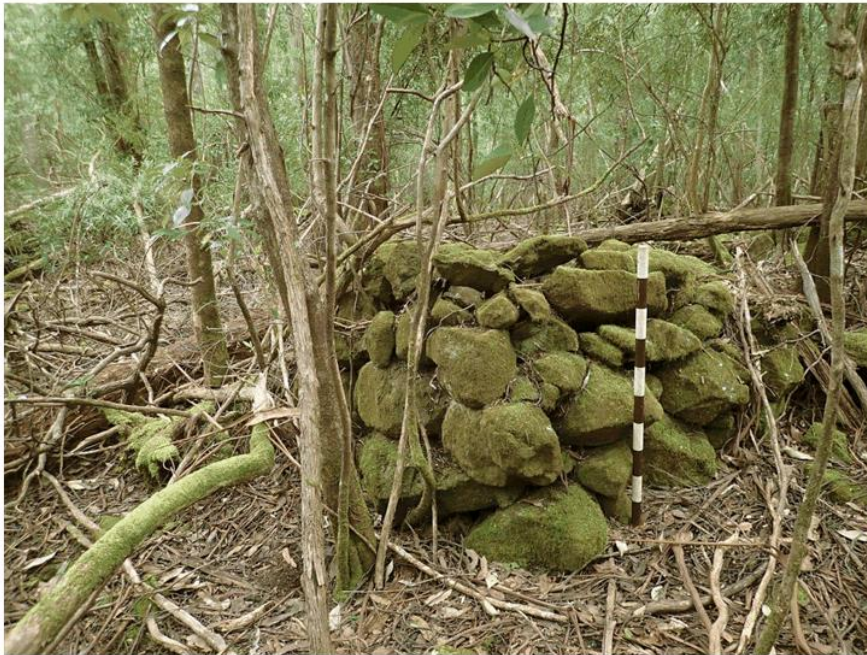
Figure 6.2.4 A stone cairn formed as part of early nineteenth century timber getting, indicative of the high levels of disturbance caused by the European modification of this area. The scale has 100mm marks (15 February 2021).

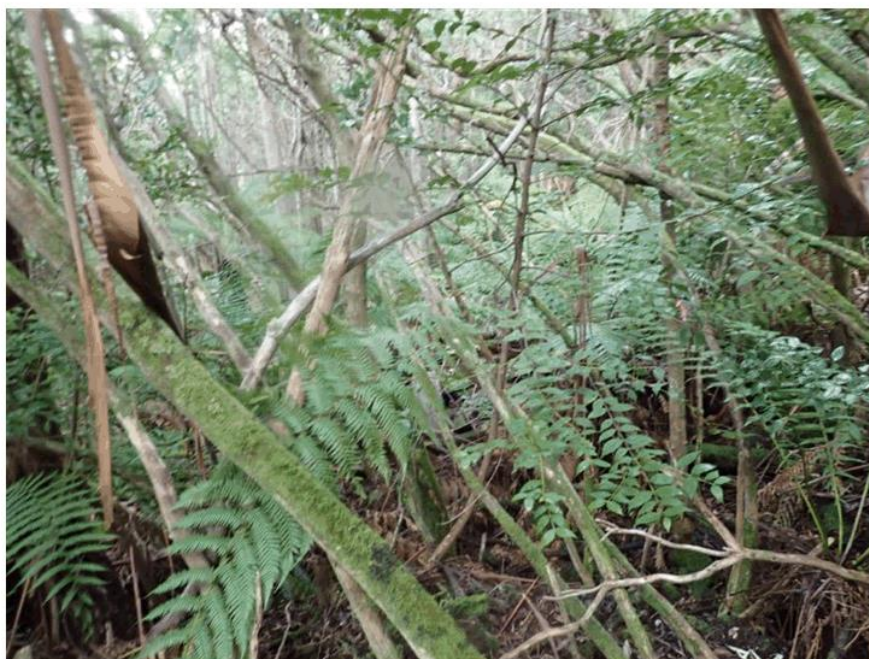
Figure 5.1.1 Typical vegetation and ground surface visibility within Survey Area One; visible in the photograph is pink flagging tape marking the location of proposed Track 1a.

Parts of the Circle Track and vehicle track were observed within this survey area. The proposed Tracks 1a and 1b both intersect with the Circle Track and Track 1b is within the vehicle access track. The intersection of the proposed Track 1a occurs with Circle Track both close to Pinnacle Road and at some distance to the east whereas Track 1b is likely to cross the Circle Track only close to Pinnacle Road. At this location Circle Track is an approximately 1m wide clay pad with either a rough stone rubble border or where raised above the slope slightly, supported by random coursed rubble.

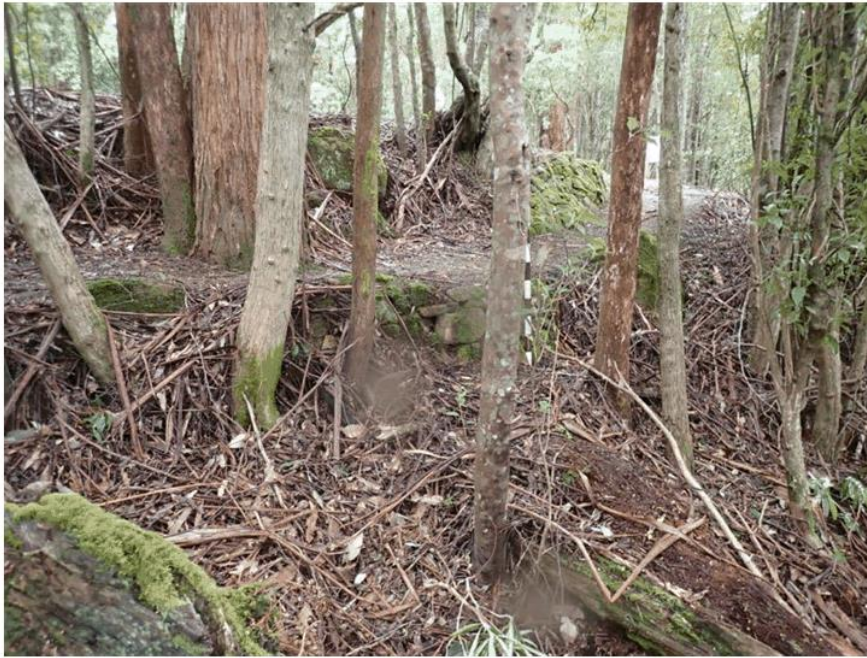
Figure 5.2.1 View west showing the entrance to the Circle Track adjacent to Pinnacle Road. Shown in the centre of the photograph is the random coursed rubble supporting structure below the track. The scale has 100mm marks.

This section of the Circle Track consists of a northeast aligned benched track up to 1.5m in width, with stones forming part of the tracks structure as a footing in areas of steeper grade or as edging, possibly pushed to the side during construction, along the length of the track. The surface of this track is a natural clay pad. In some places within the study area the track is less distinct or covered with debris. It is likely that this track was constructed in the early twentieth century to connect existing tracks and is therefore not a primary element in the historical track network of the mountain.

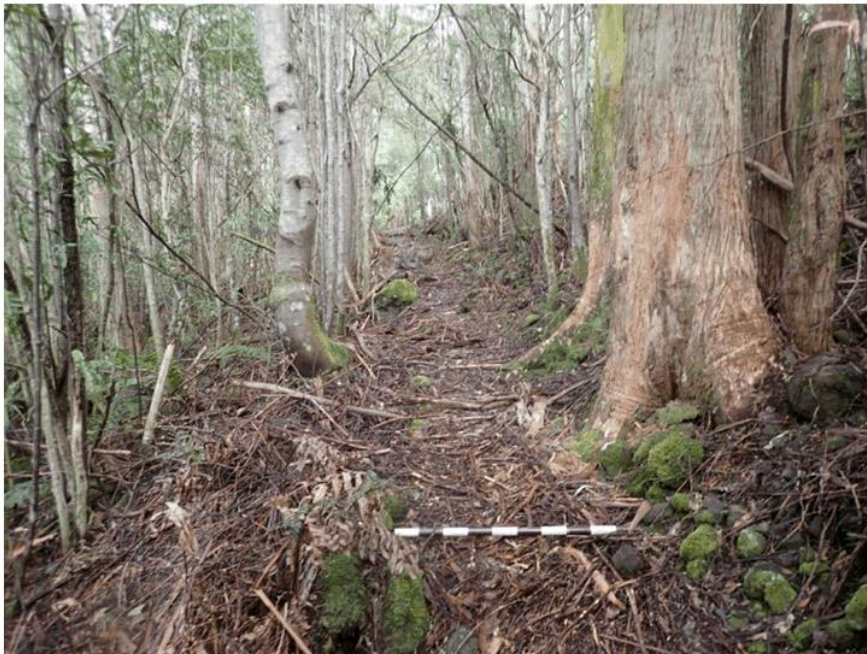
Figure 5.2.2 View to the west over the centre of the Circle Track showing the pink flagging tape marking the line of the proposed Track 1a visible in the right of the photograph.

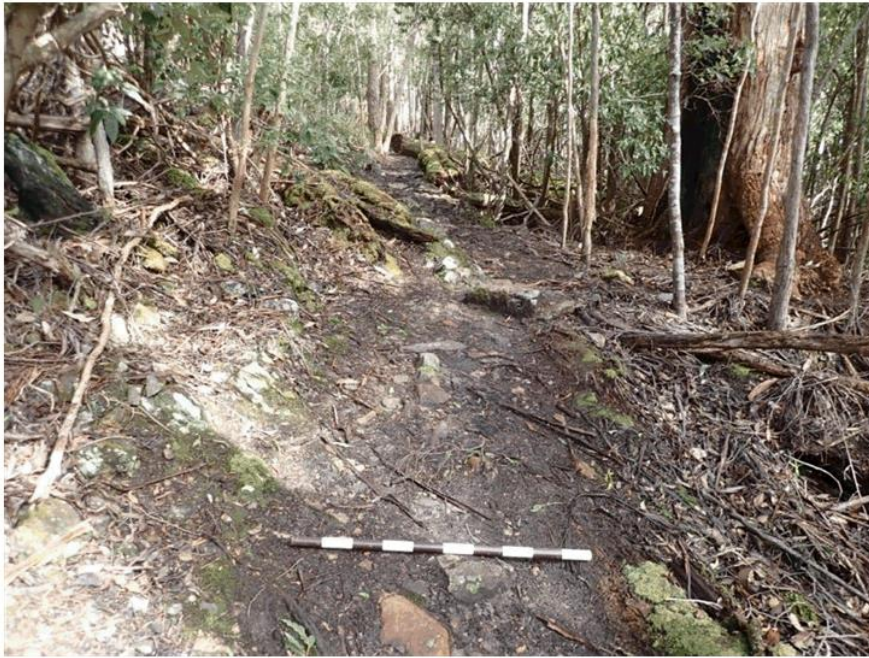
This feature consists of a linear path that runs north to south across the study area. It varies in width between 1-1.2m and the grade varies along the length of the track. Within the study area the track is formed of a clay pad with occasional areas of rough coursed rubble edges. It is likely that as this track connects the Rivulet Track and the Fingerpost Track. It is part of late twentieth century construction or reconstruction. Little additional information is known about this track.

Figure 5.2.3 Looking north along Woods Track from the point where Track 1a is proposed to intersect with it. The scale has 100mm marks.
