CITY OF HOBART

City Planning Committee Meeting

Monday, 30 August 2021

7.1 APPLICATIONS UNDER THE HOBART INTERIM PLANNING SCHEME 2015	7
7.1.1 251 Macquarie Street and 245-247 Macquarie Street, Hobart - Three Multiple Dwellings (Two Existing, One New).....	7

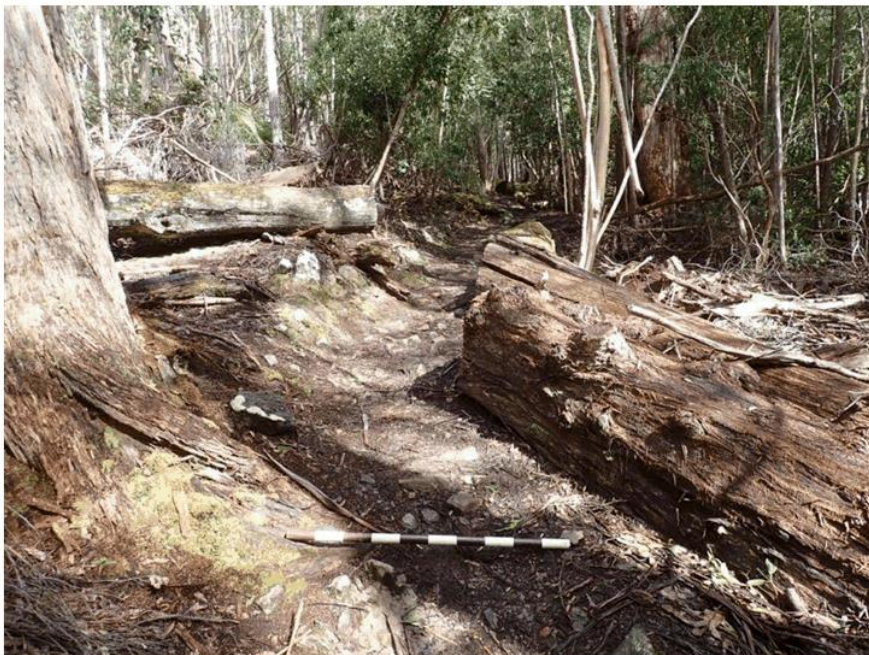
Figure 5.2.4 View to the west over the centre of the track. The scale has 100mm marks.

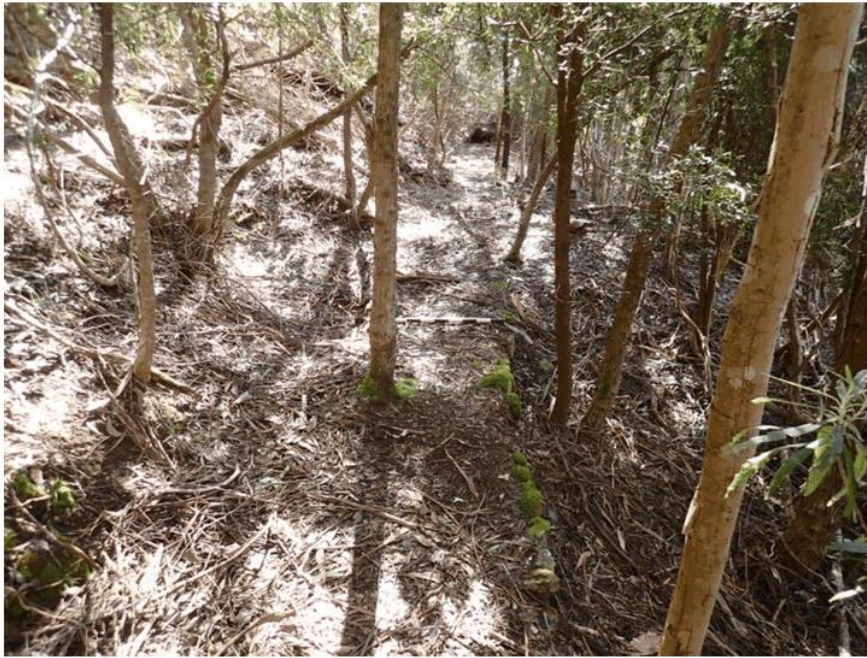
This track is formed of a combination of benching, uncoursed random rubble facing beneath and a clay surface. However, this track is in varying states of repair with 5-10m stretches no longer being visible on the surface and possibly entirely removed. Throughout the length of the track small trees and saplings are growing and in some sections the track is no longer passable due to large trees that have fallen across the way. This track is most distinct at its junction with the former section of the Fingerpost Track. However some sections of this track where it crosses low points in the terrain exhibit up to 400mm of random uncoursed rubble beneath the track surface. The track is reasonably level with benching in parts of the hill side in order to continue the curve of the track around the hill face. This track is at least 200m in length within the study area and continues further to both the north and the south.

Figure 5.2.5 Looking north along the unnamed remnant track. The scale has 100mm marks.

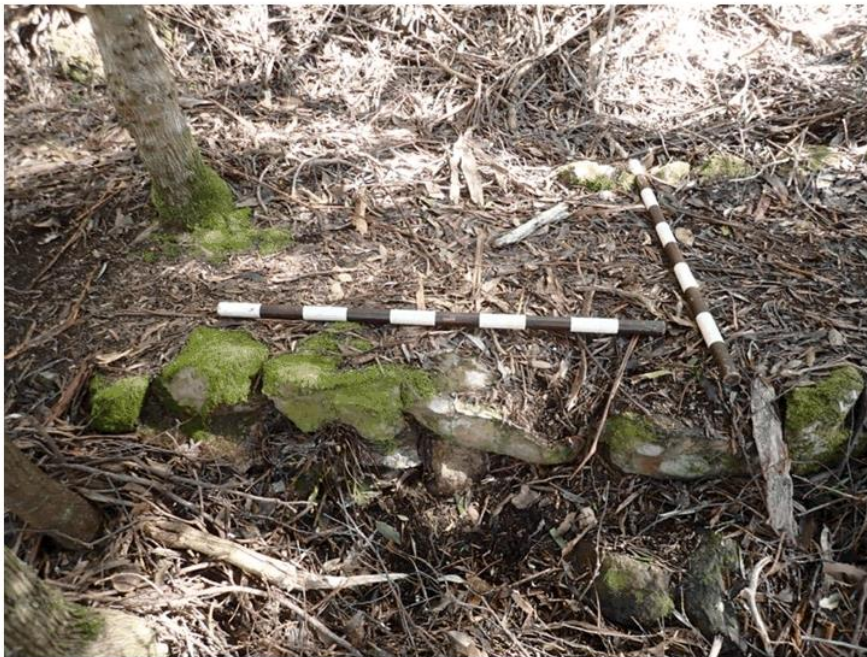
Figure 5.2.6 Detail view of the uncoursed stone rubble forming the base of the track. The scale has 100mm marks.

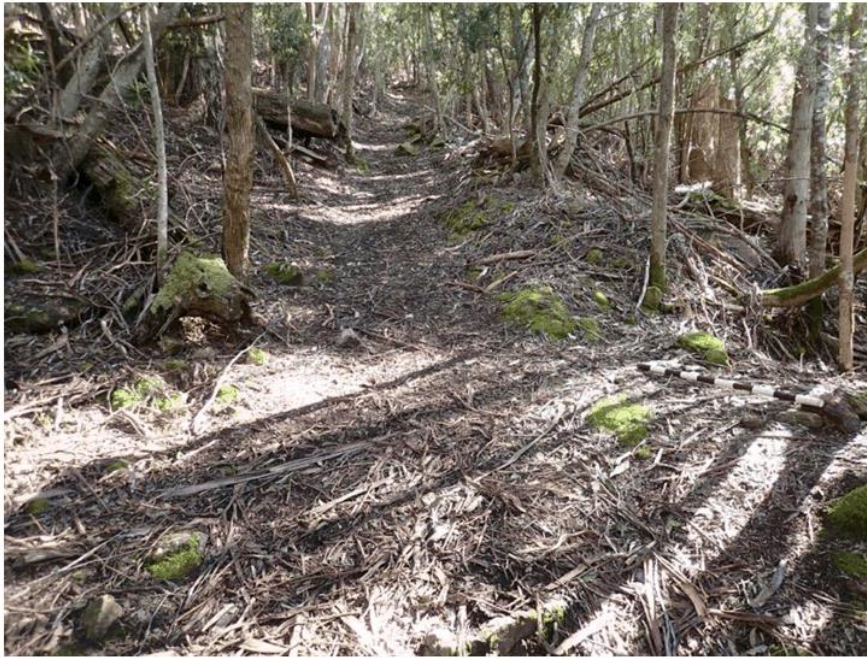
This feature is an approximately 120m long section of the former Fingerpost Track formed of natural clay and rock. It is 1-1.4m wide and is formed on a rocky clay surface, which likely represents the wearing down of this track in the natural strata of this area. The track surface is within a slightly concave depression that likely indicates the length of time and the informal manner of formation that has created the current form of this track, with it likely being in use from the middle of the nineteenth century. This track intersects with another track, currently unused but more formally constructed, likely later than the Fingerpost Track, about half way up its length.

Figure 5.2.7 Looking south along a former part of the Fingerpost Track, the scale in the right of the photograph indicates its intersection with the unnamed remnant track. The scale has 100mm marks.

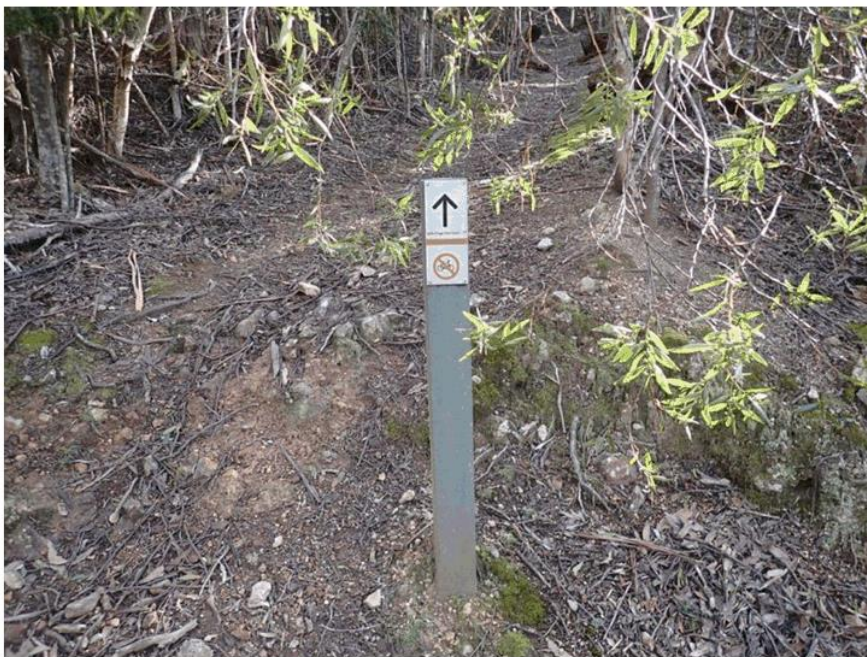
Figure 5.2.8 Looking south along the former part of Fingerpost Track near its intersection with O'Grady's Falls Fire Trail.

The provided provisional alignment of the proposed Track 1b will cross and recross Fingerpost Track several times, however, after the field investigation, discussion with Hobart City Council has established that the alignment is not intended to reach this far out of the study area and that Fingerpost Track will not be damaged by the proposed works. Knowing that Hobart City Council have committed to this change it is possible to formulate the following mitigation advice.

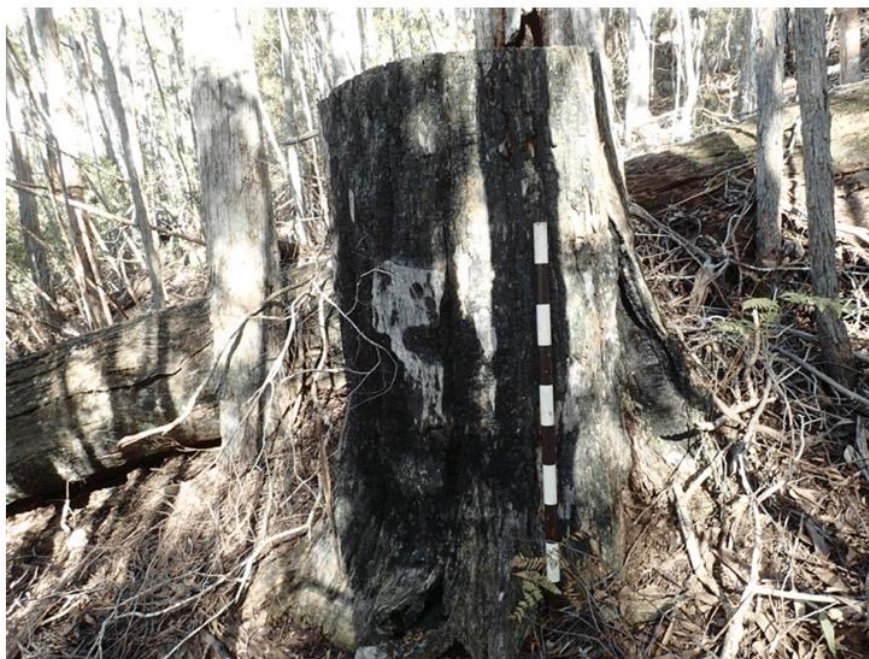
This feature is a single sawn Eucalypt stump on a moderately graded slope within the study area. It consists of a single stump ~1m in diameter with a clear saw cut at its surface. However, it is not clear from any marks on the timber by what method the tree had been felled. No other similarly modified stumps were extent in this area.

Figure 5.2.9 Looking east at the sawn stump. The scale has 100mm marks.

The presence of this sawn stump should be noted in works specifications and avoided if consideration of alterations to the proposed track take place. All staff and contractors should be given heritage inductions regarding historical archaeological features and deposits with specific reference to cultural traces left by timber-getting.

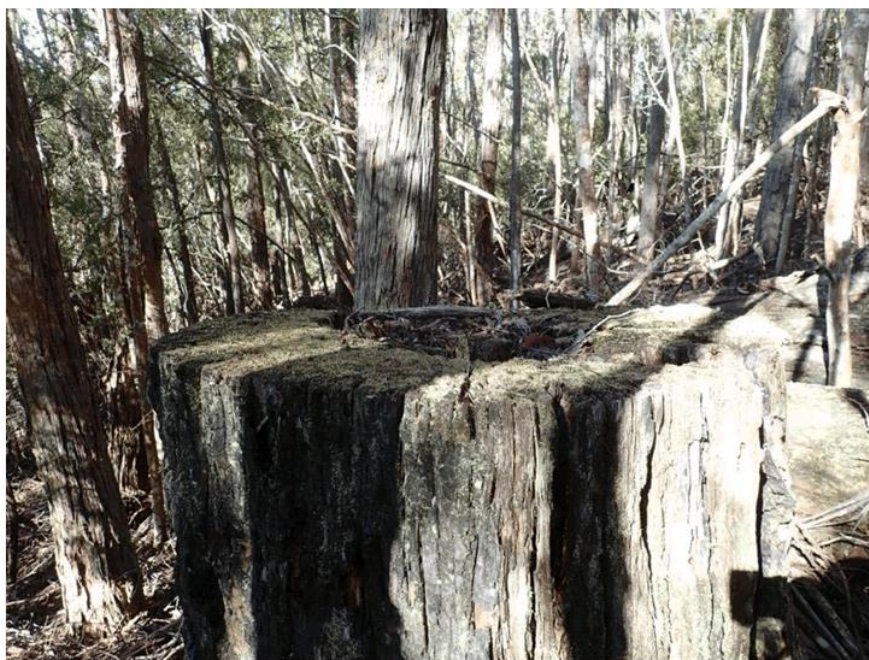
Figure 5.2.10 Detail view of the surface of the sawn stump showing that its degradation precludes accurate identification of its method of sawing.

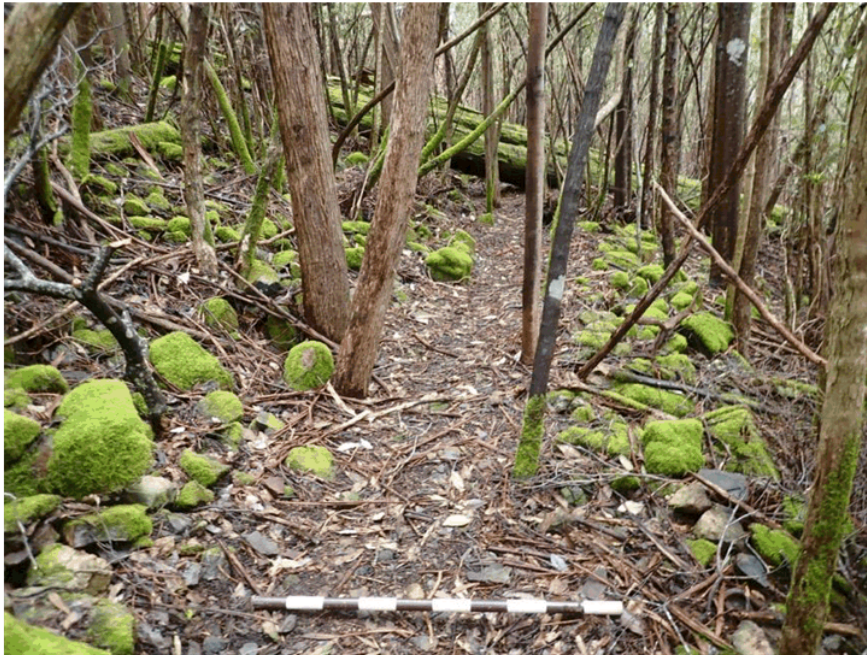
Where present the Featherstone Cascades Track varies from between 900-120mm in width, with stone rubble bordering either side, likely as a result of being moved out of the way during construction. The track is discernible on the northwestern approach but varies in its state of repair, with some sections heavily damaged by tree growth and deadfall. Generally only spindly mid-storey trees are growing in the surface of the track.

Figure 5.2.11 Looking north northwest along Featherstones Cascade Track. The scale has 100mm marks.

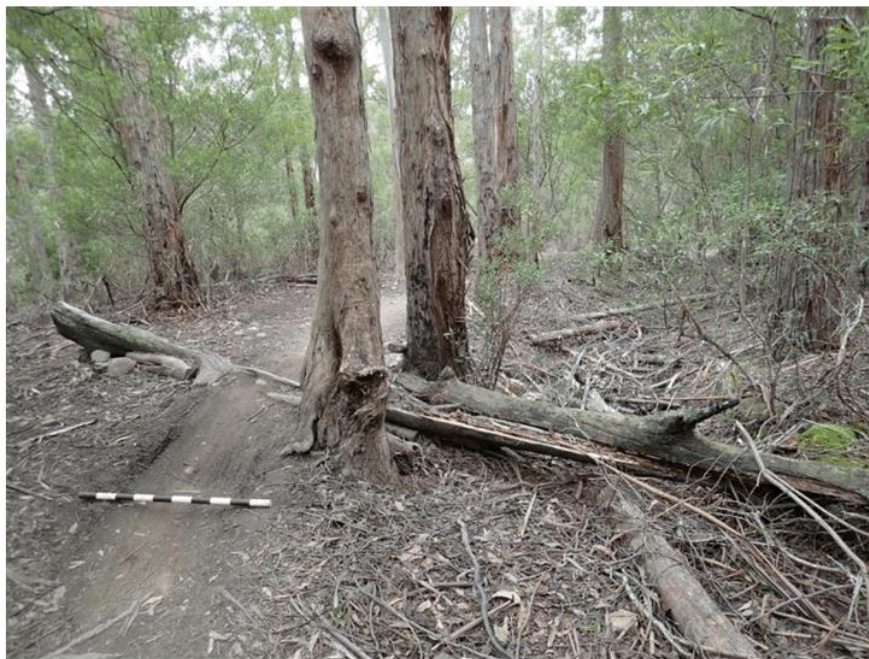
Generally the snig tracks display an arrangement consistent with an early nineteenth century phase of timber-getting and a distribution network that relied on logging roads to the south and east of the study area. Strikingly, there is very little indication that the snig tracks were leading northwards to the Luge Track immediately to the north of the study area. This will be discussed further in Section 6.0 below but it is possible to state that this indicates that these tracks may have predated the formation of this track.

Figure 5.3.1 Looking east along the Upper Luge Track, left of photograph, and a snig track, right of photograph. The snig track is partially obscured by a large amount of deadfall and leaf litter. The scale has 100mm marks.

The Upper Luge Track should not be moved from its present location; any change in its current alignment will widen the extent of its impact and the further this track drifts southwards the likelier it is to cause impact to additional historic heritage features. Given the richness of the historic heritage in the surrounding landscape, the long term use of the Upper Luge Track in its current location should be considered to be the minimal impact approach. In making the Upper Luge Track fit for its current purpose within the context of safety, a minimum of modification should take place. However, whatever measures are necessary to maintain the alignment of this track without additional braiding should be used (e.g track hardening or water bars). Where possible run off should be channelled away from the adjacent sections of snig track and fanned out on the surrounding terrain to avoid accidental erosion and the creation of rills. Once again, given the difficulty of closing this track and the sensitivity of the surrounding terrain, the Upper Luge Track should be formalised and maintained as much as necessary as a sacrificial track to avoid the widening of already existing impact.

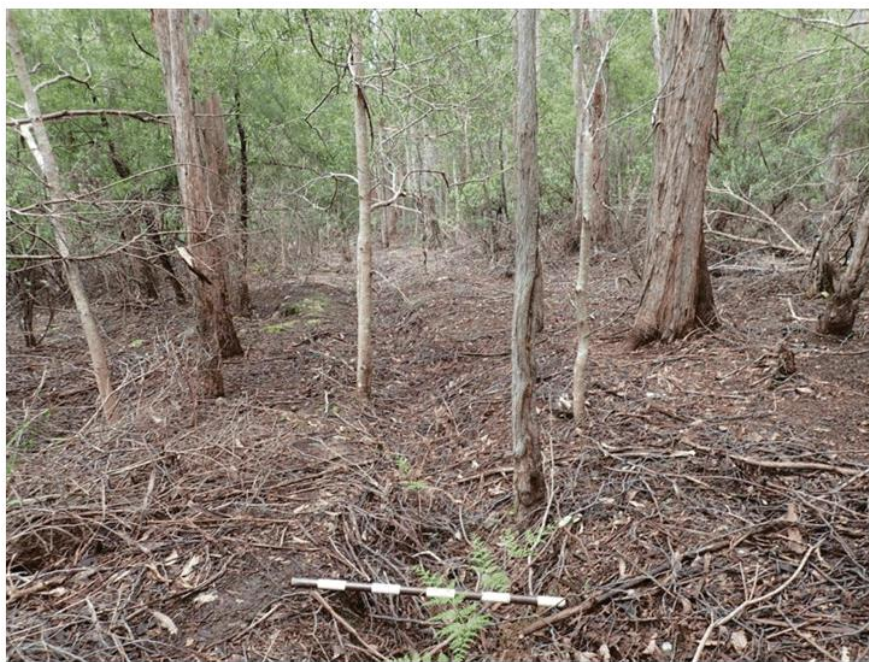
Figure 5.3.2 Looking southeast along the line of Snig Track 1.

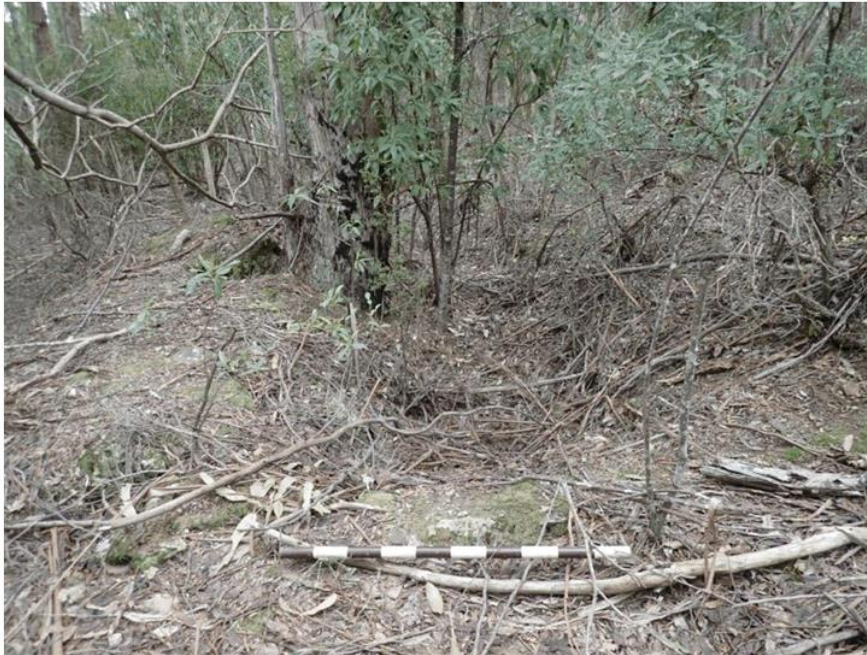
With all of these features the taphonomic processes affecting them has rendered them less distinct and rounded the edges of the cut and filled in sections of the cut.

Figure 5.3.3 View to the southwest along Sawpit 1, note the distinct hard clay soil in the bottom of the photograph indicating that this was a pit and not a snig track. The scale has 100mm marks.

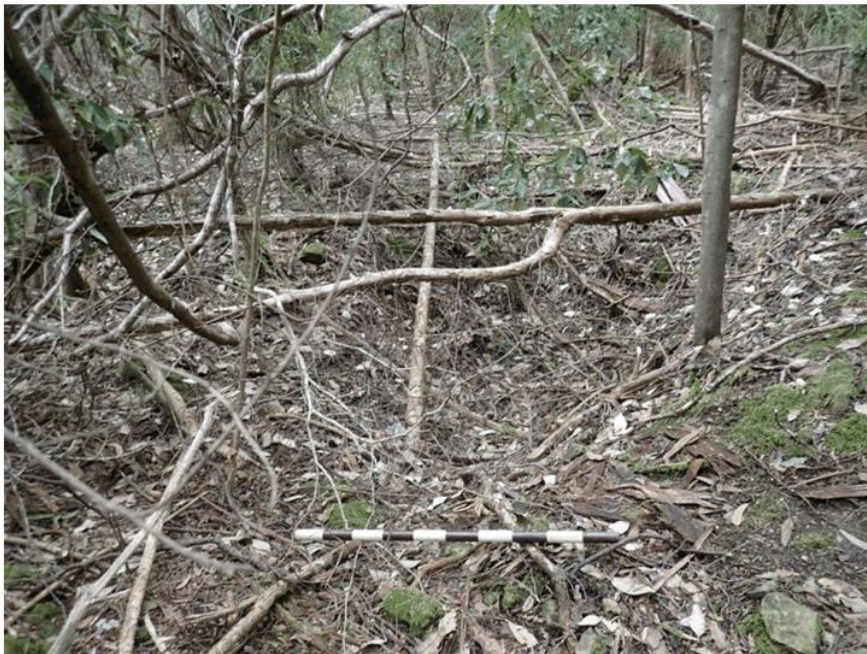
- Sawpit 4 was a small sawpit measuring 8 x 2m in plan and not more than 500mm in depth, but as elsewhere a significant amount of organic matter had contributed to filling the bottom of this pit.

Figure 5.3.4 Looking to the south over potential Sawpit 4, although this feature is obscured by leaf litter and deadfall it is neither a snig track nor natural soil disturbance arising from an uprooted tree. The scale has 100mm marks.

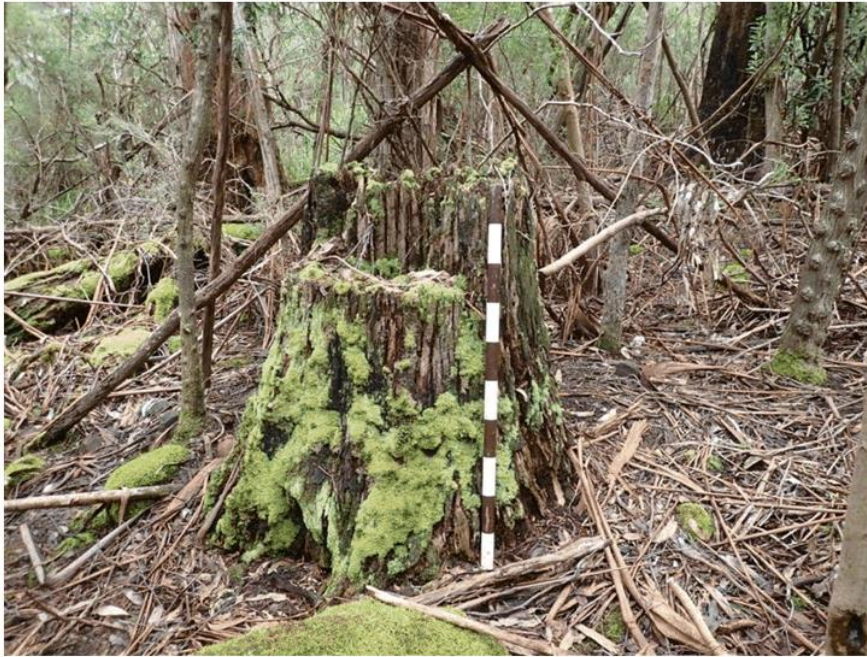
Spread throughout this area were a series of stumps, clearly exhibiting notch cuts in most cases and occasionally accompanied by cut trunks lying on the ground nearby. These stumps varied in height from 1-1.2m and generally measured >1m in diameter. The stumps exhibited evidence of fire damage likely caused by bushfires since their felling; some of these features were significantly decayed but in all cases evidence of felling was present. Although the surface of any of these features was not intact enough to discern cut marks, the notch cuts combined with the very level surface of the stumps were a clear indication that these trees had been felled. In some cases, as around Stump 2 and Stump 9 there were sawn trunks present on the nearby ground surface. These trunks exhibited square cuts on their distal ends but it is not clear in what manner these cuts were made and these features have not been recorded independently. Similarly within the Timber-Getting Complex there were a number of sawn logs that exhibited possible cut surfaces yet as these could not be clearly attributed to felling activity associated with timber-getting they have not been recorded as historical features.

Figure 5.3.5 Detail view of Stump 7, the notch cut is clearly visible facing towards the viewer. The scale has 100mm marks.

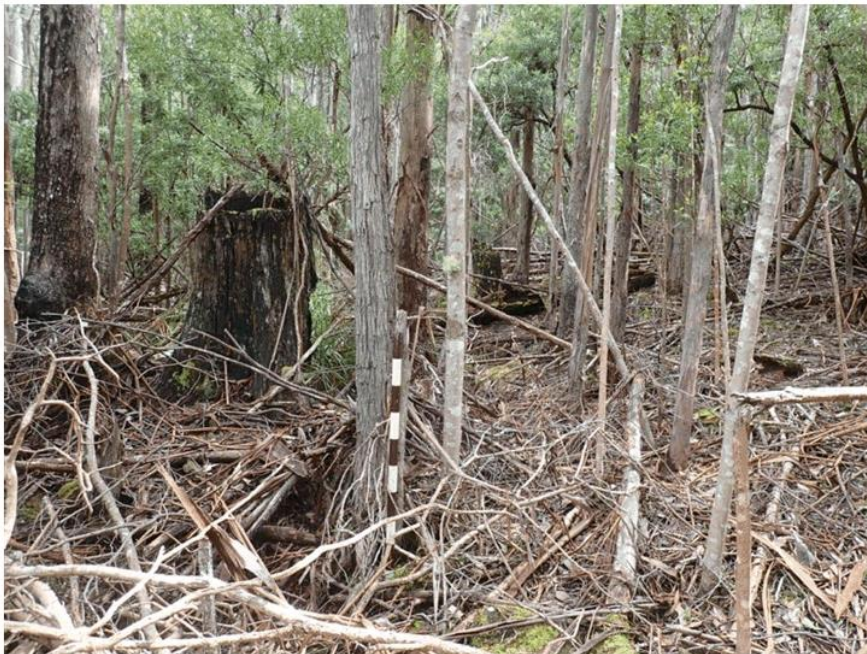
Figure 5.3.6 Looking to the west and showing two of the three closely spaced stumps (Sawn Stump 4 to 6) in the centre of the study area. A notch cut is visible on the stump in the left of the photograph. The scale has 100mm marks.

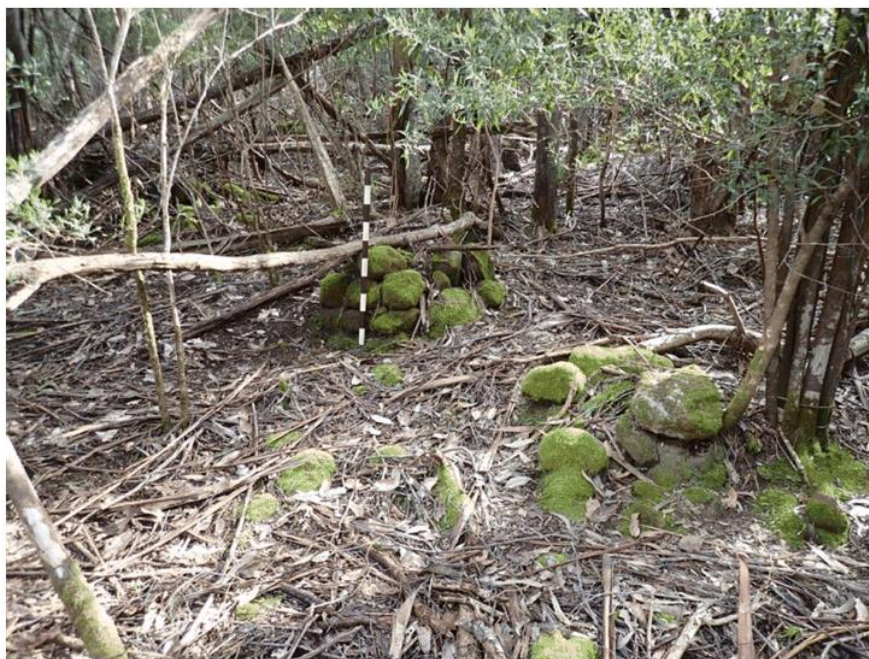
To the north of both these groups of features at a distance of 30m was a second terraced area, in an already very level area of the ridge crest which measured approximately 10x5m in plan, were a set of coursed stone features that most closely approximate *in situ* footings in the whole complex. Three courses were evident in one of these features although less than a metre remained of its length.

Figure 5.3.7 Looking north to the partly coursed random rubble features in the area of possible stone footings. The scale has 100mm marks.

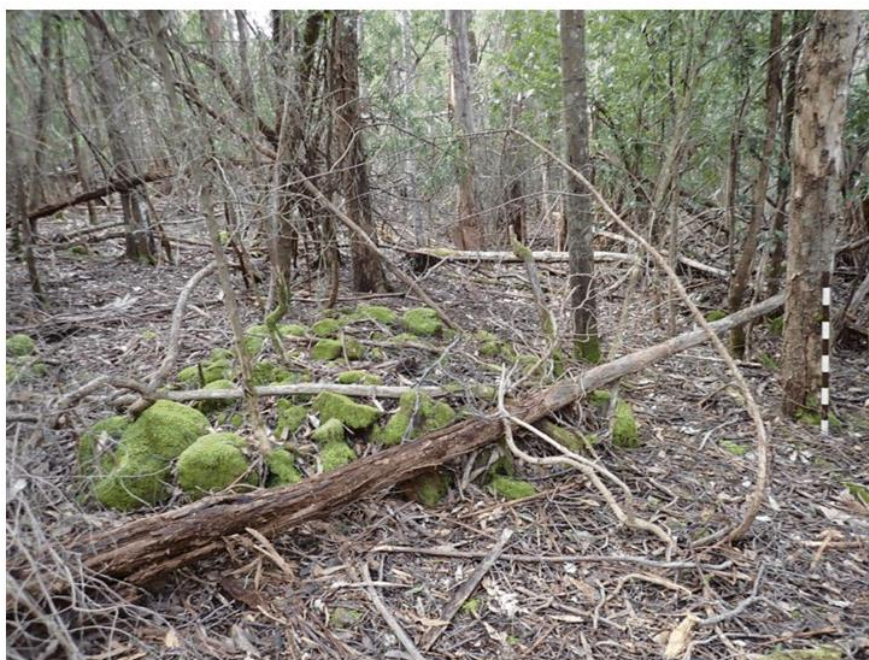
Figure 5.3.8 A rectilinear feature in the area of stone footings. Looking east at the sawn stump. The scale has 100mm marks.

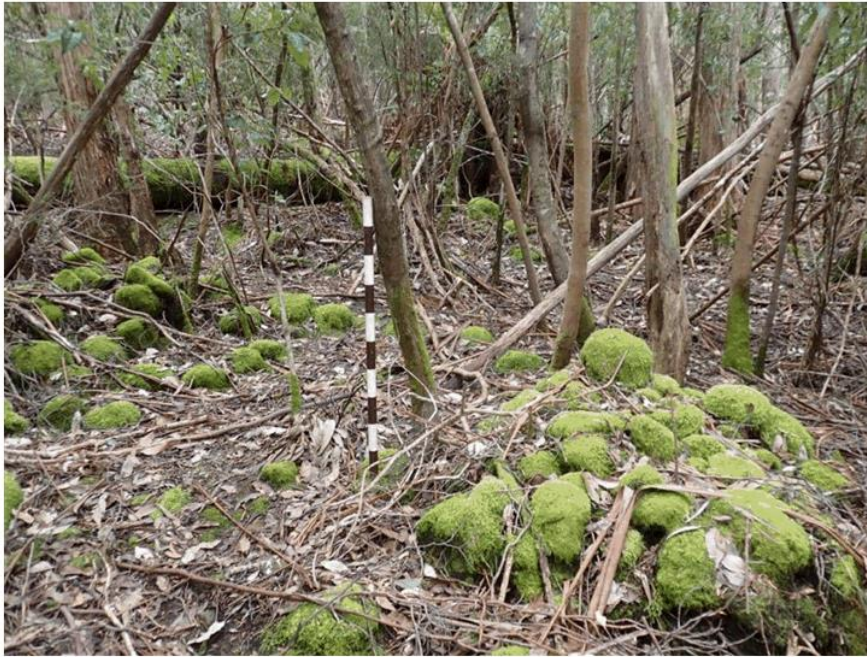
Figure 5.3.9 Looking to the northwest over the stone features in the foreground and the snig track, heavily overgrown, immediately behind them in the centre of the photograph. A corresponding set of stone features are just visible to the northwest of the snig track. The scales have 100mm marks.

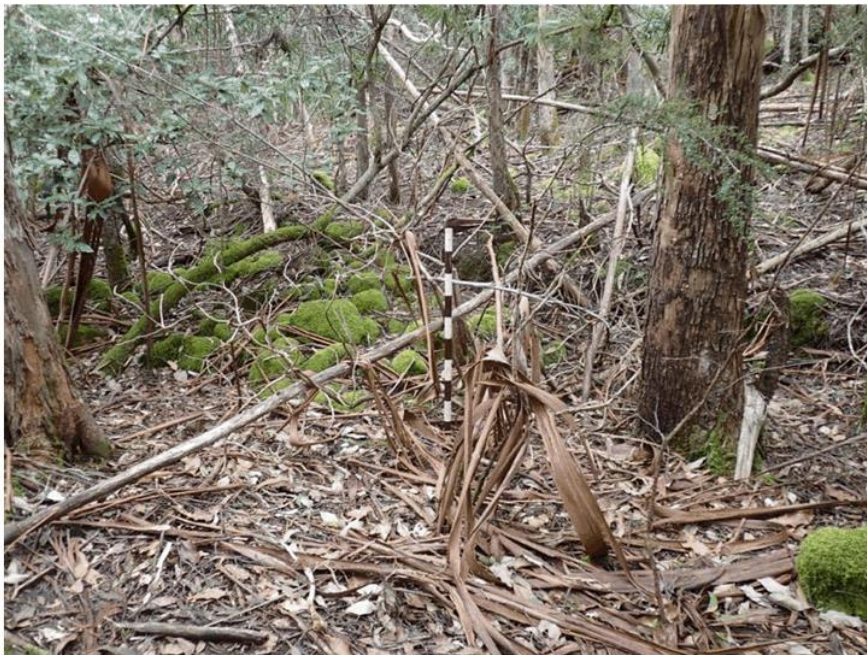
Figure 5.3.10 Looking to the west over the stone feature and benched area in 'Bart's Cut.' The scale has 100mm marks.

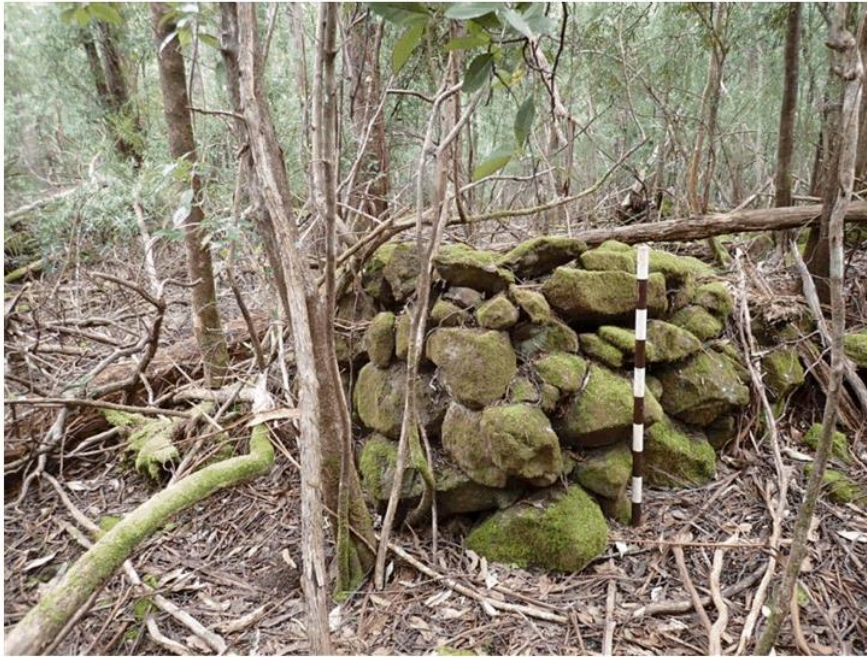
Figure 5.3.11 Looking to the south at a clearly constructed stone feature, nearly a metre above the current ground surface; note that there is no additional evidence of bonding or other structural elements. The scale has 100mm marks.

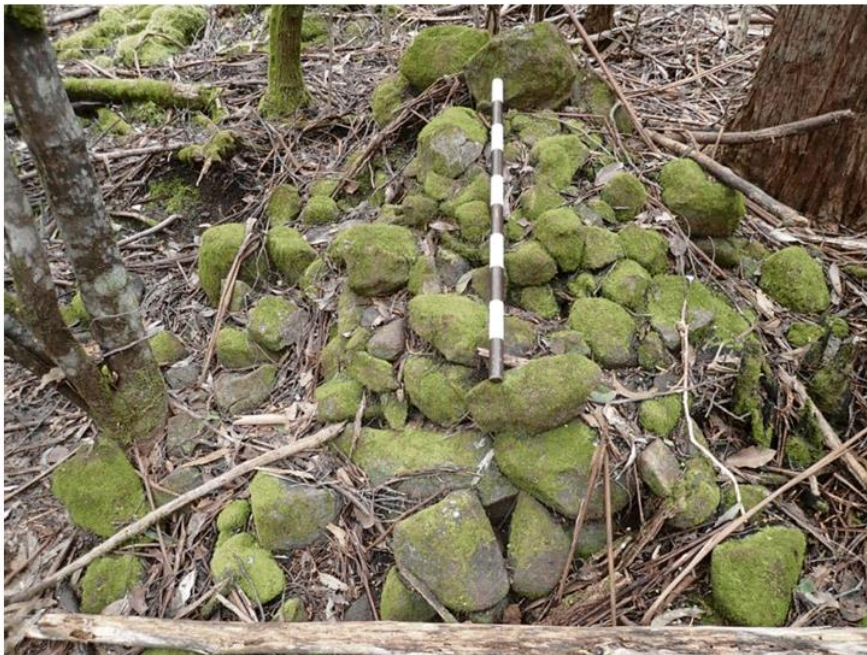
The stone features varied in morphology but were largely consistent in size, most being less than 2 x 2m in plan. In some cases the features displayed were formed from coursed rubble and in some cases from uncoursed rubble. Some of these features appeared simply as concentrations of rubble resting in a rough, but generally similar sized shape, pile on the ground surface. However, it must be emphasised that this appearance has been caused by taphonomic factors affecting this woodland site. Falling limbs and trees have likely damaged some of these structures and deadfall and leaf litter has also likely obscured large parts of these features and it is therefore likely that they are merely the surficial elements of more substantial structures that are now partially buried. None of these features exceeded a metre in height with coursed and uncoursed features being the tallest and the unordered piles of stone lying much closer to the ground. This is further evidence that in the more disturbed features that their disorganisation has resulted from taphonomic disturbance after construction.

Figure 5.3.12 Detail view of the surface of a stone feature. The scale has 100mm marks.

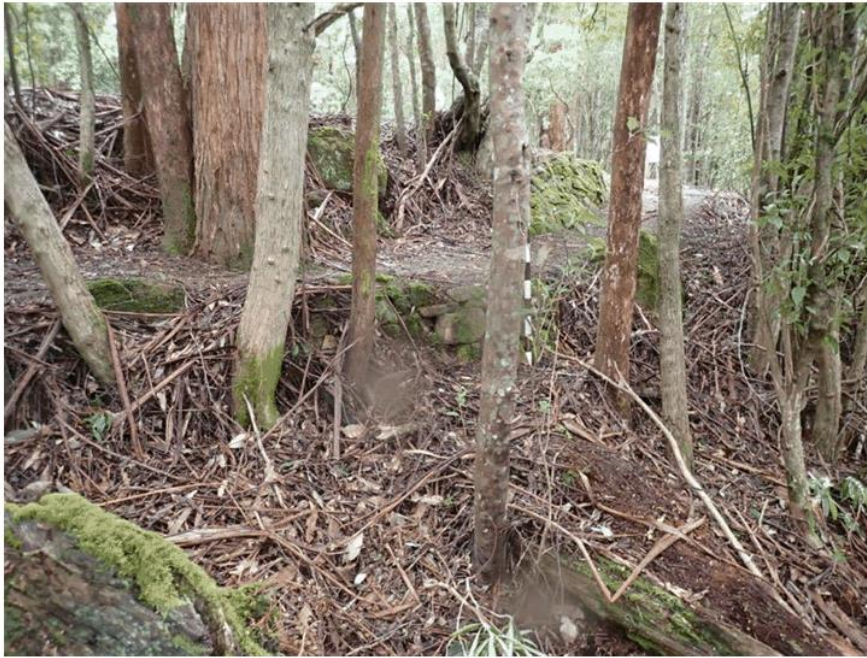
Figure B.1.1 View west showing the entrance to the Circle Track adjacent to Pinnacle Road. Shown in the centre of the photograph is the random coursed rubble supporting structure below the track. The scale has 100mm marks.

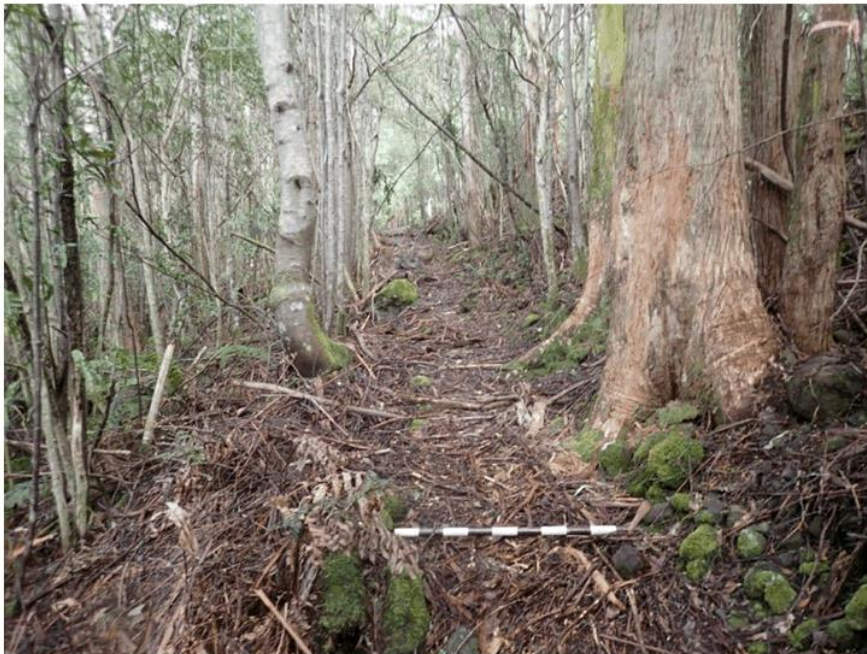
Figure B.1.2 View to the west over the centre of the Circle Track showing the pink flagging tape marking the line of the proposed Track 1a visible in the right of the photograph.

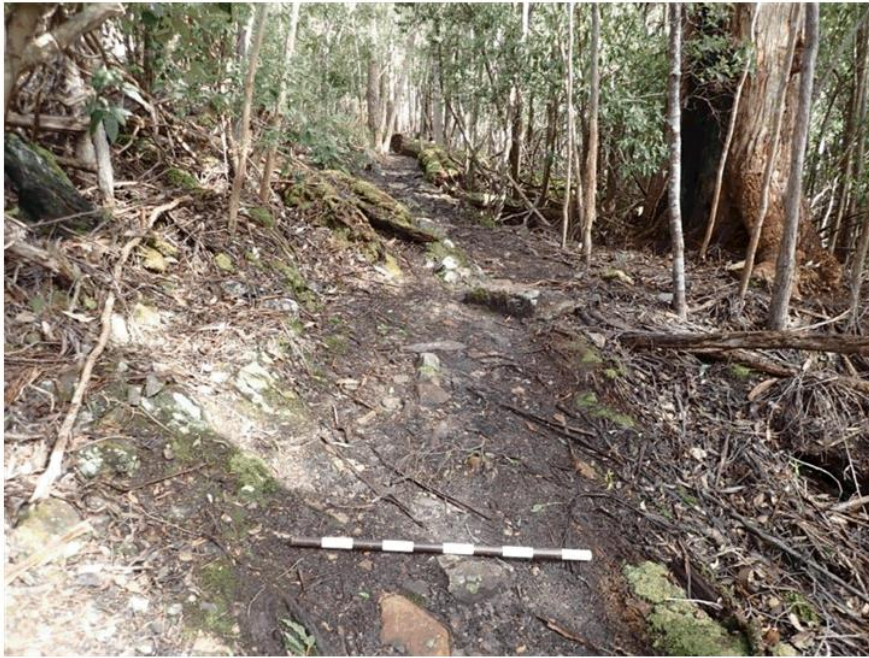
Figure B.1.3 Looking north along Woods Track from the point where Track 1a is proposed to intersect with it. The scale has 100mm marks.

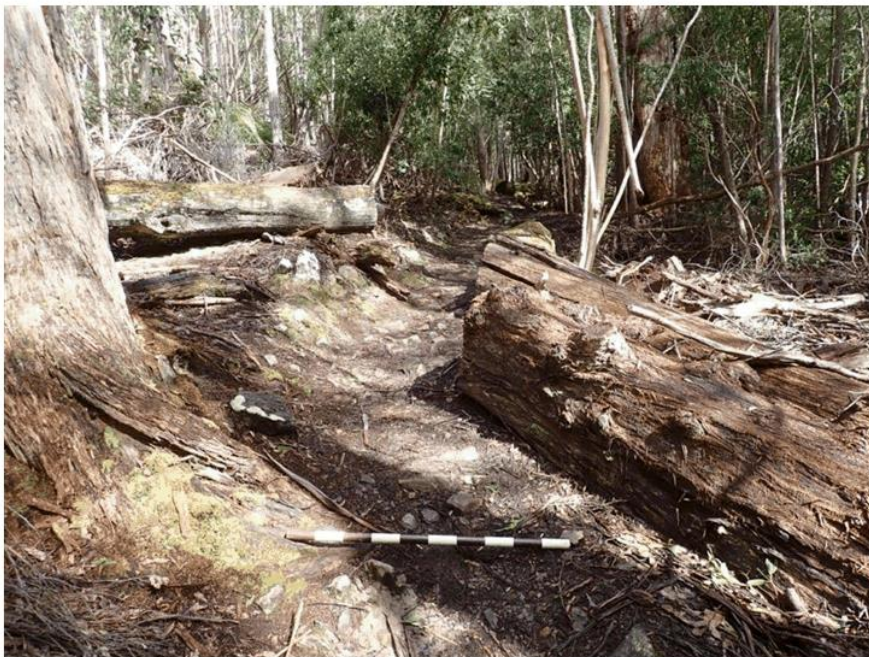
Figure B.1.4 View to the west over the centre of the track. The scale has 100mm marks.

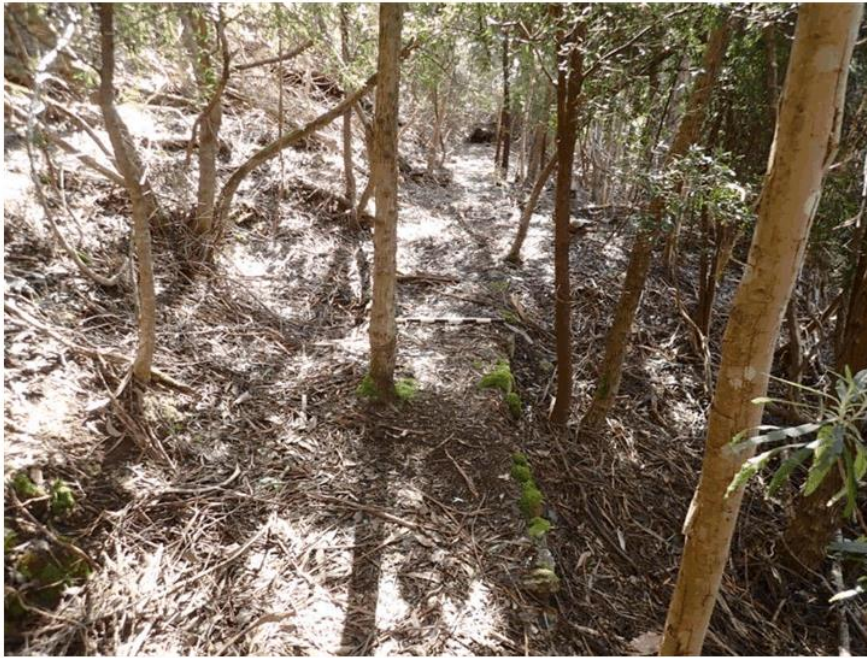
Figure B.1.5 Looking north along the unnamed remnant track. The scale has 100mm marks.

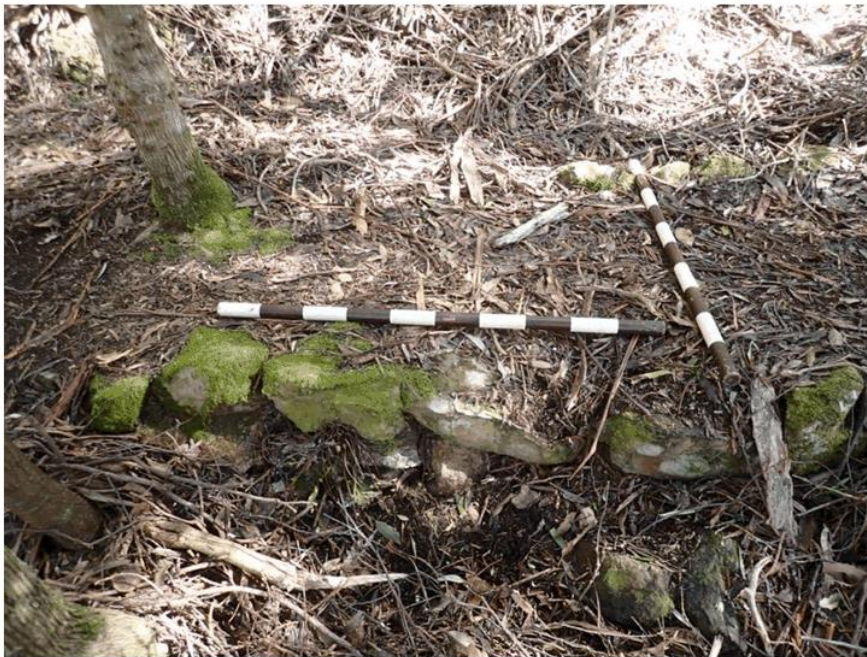
Figure B.1.6 Detail view of the uncoursed stone rubble forming the base of the Boundary Track. The scale has 100mm marks.

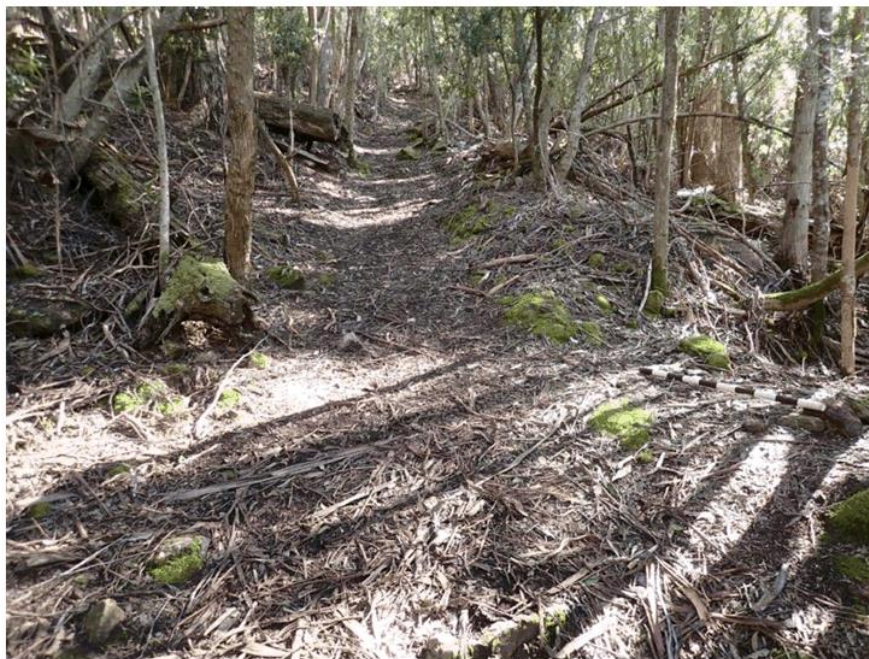
Figure B.1.7 Looking south along a former part of the Fingerpost Track, the scale in the right of the photograph indicates its intersection with the unnamed remnant track. The scale has 100mm marks.

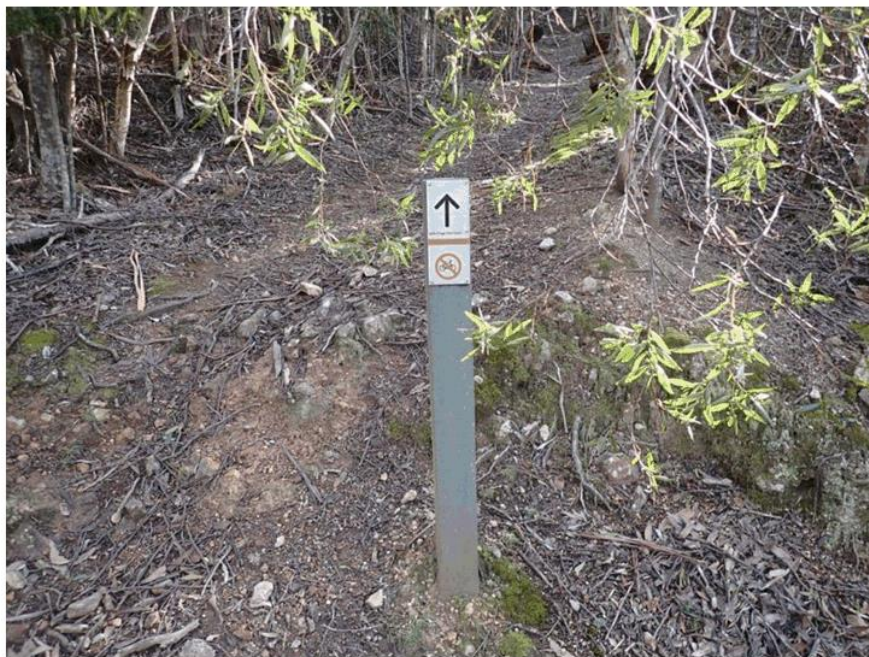
Figure B.1.8 Looking south along the former part of Fingerpost Track near its intersection with O'Grady's Falls Fire Trail.

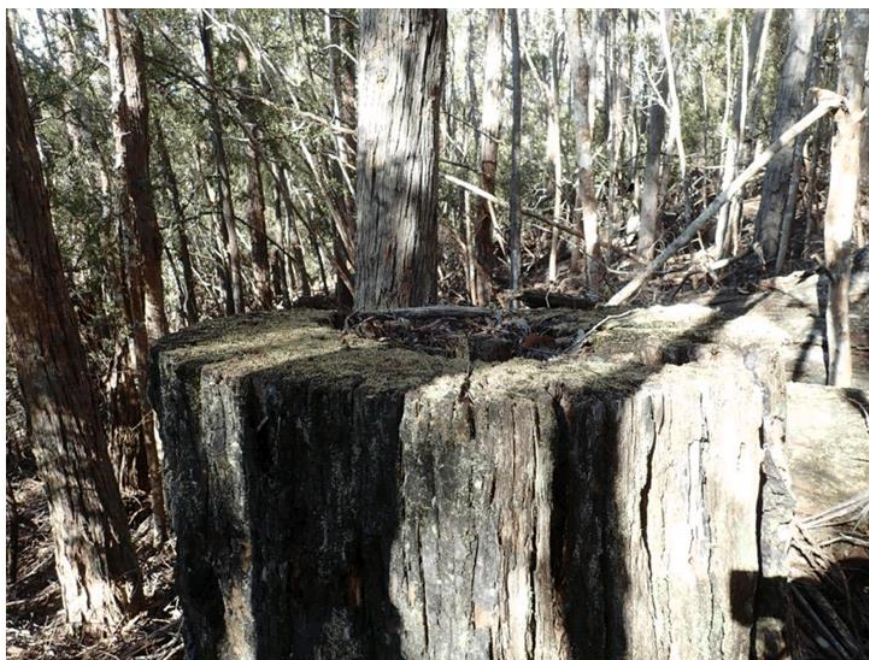
Figure B.1.10 Detail view of the surface of the sawn stump showing that its degradation precludes accurate identification of its method of sawing.

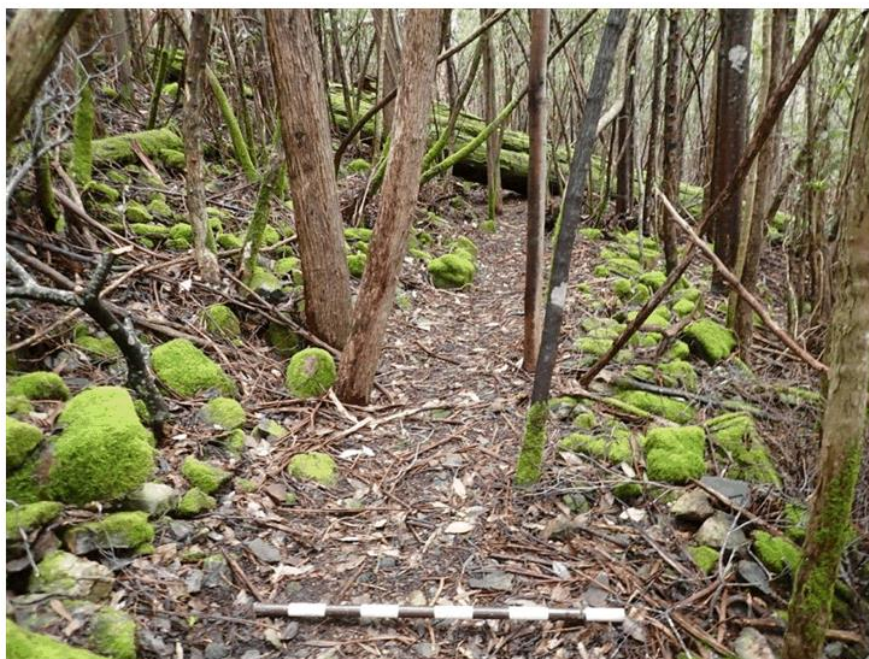
Figure B.1.11 Looking north northwest along Featherstones Cascade Track. The scale has 100mm marks.

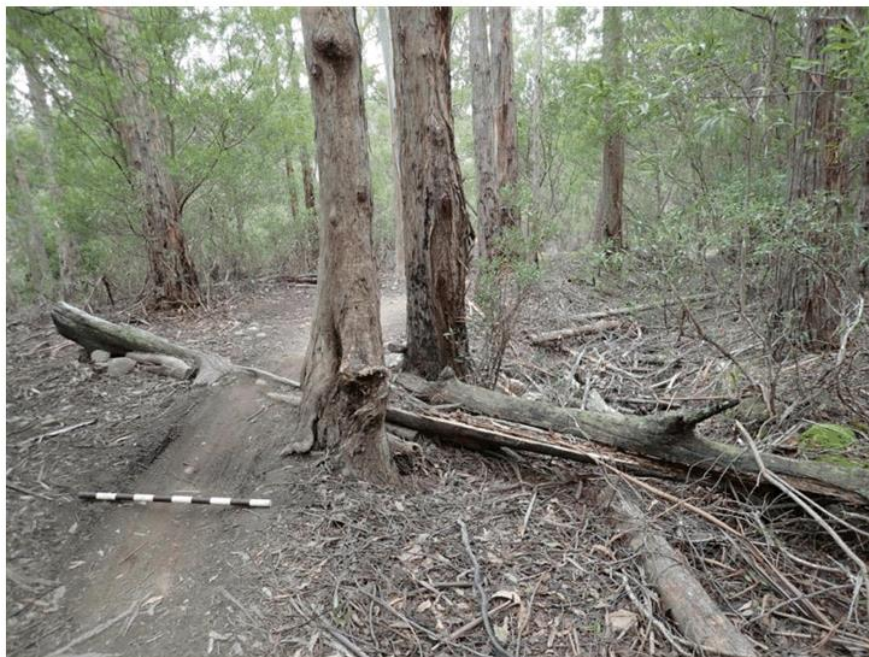
Figure B.2.1 Looking east along the Upper Luge Track, left of photograph, and a snig track, right of photograph. The snig track is partially obscured by a large amount of deadfall and leaf litter. The scale has 100mm marks.

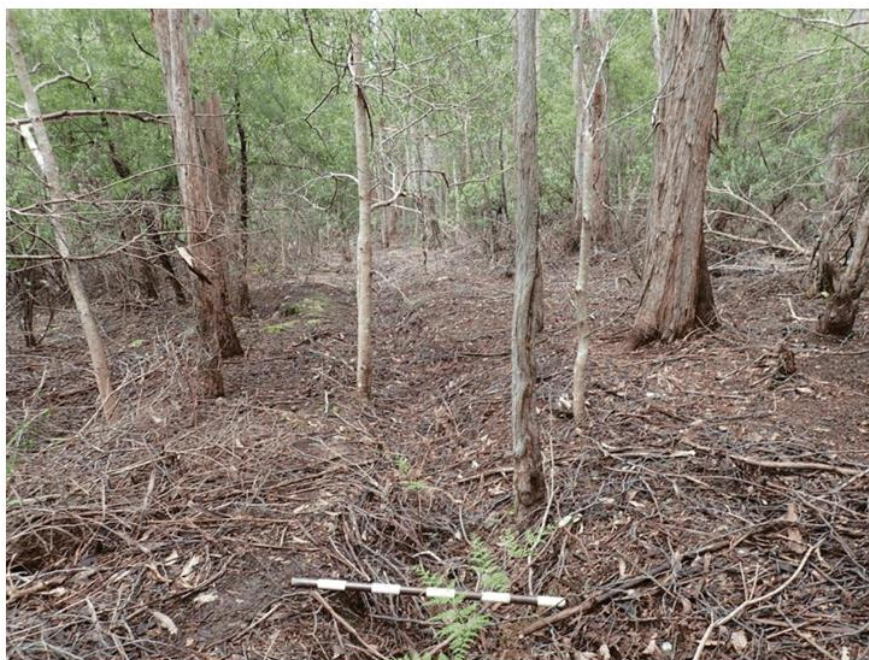
Figure B.2.2 Looking southeast along the line of Snig Track 1.

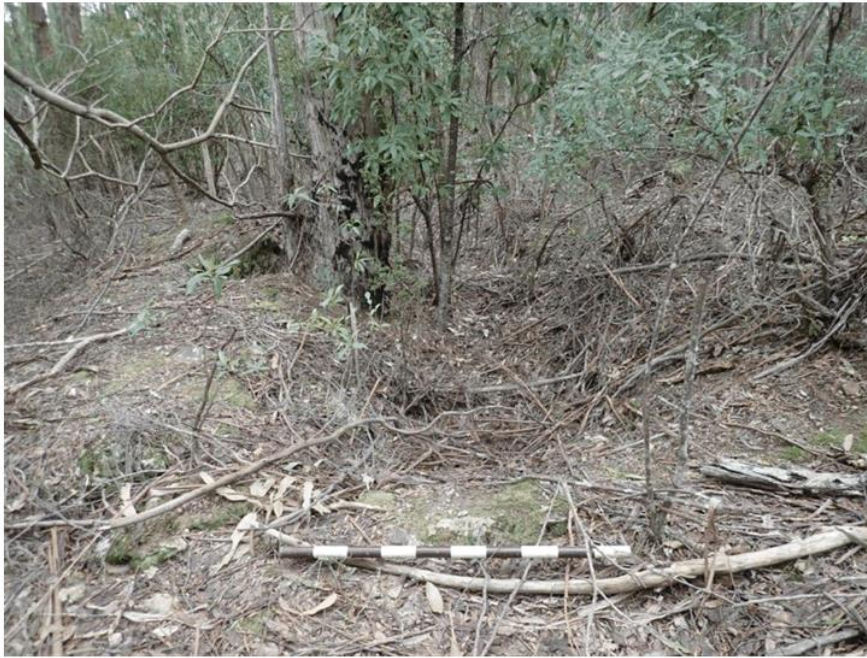
Figure B.2.3 View to the southwest along Sawpit 1, note the distinct hard clay soil in the bottom of the photograph indicating that this was a pit and not a snag track. The scale has 100mm marks.
