CITY OF HOBART

City Planning Committee Meeting

Monday, 30 August 2021

7.1 APPLICATIONS UNDER THE HOBART INTERIM PLANNING SCHEME 2015	7
7.1.1 251 Macquarie Street and 245-247 Macquarie Street, Hobart - Three Multiple Dwellings (Two Existing, One New).....	7

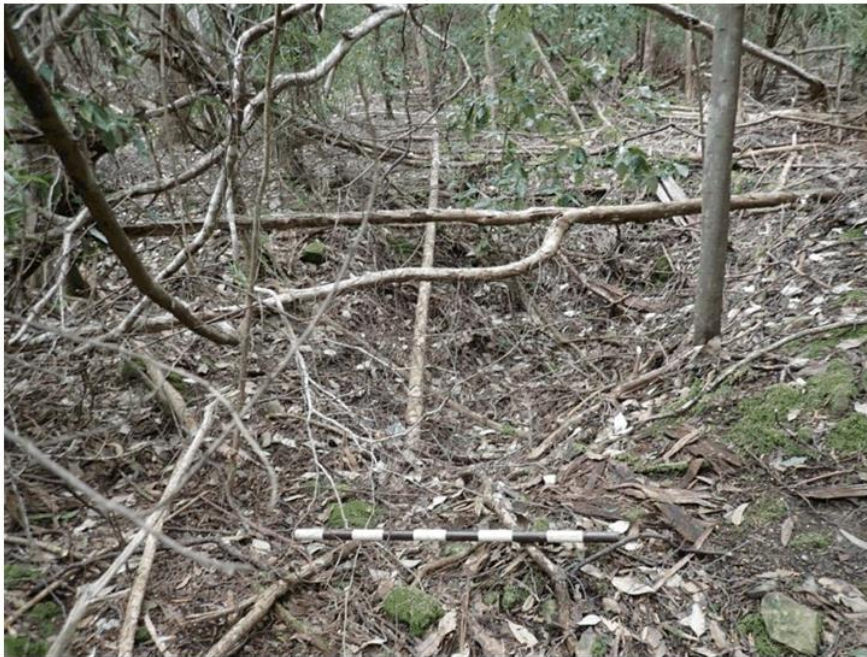
Figure B.2.4 Looking to the south over potential Sawpit 4, although this feature is obscured by leaf litter and deadfall it is neither a snag track or natural soil disturbance arising from an uprooted tree. The scale has 100mm marks.

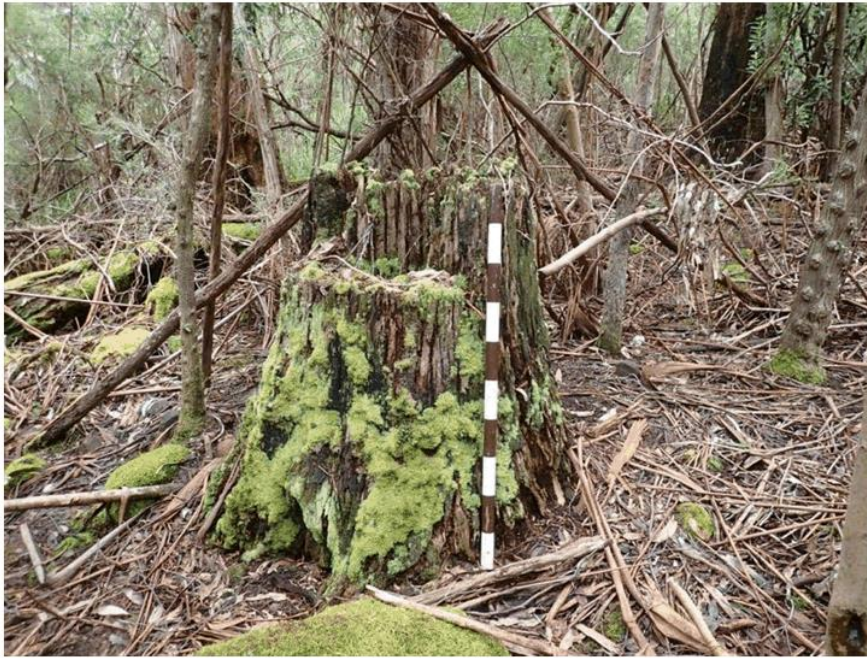
Figure B.2.5 Detail view of Stump 7, the notch cut is clearly visible facing towards the viewer. The scale has 100mm marks.

Spread throughout this area were a series of stumps, clearly exhibiting notch cuts in most cases and occasionally accompanied by cut trunks lying on the ground nearby. These stumps varied in height from 1-1.2m and generally measured >1m in diameter. The stumps exhibited evidence of fire damage likely caused by bushfires since their felling some of these features were significantly decayed but in all cases evidence of felling was present. Although the surface of any of these features was not intact enough to discern cut marks, the notch cuts combined with the very level surface of the stumps were a clear indication that these trees had been felled. In some cases, as around Stump 2 and Stump 9 there were sawn trunks present on the nearby ground surface. These trunks exhibited square cuts on their distal ends but it is not clear in what manner these cuts were made and these features have not been recorded independently. Similarly within the Timber-Getting Complex there were a number of sawn logs that exhibited possibly cut surfaces yet as these could not be clearly attributed to felling activity associated with timber-getting they have not been recorded as historical features.

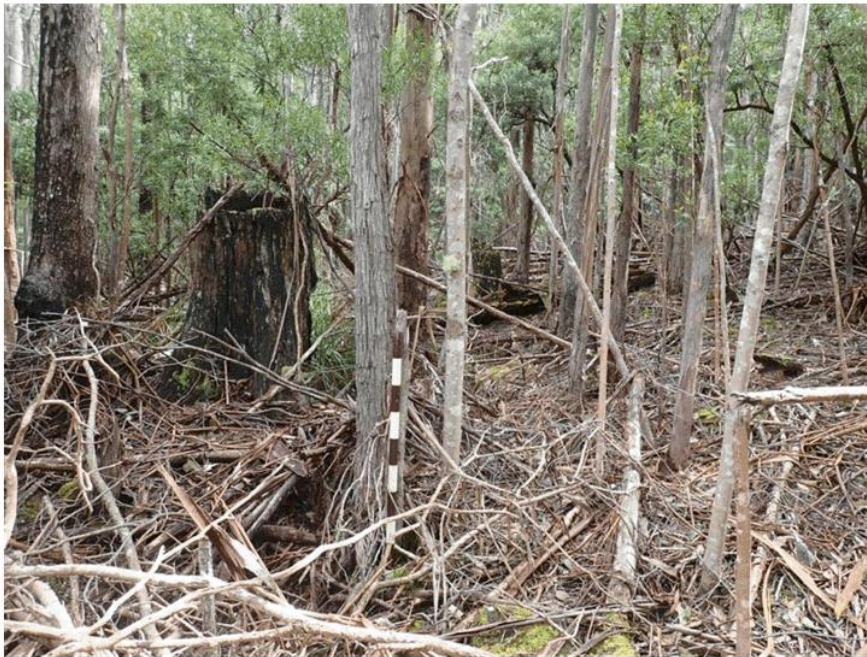
Figure B.2.6 Looking to the west and showing two of the three closely spaced stumps (Sawn Stump 4 to 6) in the centre of the study area. A notch cut is visible on the stump in the left of the photograph. The scale has 100mm marks.

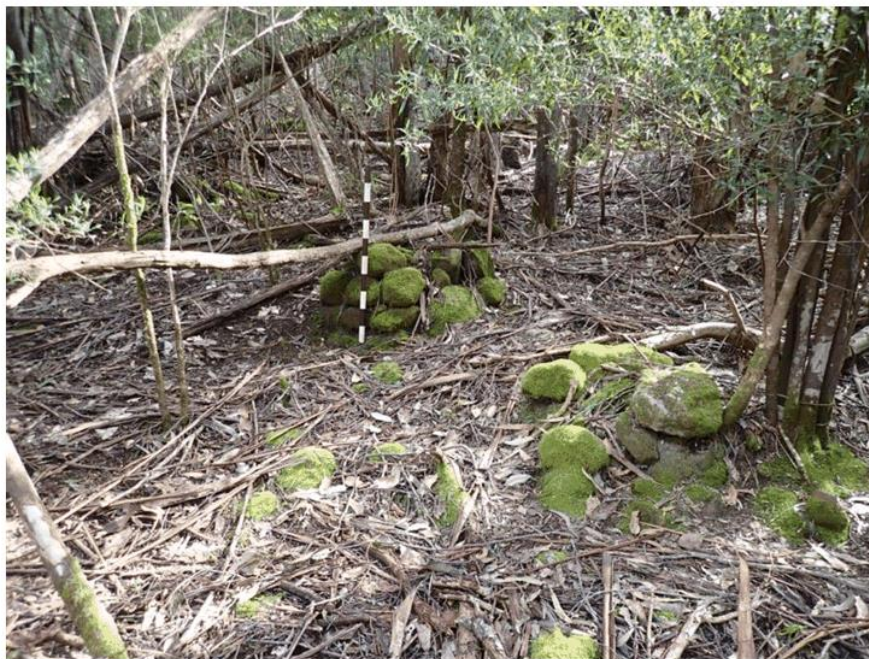
Figure B.2.7 Looking north to the partly coursed random rubble features in the area of possible stone footings. The scale has 100mm marks.

The stone features varied in morphology but were largely consistent in size, most being less than 2 x 2m in plan. In some cases the features displayed were formed from coursed rubble and in some cases from uncoursed rubble. Some of these features appeared simply as concentrations of rubble resting in a rough, but roughly similar sized shape, pile on the ground surface. However, it must be emphasised that this appearance has been caused by taphonomic factors affecting this woodland site. Falling limbs and trees have likely damaged some of these structures and deadfall and leaf litter has also likely obscured large parts of these features and it is therefore likely that they are merely the surficial elements of more substantial structures that are now partially buried. None of these features exceeded a metre in height with coursed and uncoursed features being the tallest and the unordered piles of stone lying much closer to the ground. This is further evidence that in the more disturbed features that their disorganisation has resulted from taphonomic disturbance after construction.

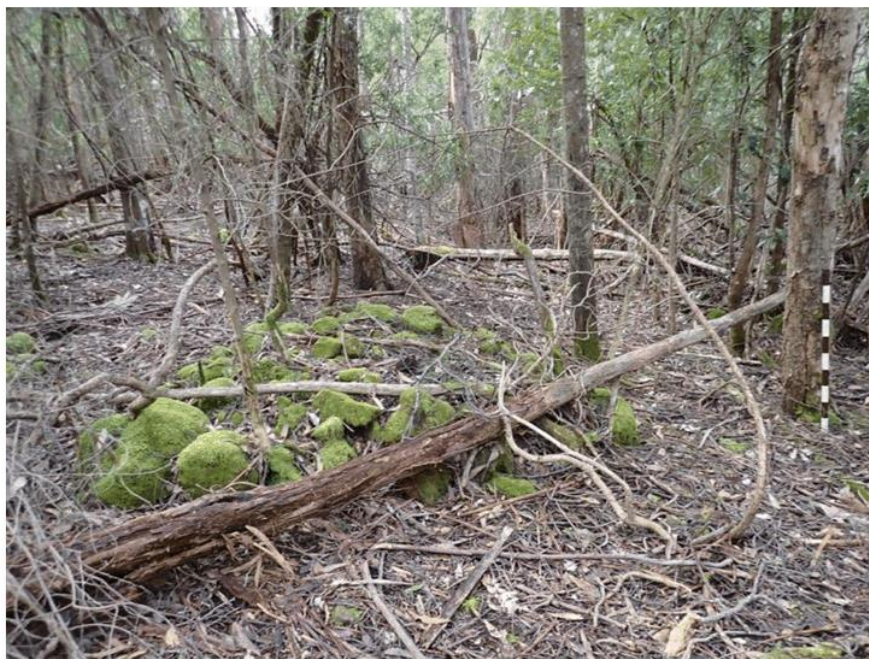
Figure B.2.8 A rectilinear feature in the area of stone footings. Looking east at the sawn stump. The scale has 100mm marks.

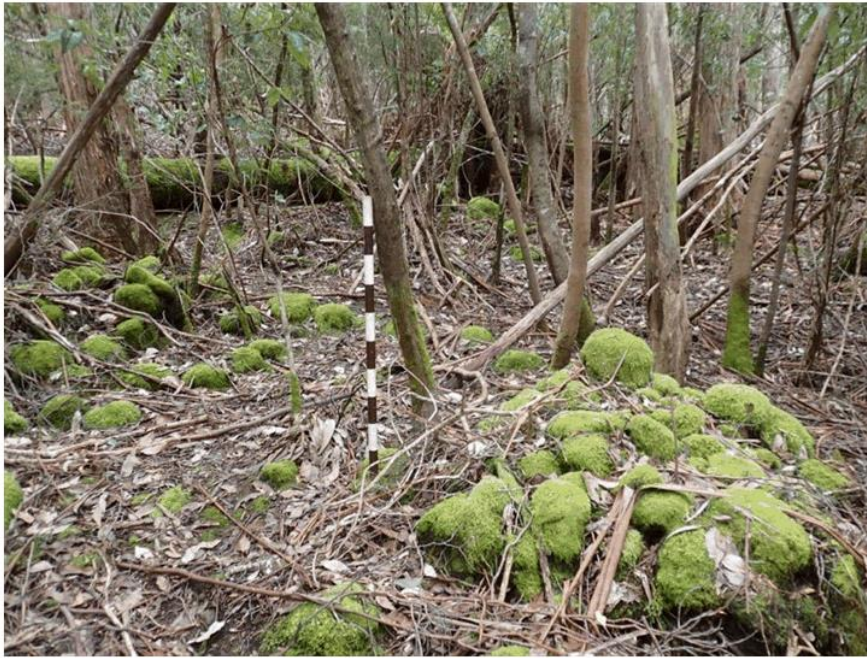
Figure B.2.9 Looking to the northwest over the stone features in the foreground and the snig track, heavily overgrown, immediately behind them in the centre of the photograph. A corresponding set of stone features are just visible to the northwest of the snig track. The scales have 100mm marks.

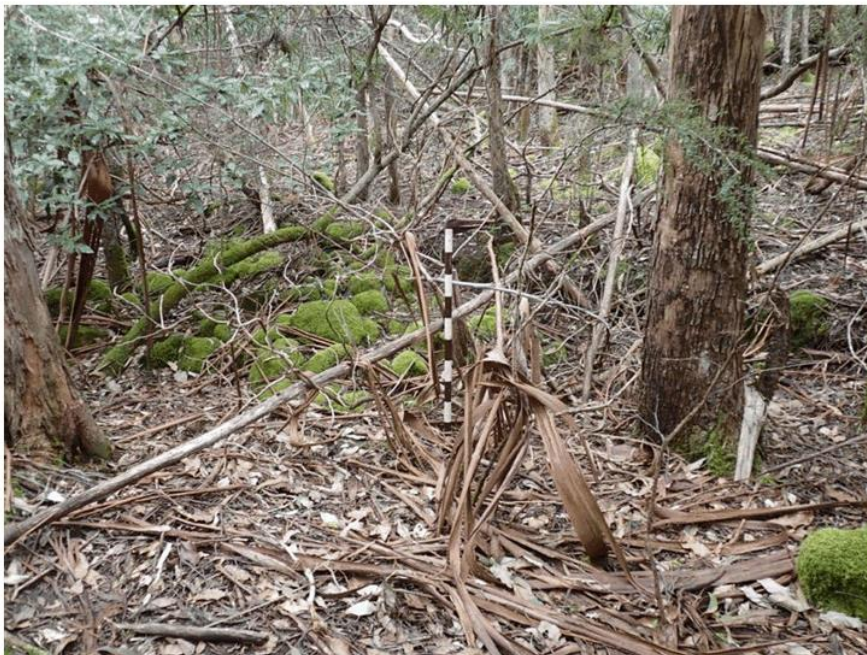
Figure B.2.10 Looking to the west over the stone feature and benched area in 'Bart's Cut.' The scale has 100mm marks.

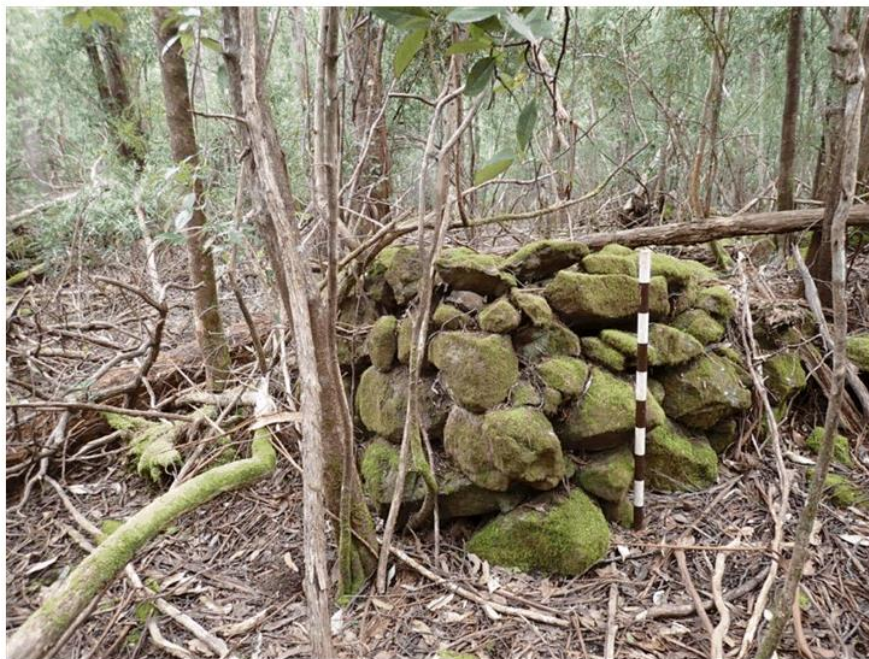
Figure B.2.11 Looking to the south at a clearly constructed stone feature, nearly a metre above the current ground surface; there is no additional evidence of bonding or other structural elements. The scale has 100mm marks.

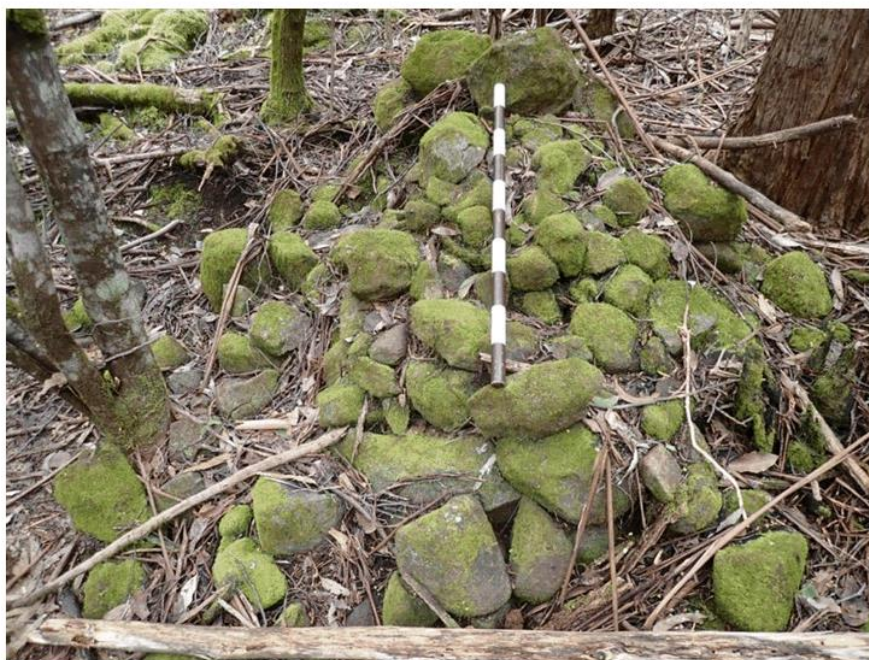
Figure B.2.12 Detail view of the surface of a stone feature. The scale has 100mm marks.

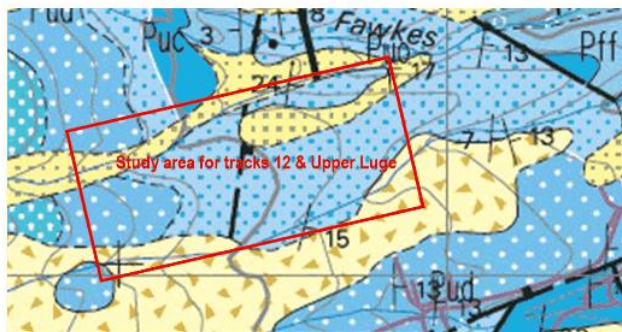
An excerpt of the mapsheet of Hobart, scale 1:25,000, dated May 2006 produced by Mineral Resources Tasmania (MRT) is shown below.

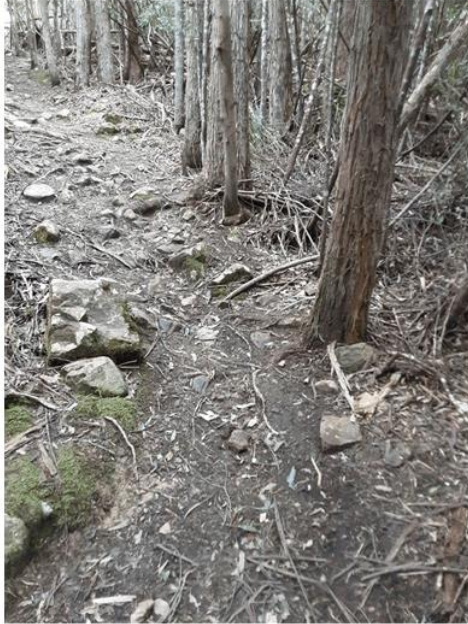
Figure 3 - Cobbles & boulders over surface

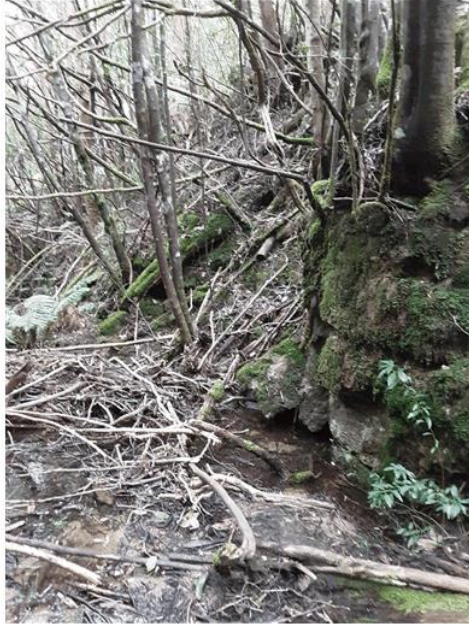
Figure 5 - outcropping rock at creek crossing

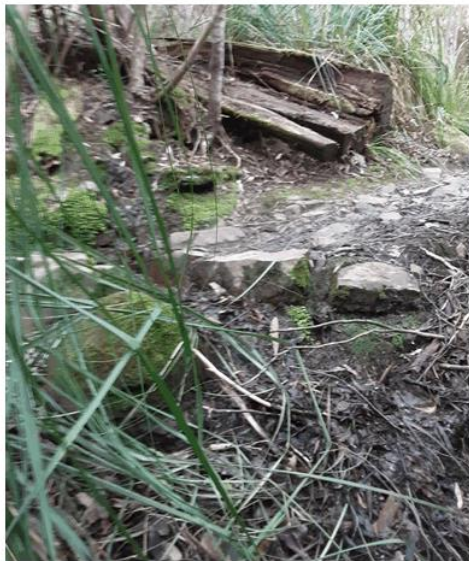
Figure 6 - Boulders & Large old tree trunks

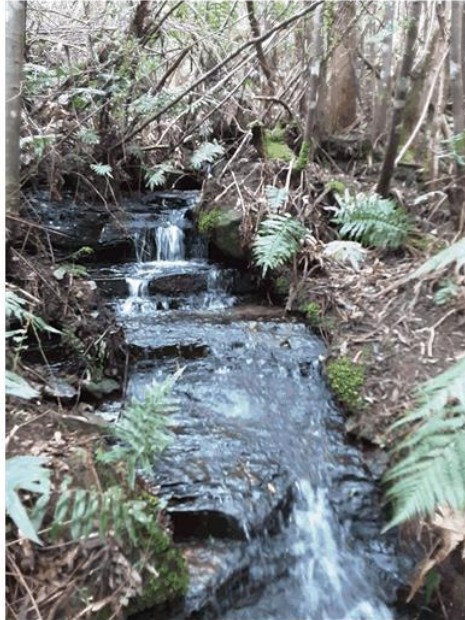
Figure 7 - Outcropping rock at stream

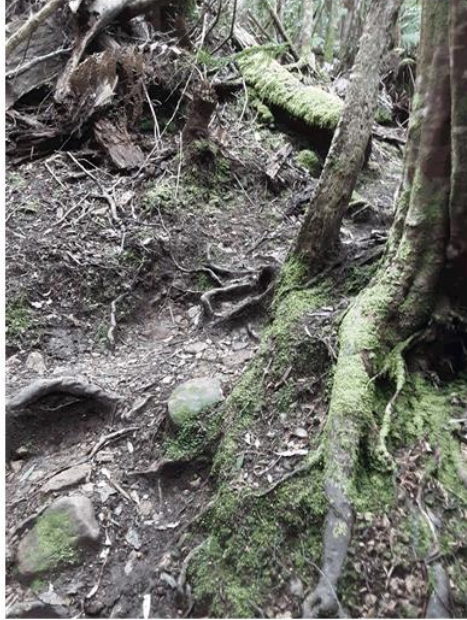
Figure 9 - Angular boulders held by tree roots

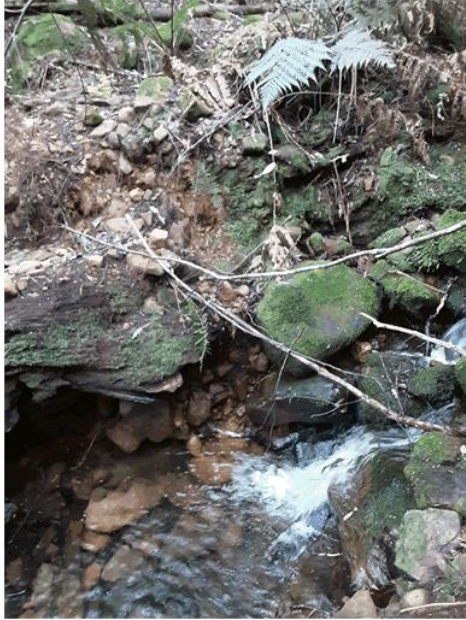
Figure 11 - Alluvium & Boulders in stream

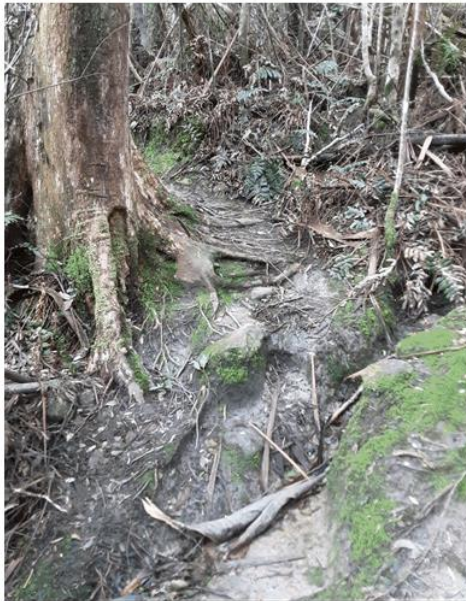
Figure 12 - Erosion of fine sands

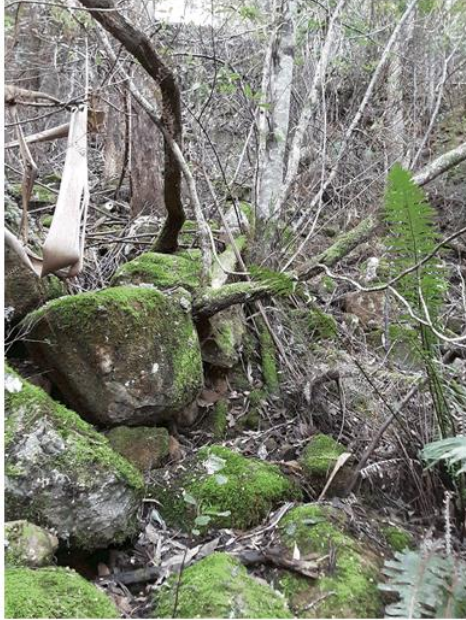
Figure 13 - Boulders on slope below Shoobridge Bend

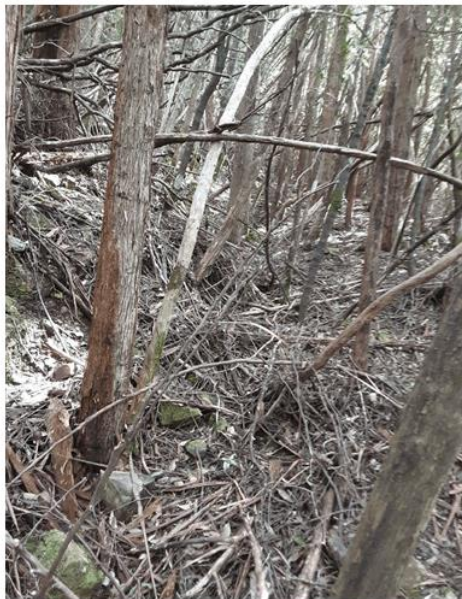
Figure 16 - Older track or terracing

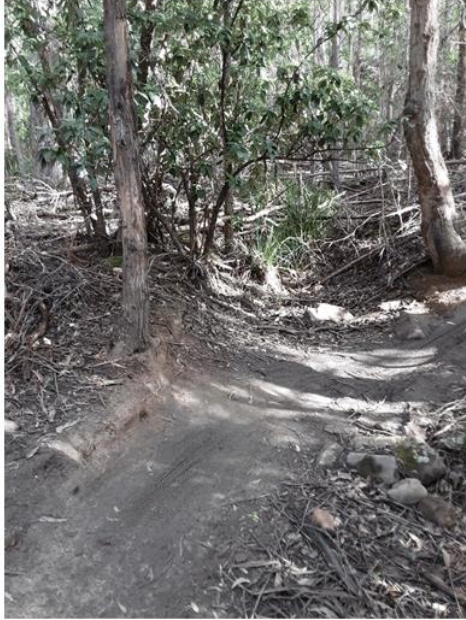
Figure 18 - existing track surface over cobbles

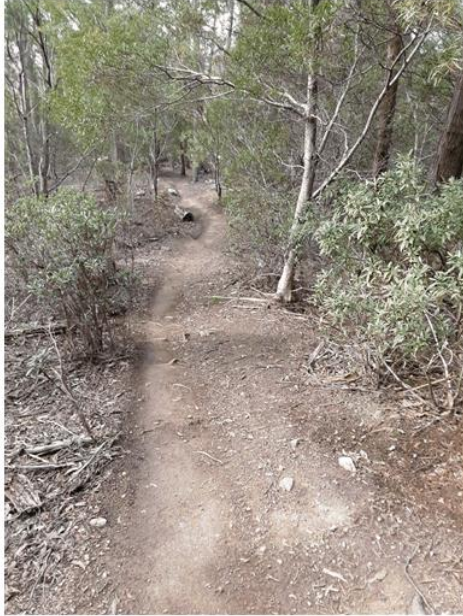
Figure 20 - soils with some cobbles

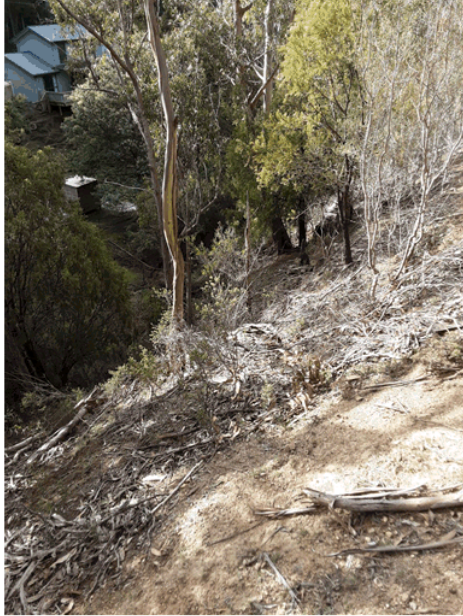
Figure 22 - Instability at Old Farm

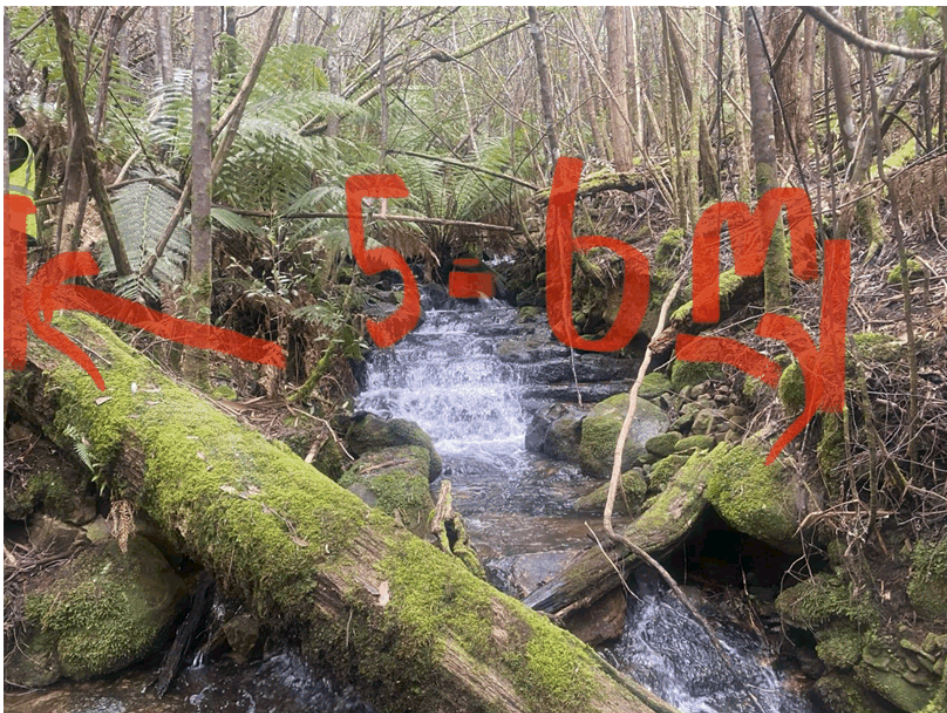
Hobart Rivulet / Rocky Wheeln crossing (proposed 6m bridge):

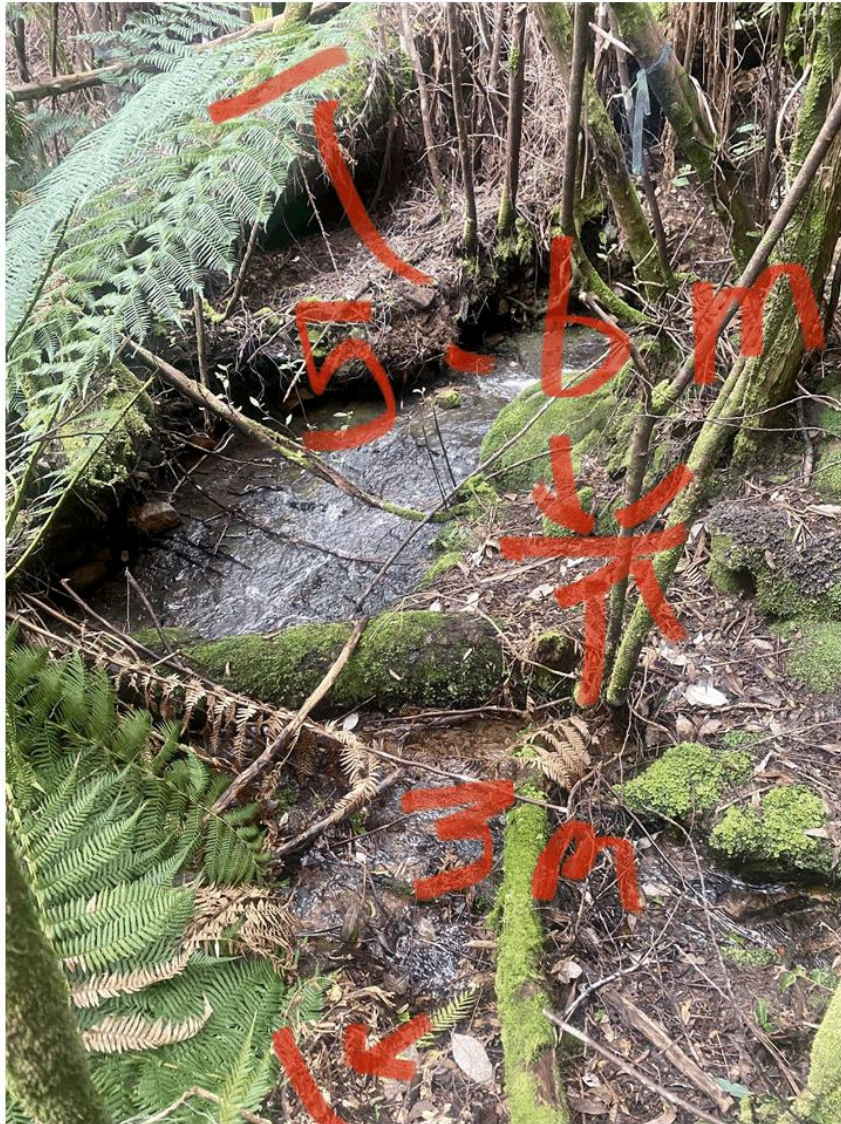
Hobart Rivulet / Free Wheeln crossing (proposed 6m + 3m bridge or causeway):

Note that just below this crossings a small spring enters as shown lower right on the photo. It is proposed that either a short bridge or boulder causeway crossing be installed here.

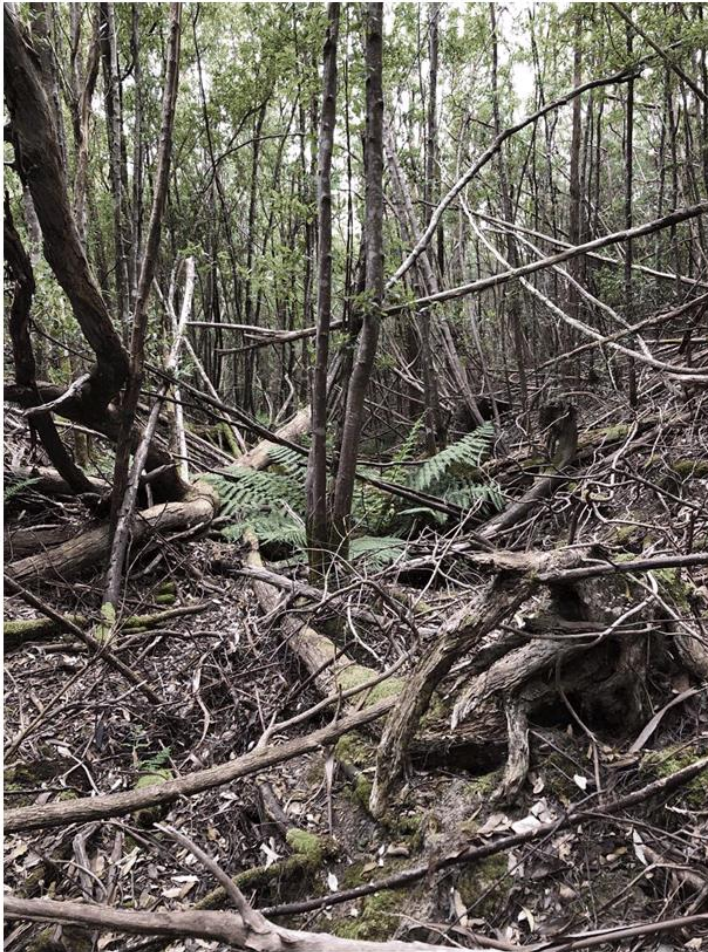
Hobart rivulet tributary lower crossing (proposed causeway)

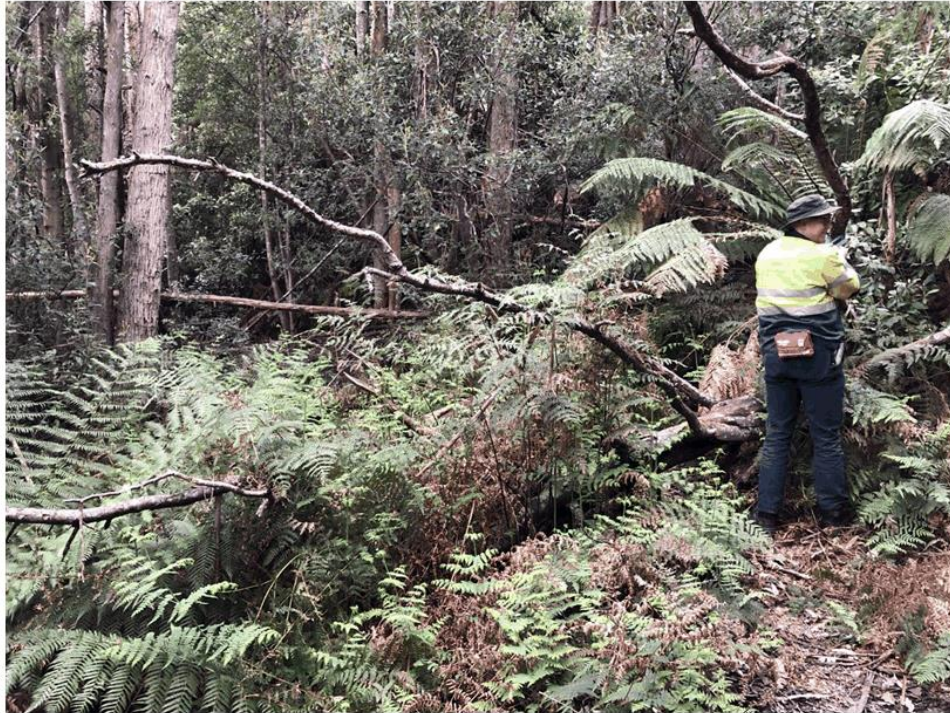
Hobart rivulet tributary upper crossing (proposed causeway)

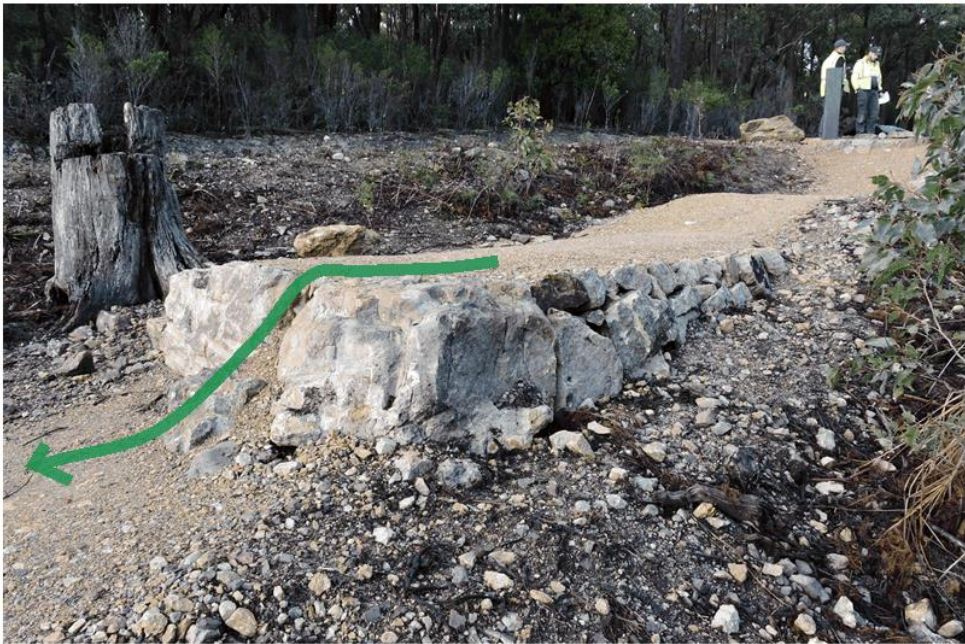
Drop off. Boulders are angles to allow bikes to roll over or climb up.

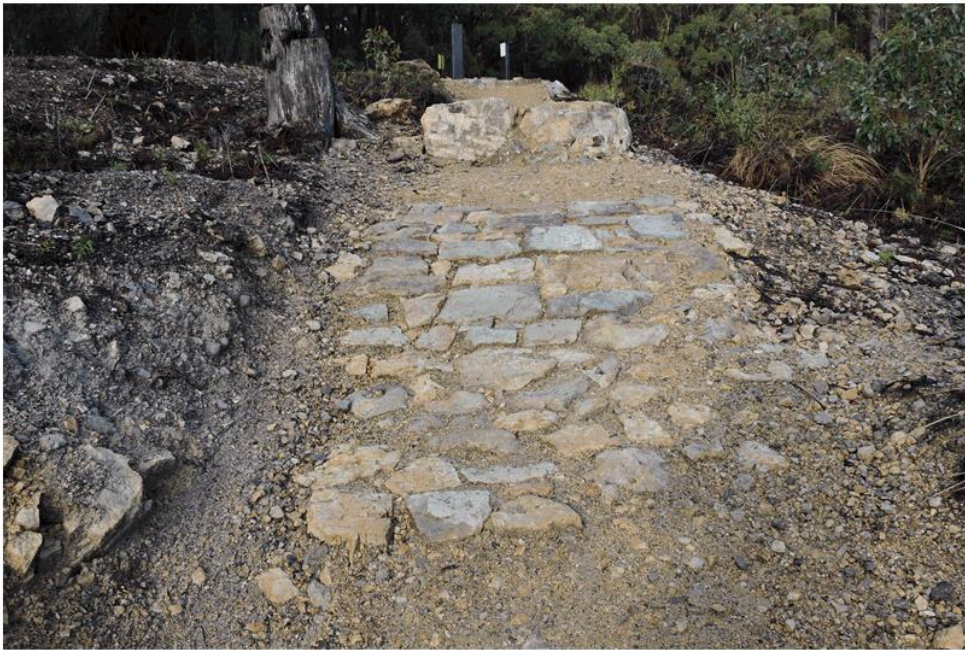
Rock armoured landing zone prevents erosion

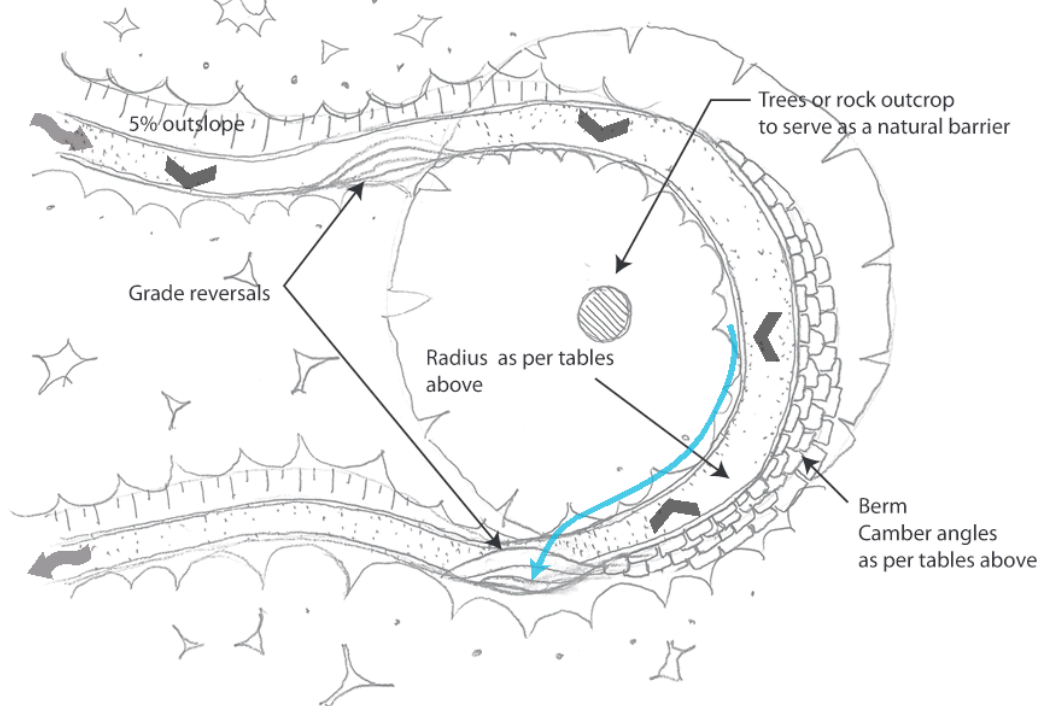
Grade dips are small-scale grade breaks that create a small low point in the track surface which intercepts water flowing down the track and diverts it off.

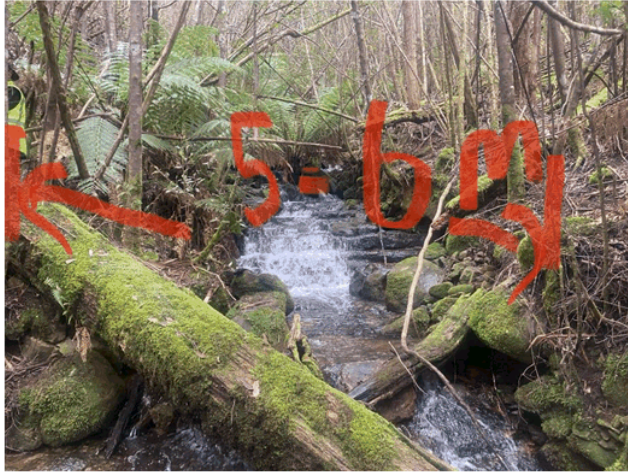
Photo 1: Hobart Rivulet / Rocky Wheel'n crossing (proposed 6m bridge):

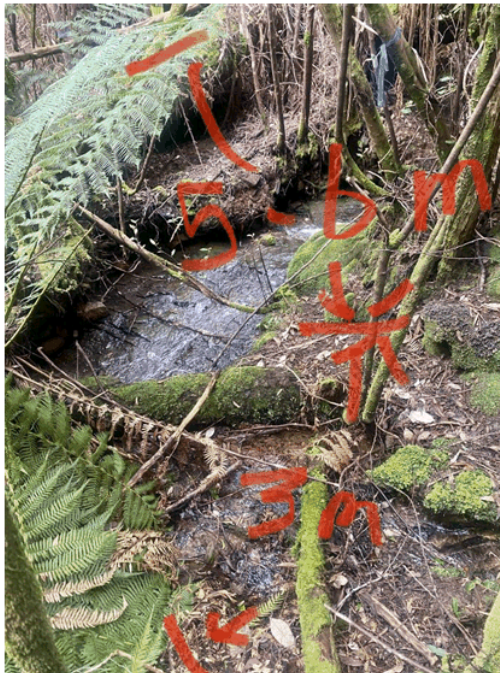
Photo 2: Hobart Rivulet / Free Wheel'n crossing (proposed 6m bridge + 3m bridge or causeway):

Both Rocky Wheel'n and Free Wheel'n tracks adjoin O'Grady's Fire Trail along an old unused machinery track and hence this section will be dual direction and shared use. Track width here may increase to 1.8 m where terrain allows and user conflicts may be anticipated.

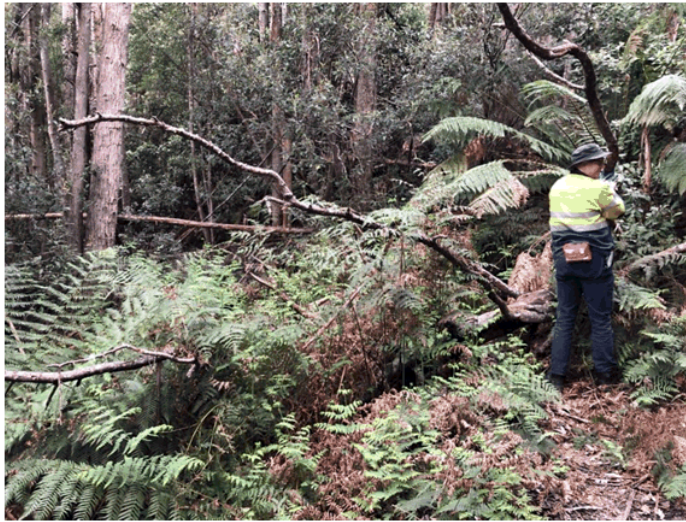
Photo 4: Hobart rivulet tributary upper crossing (proposed causeway)

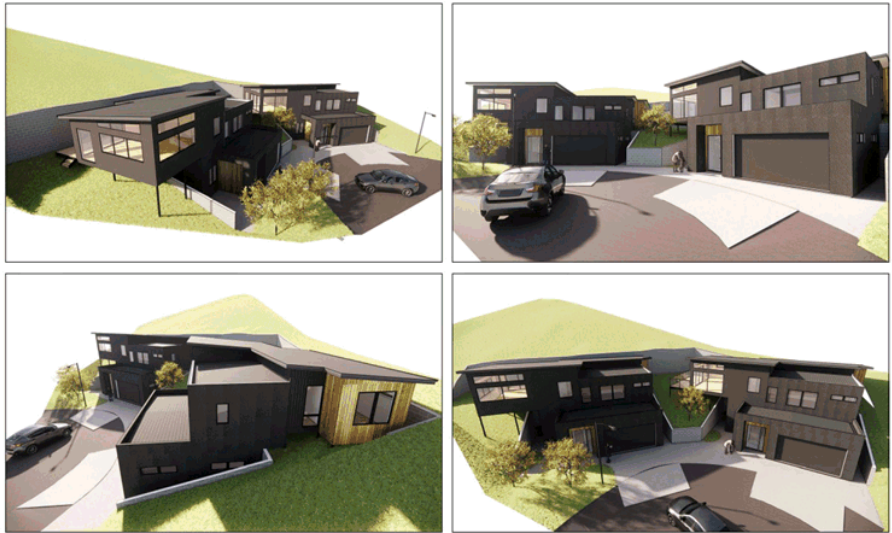
Figure 4: External perspectives of proposed development.

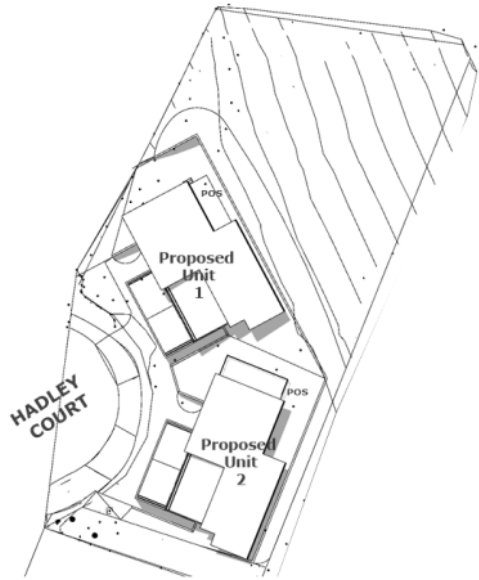
12pm - Summer Solstice
Scale: 1 : 300
1
A02

Summer Sun Diagrams

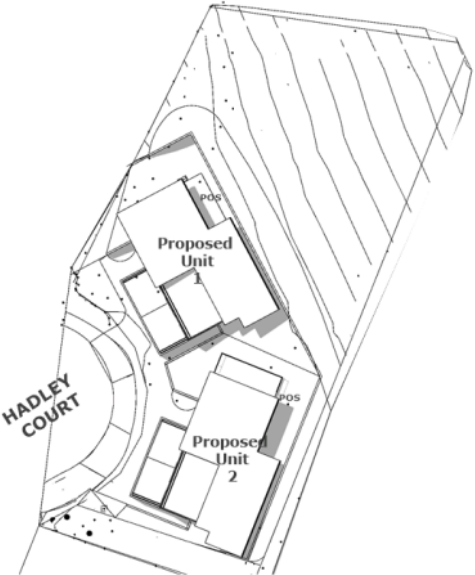
1pm - Summer Solstice
Scale: 1 : 300

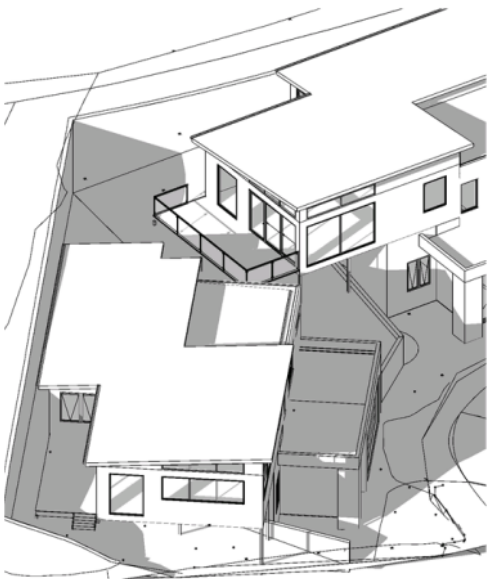
12pm - Winter Solstice
Scale: 1 : 300

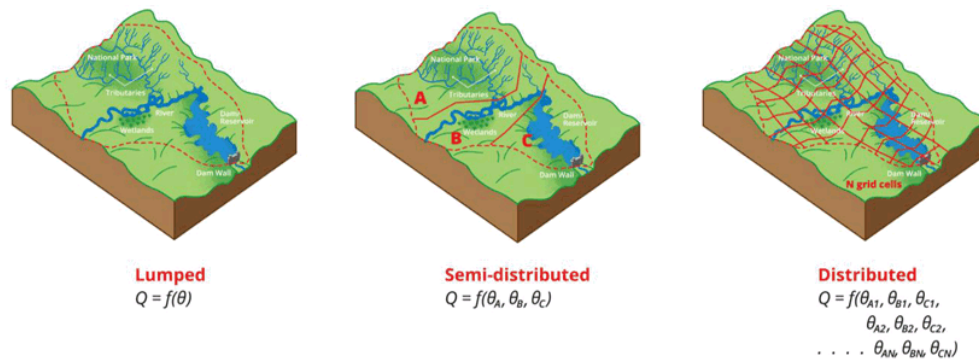
Figure 2: Catchment modelling options

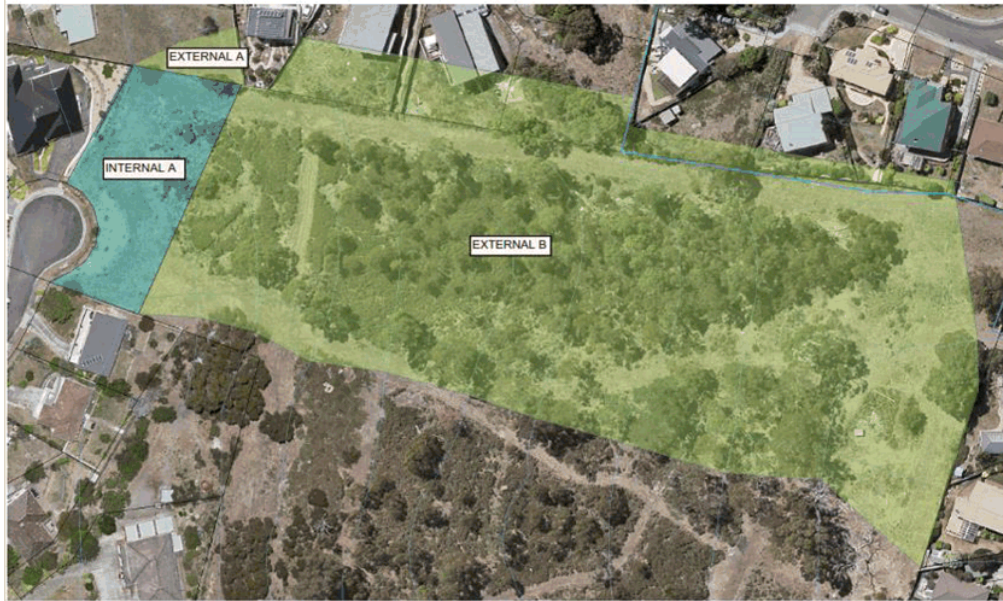
Figure 3: Catchments
