CITY OF HOBART

- 7.2 Hobart Interim Planning Scheme - Planning Scheme Amendment PSA-17-5 and S43A Permit Application PLN-17-479 - 286 Argyle Street, North Hobart

Submission to City of Hobart in
support of a Section 43A request to amend the
Hobart Interim Planning Scheme 2015 and
permit application for residential apartments

ENVIRONMENTAL SITE ASSESSMENT
286-288 ARGYLE STREET, NORTH HOBART
JULY 2017

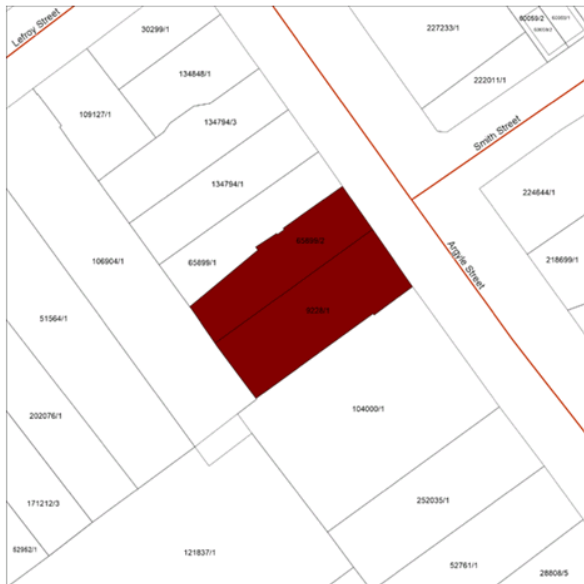
Figure 1: Area of land to be rezoned to Inner Residential

The proposed amendment seeks approval to rezone the land from Light Industrial to Inner Residential under the Interim Planning Scheme as shown in Figure 1 below.

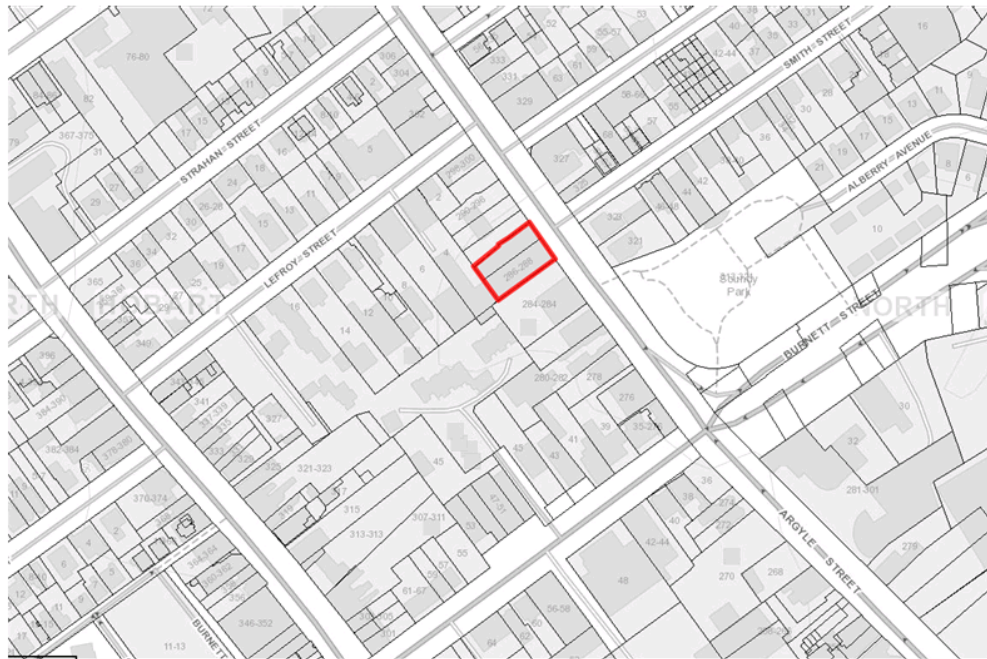
Figure 2: Land subject to the amendment request (source: www.maps.thelist.tas.gov.au).

The subject land is as shown in **Figure 2** below.

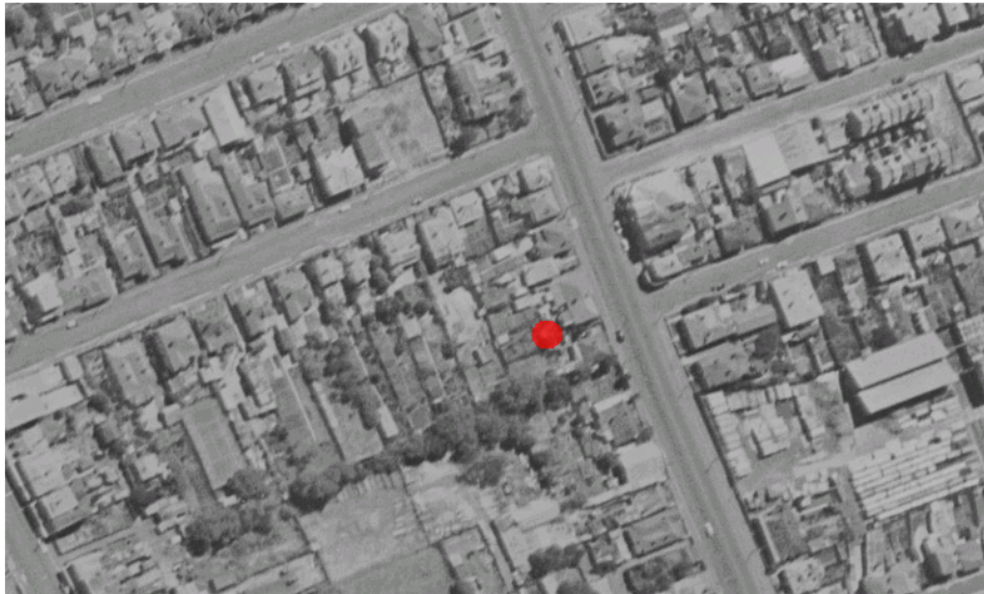
Figure 3: Aerial imagery from 1957 showing cottages on the subject site

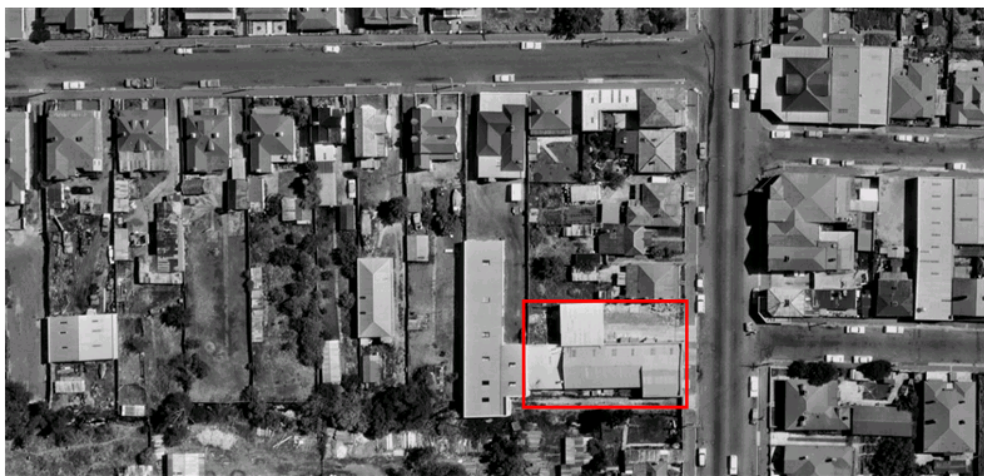
Figure 4: Aerial imagery from 1965 showing the conversion of the site to industrial purposes

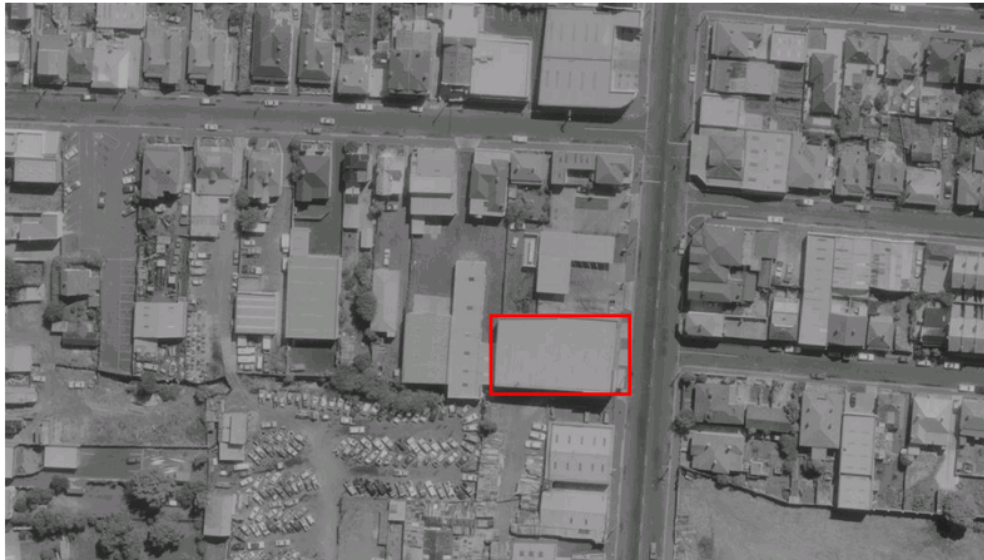
Figure 5: Aerial imagery from 1984 showing current building. The car yard in the centre of the street block is the land which was converted to residential through an infill project funded under the Better Cities Program.

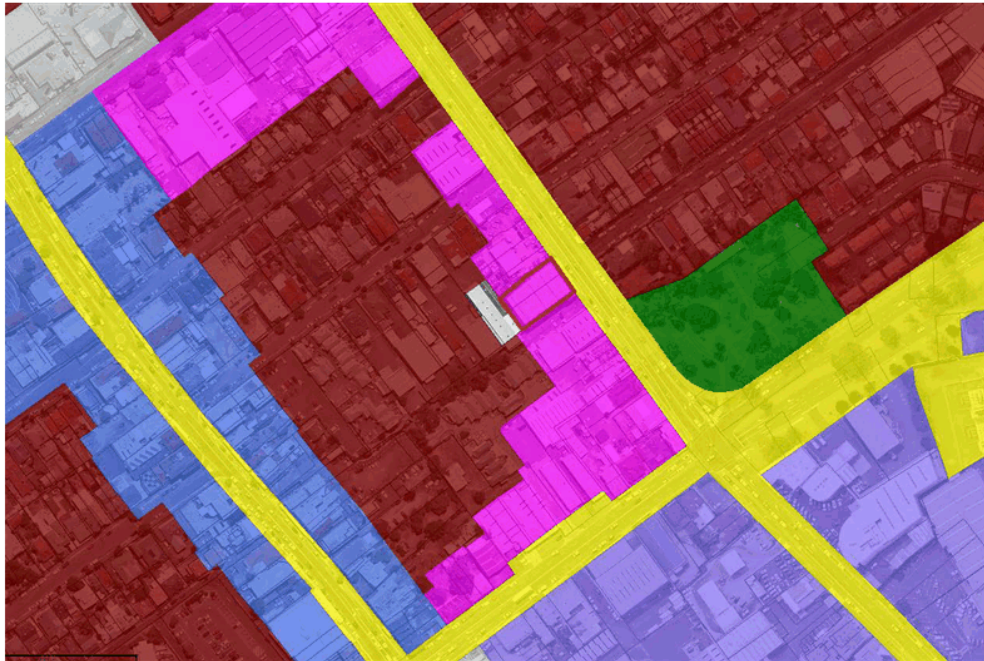
Figure 3: Existing zoning under the Hobart Interim Planning Scheme 2015 (source: www.thelist.tas.gov.au)

The strip of properties on the same side of Argyle Street as the subject land extending between Burnett and Federal Streets is generally within the Light Industrial zone as shown in Figure 2 below. Existing land uses, are however, varied and include service industries, bulk goods, retail, food services, residential and business and professional services. The mix of uses are indicative of the area not being a planned industrial estate and was originally a residential area.

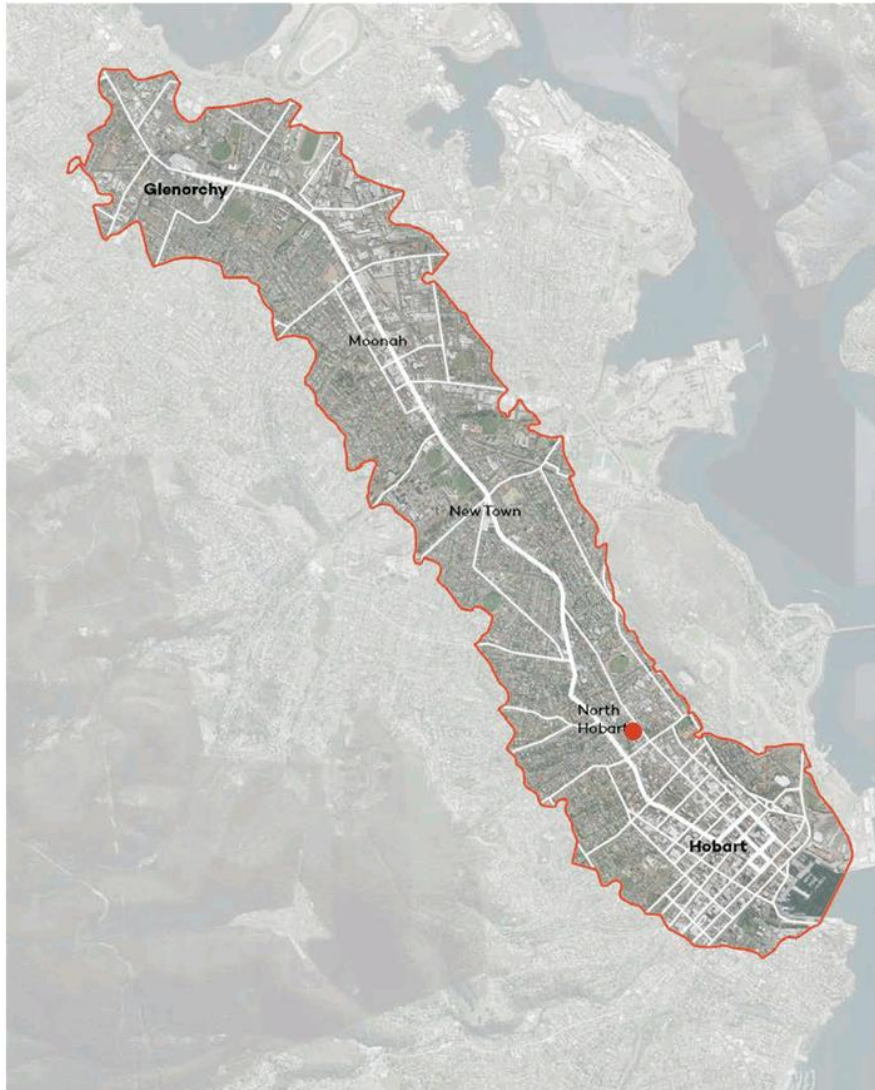
Figure 4. Area of land within walking distance of the Hobart to Glenorchy transit corridor. The location of the subject site is shown with the red dot (source: Infill Development Pilot Project, Stage 1 Report)

Land within a 400 metre corridor of the Hobart to Glenorchy Transit Corridor (see Figure 4 over page) has not only been identified as a densification area but subject to further studies such as the Infill Development Pilot Project to identify specific opportunities for further residential use and development.

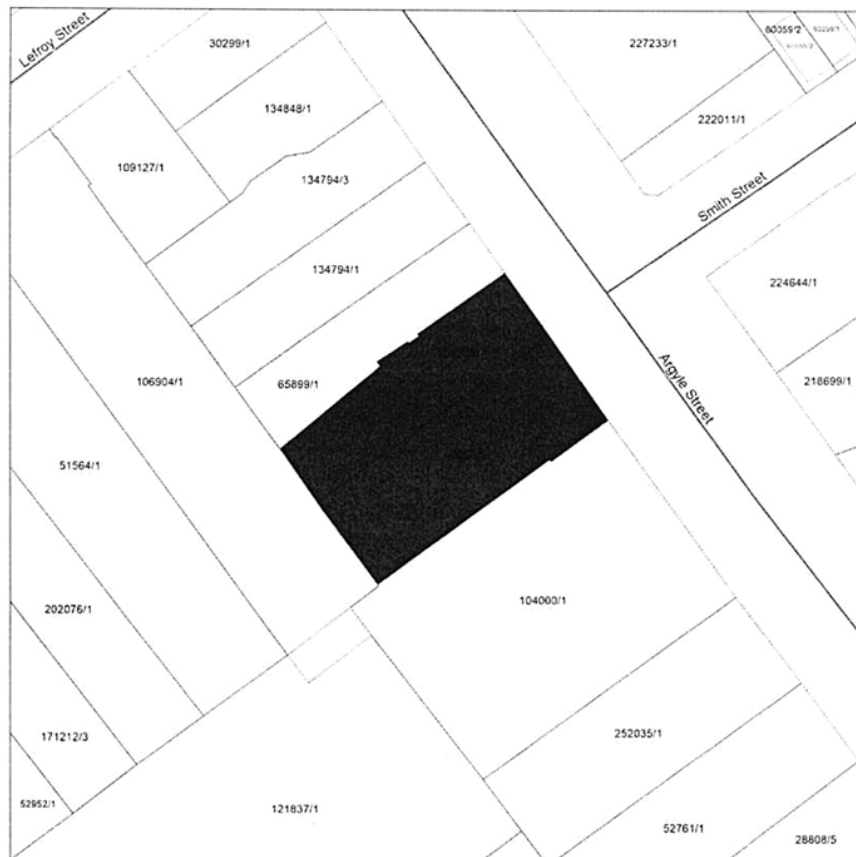
Figure 1: Proposed Rezoning.

1. Rezone the land contained in Certificate of Title Volume 9228 Folio 1 and Certificate of Title Volume 65899 Folio 2 from Light Industrial to Inner Residential as shown in Figure 1 below.

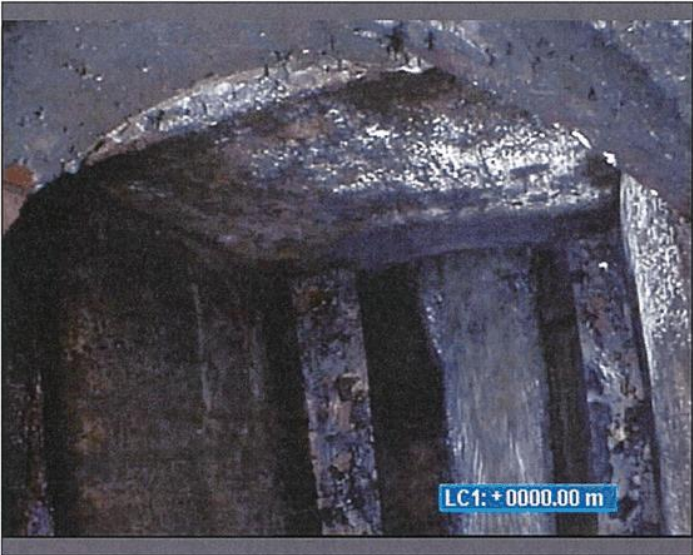
Photo: 1_1_1_A.JPG, Media No.: 300517_1, 00:00:00
0m, Start node, maintenance hole, Nodename: A , rnd con lid in car park

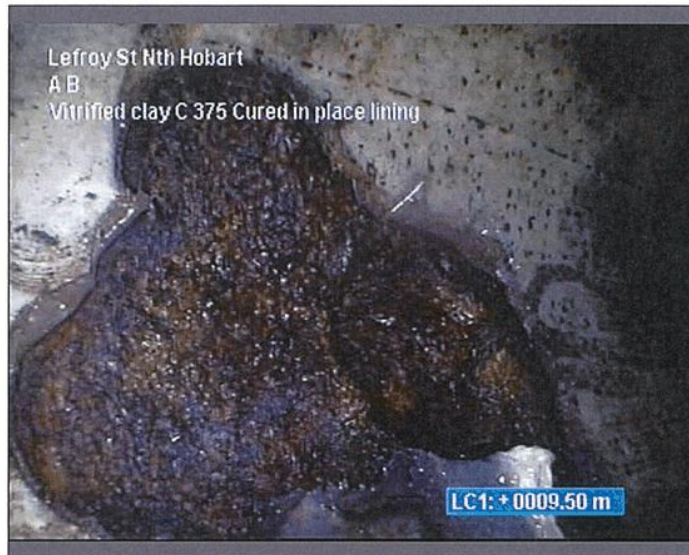
Photo: 1_1_4_A.JPG, Media No.: 300517_1, 00:03:12
9.5m, The re-establishment of a connection has been done improperly, reduction in cross sectional area: 5-20%, poorly cut open (to large), at 10 o'clock

<table><tr> <th>1:600</th> <th>Position</th> <th>Code</th> <th>Observation</th> <th>Str Rate</th> <th></th> </tr><tr> <td>9.50</td> <td>PLRC</td> <td>The re-establishment of a connection has been done improperly , reduction in cross sectional area: 5-20%, poorly cut open (to large), at 10 o'clock</td> <td></td> </tr></table>

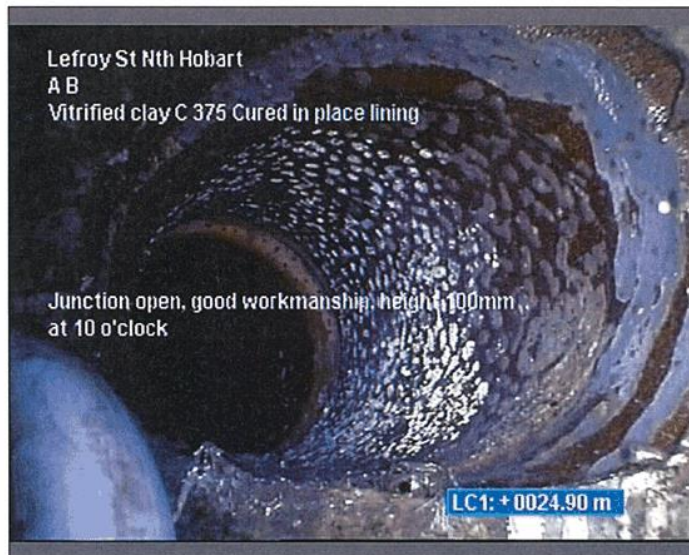
Photo: 1_1_5_A.JPG, Media No.: 300517_1, 00:05:42
24.9m, Junction open, good workmanship, height 100mm, at 10 o'clock

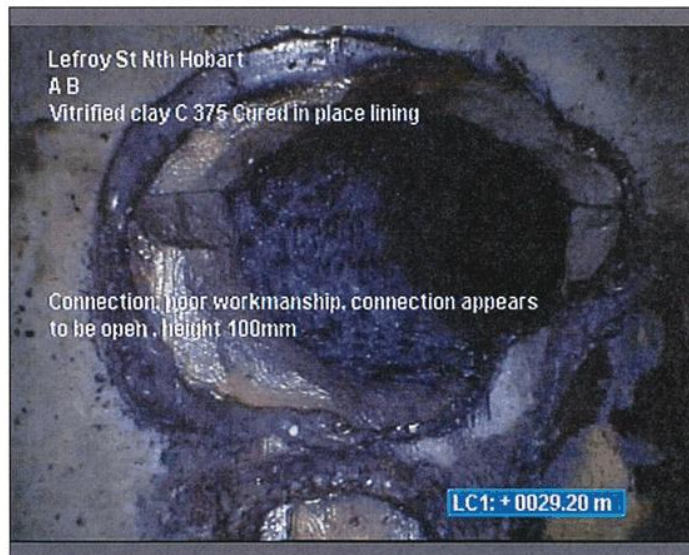
Photo: 1_1_6_A.JPG, Media No.: 300517_1, 00:07:34
29.2m, Connection, poor workmanship, connection appears to be open , height 100mm

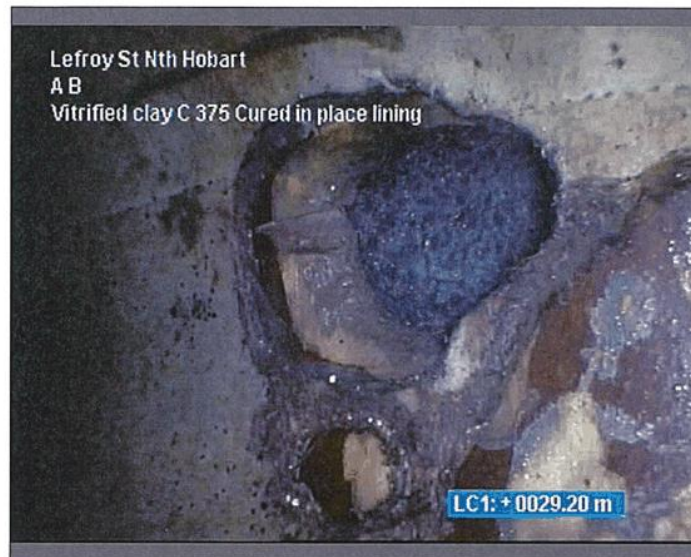
Photo: 1_1_6_B.JPG, Media No.: 300517_1, 00:07:34
29.2m, Connection, poor workmanship, connection appears to be open , height 100mm

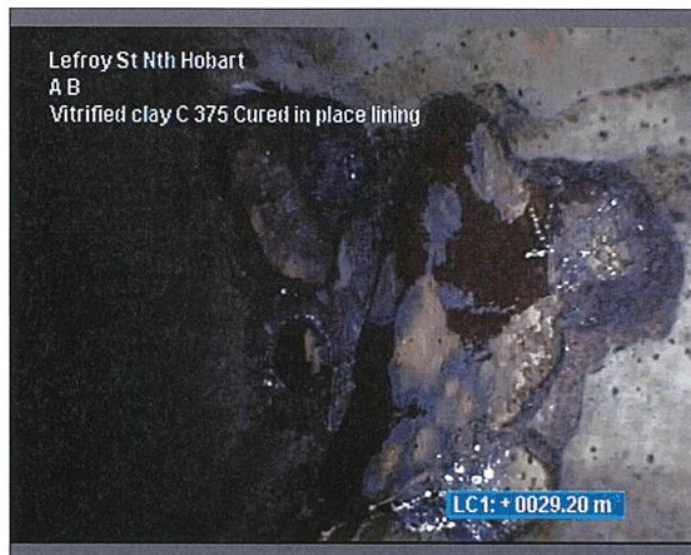
Photo: 1_1_7_A.JPG, Media No.: 300517_1, 00:07:39
29.2m, The re-establishment of a connection has been done improperly , reduction in cross sectional area: 21-50%, poorly cut out (miss), at 12 o'clock

<table><tr> <th>1:600</th> <th>Position</th> <th>Code</th> <th>Observation</th> <th>Str Rate</th> <th></th> </tr><tr> <td>29.20</td> <td>PLRC</td> <td>The re-establishment of a connection has been done improperly , reduction in cross sectional area: 21-50%, poorly cut out (miss), at 12 o'clock</td> <td></td> </tr></table>

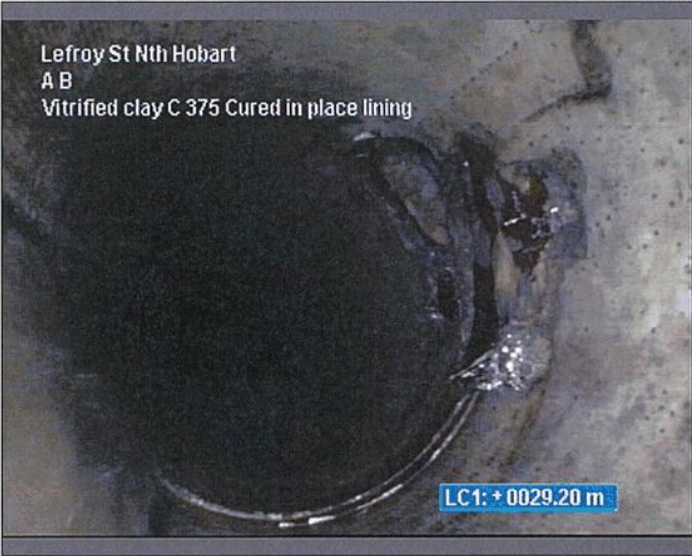
Photo: 1_1_7_B.JPG, Media No:: 300517_1, 00:07:39
29.2m, The re-establishment of a connection has been done improperly , reduction in cross sectional area: 21-50%, poorly cut out (miss), at 12 o'clock

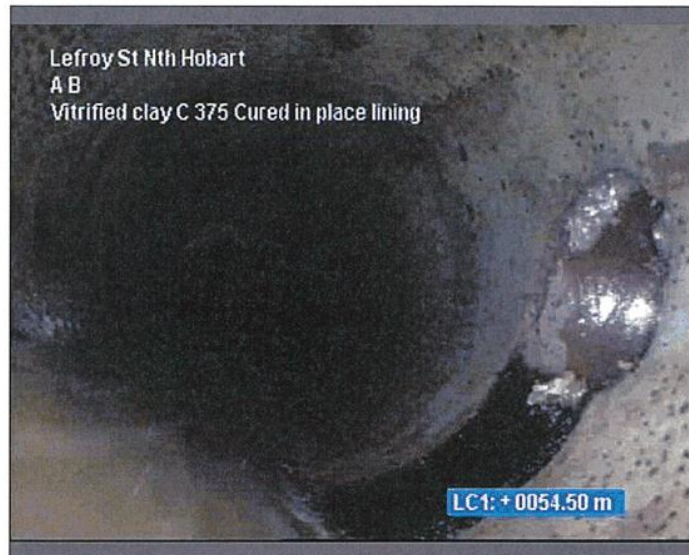
Photo: 1_1_8_B.JPG, Media No.: 300517_1, 00:11:46
54.5m, Junction open, good workmanship, height 100mm , at 2 o'clock

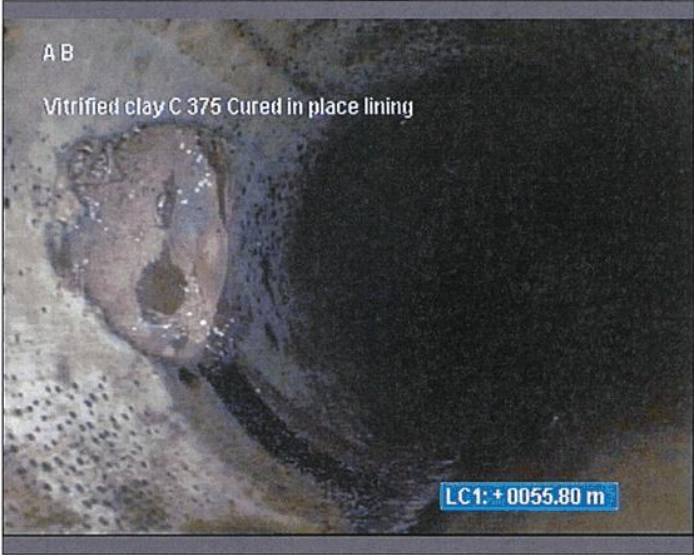
Vitrified clay C 375 Cured in place lining

Photo: 1_1_9_B.JPG, Media No:: 300517_1, 00:12:27
55.8m, Junction open, good workmanship, height 100mm , at 11 o'clock

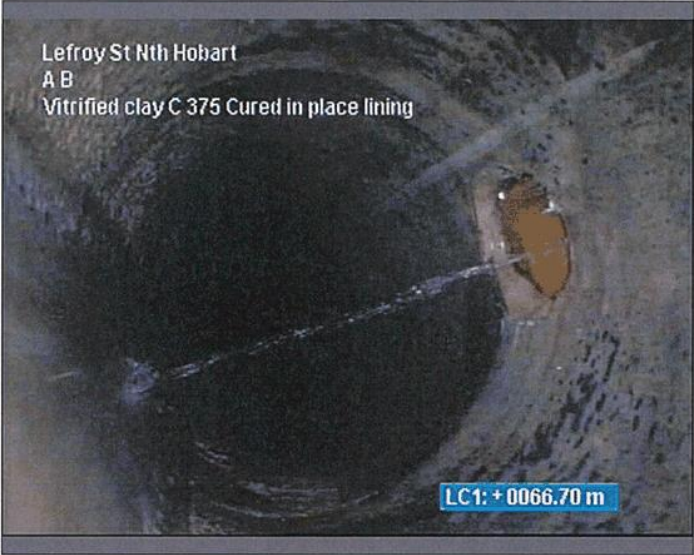
Photo: 1_1_10_B.JPG, Media No:: 300517_1, 00:14:08
66.7m, Connection, good workmanship, connection appears to be open, height 100mm , at 12 o'clock

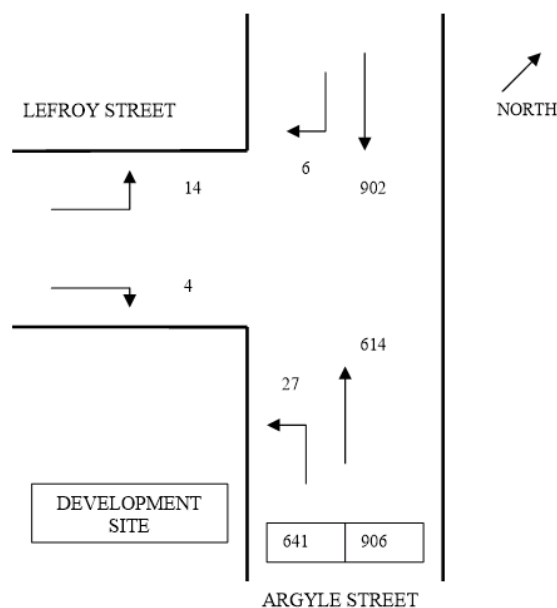
Figure 4.1: Turning traffic volumes at Lefroy Street junction with Argyle Street – 8:00am to 9:00am

The result from this survey has been summarised in Figure 4.1.

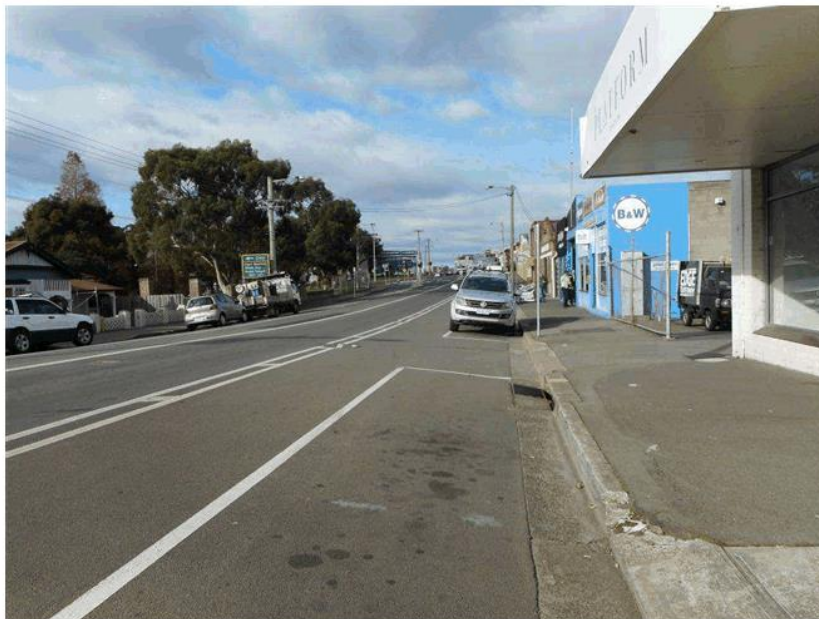
Photograph 4.1: View to south along Argyle Street from development site access driveway

As can be seen in Photographs 4.1 and 4.2, the available sight distances to and from turning vehicles at the access driveway are much greater than the desirable minimum sight distance.

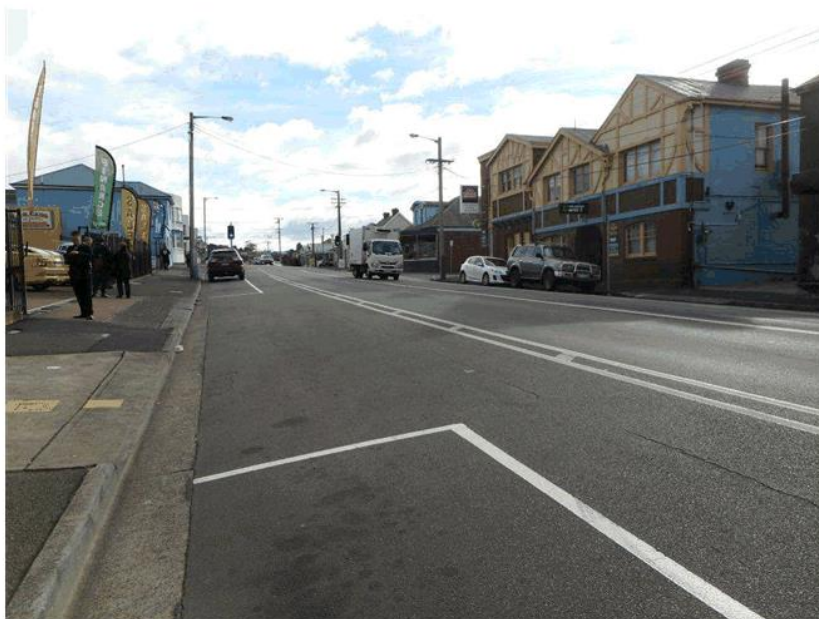
Photograph 4.2: View to north along Argyle Street from development site access driveway

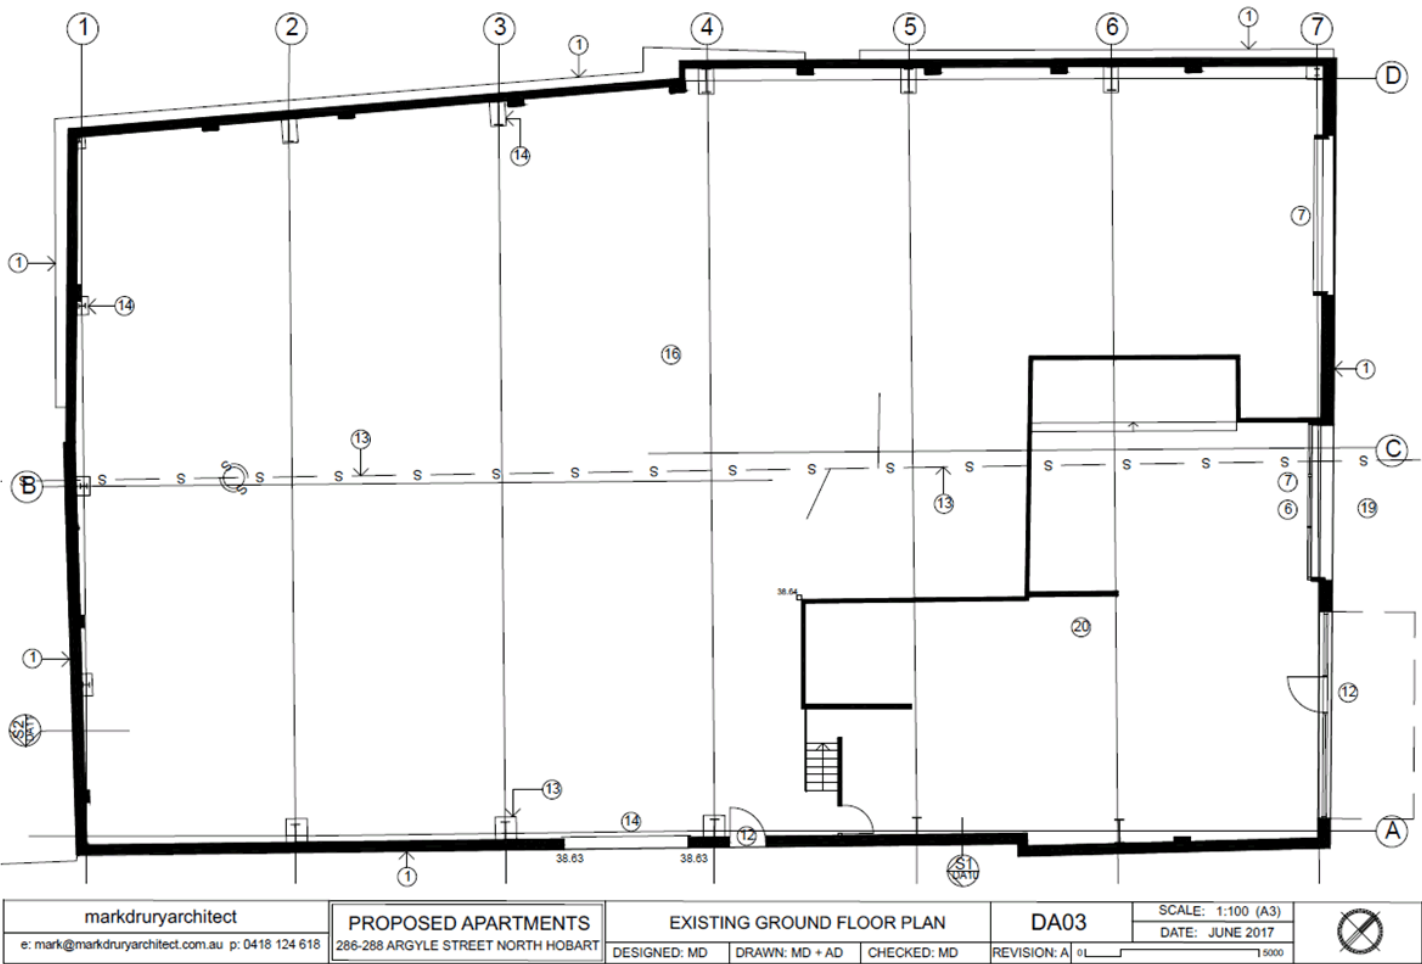
Figure 4 Existing Site Layout

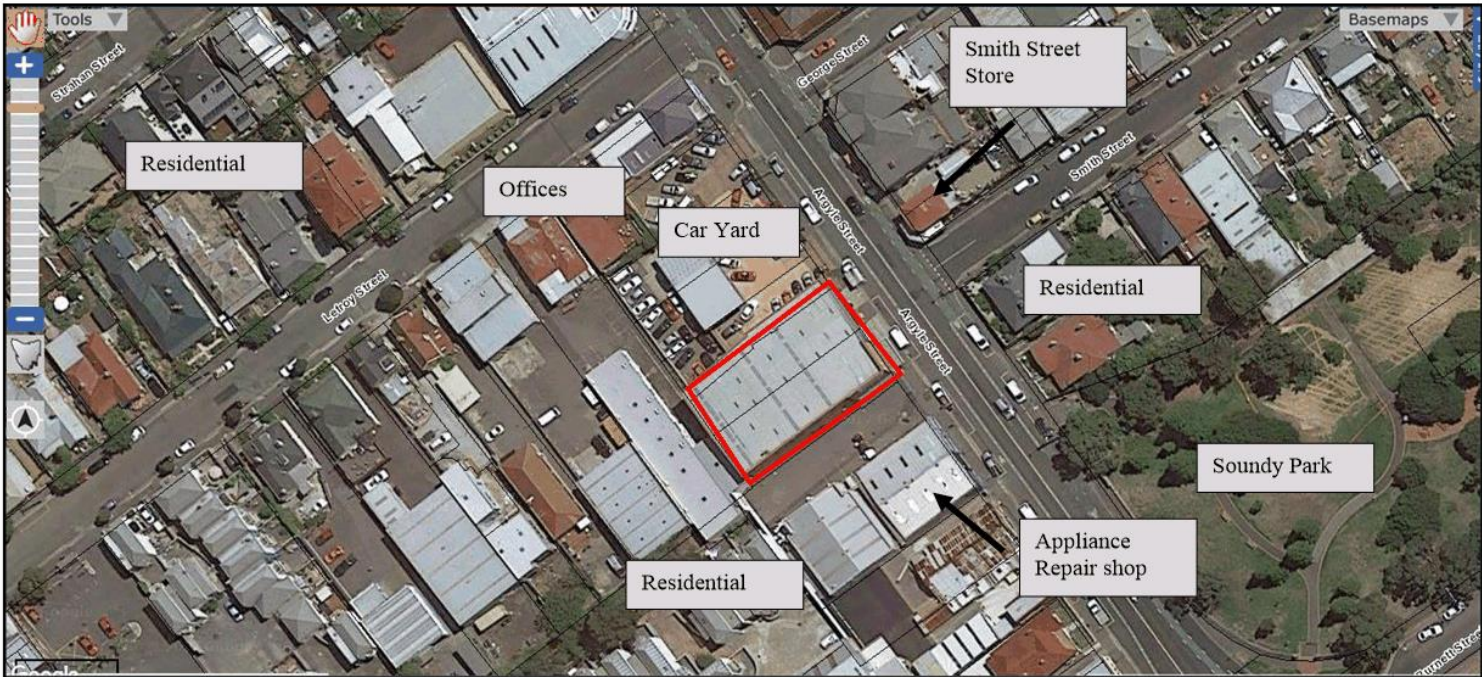
Figure 6 Site Context Plan

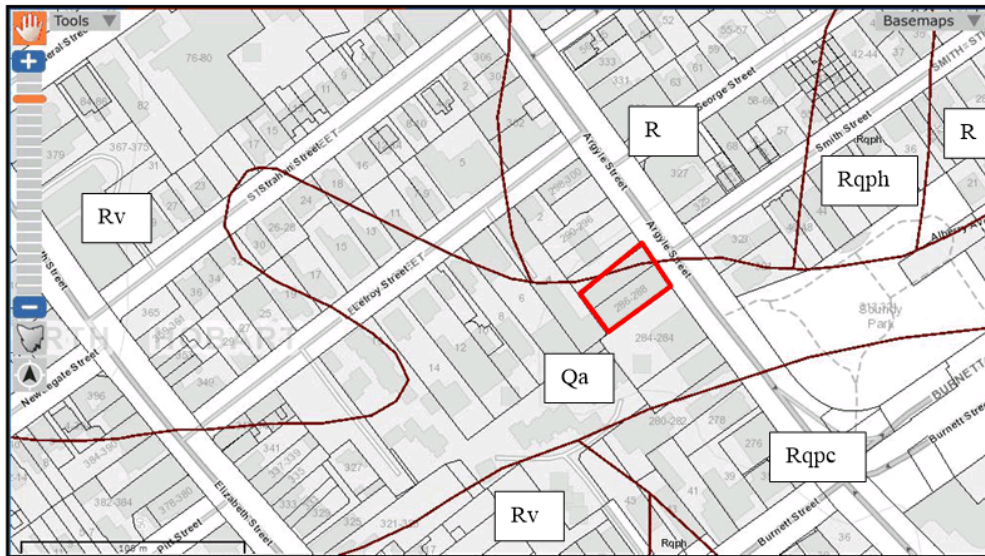
RV – Triassic Undifferentiated volcaniclastic, quartz-rich lithic and quartzose sandstone, siltstone, mudstone, carbonaceous beds and coal seams.

The geology of the site is mapped as mostly Quaternary Sediments (Qa) of alluvial gravel, sand and clay. The northern corner of the site is mapped as undifferentiated Upper Parmeener Supergroup rocks (Figure 7).

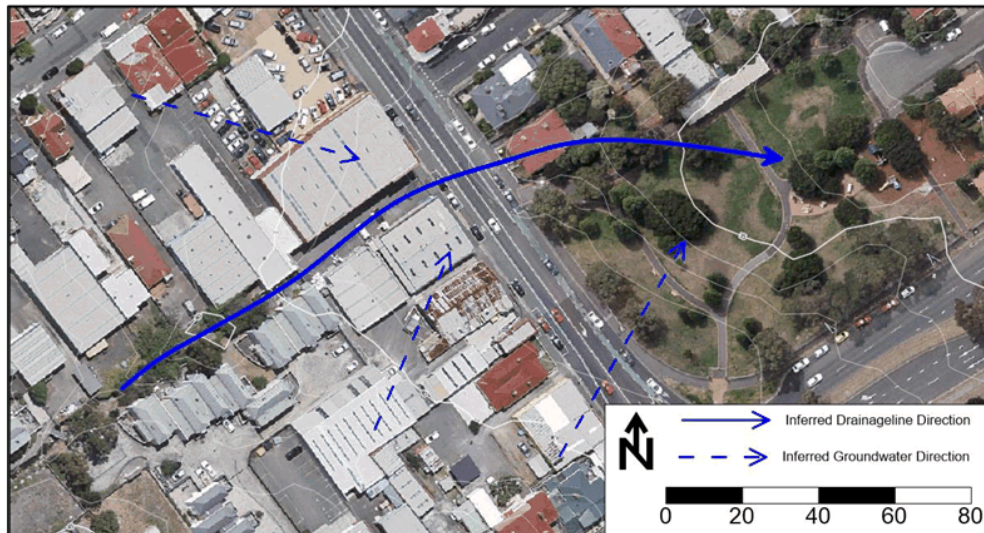
Figure 8 Inferred Groundwater Flow

The inferred groundwater flow is illustrated in Figure 8.

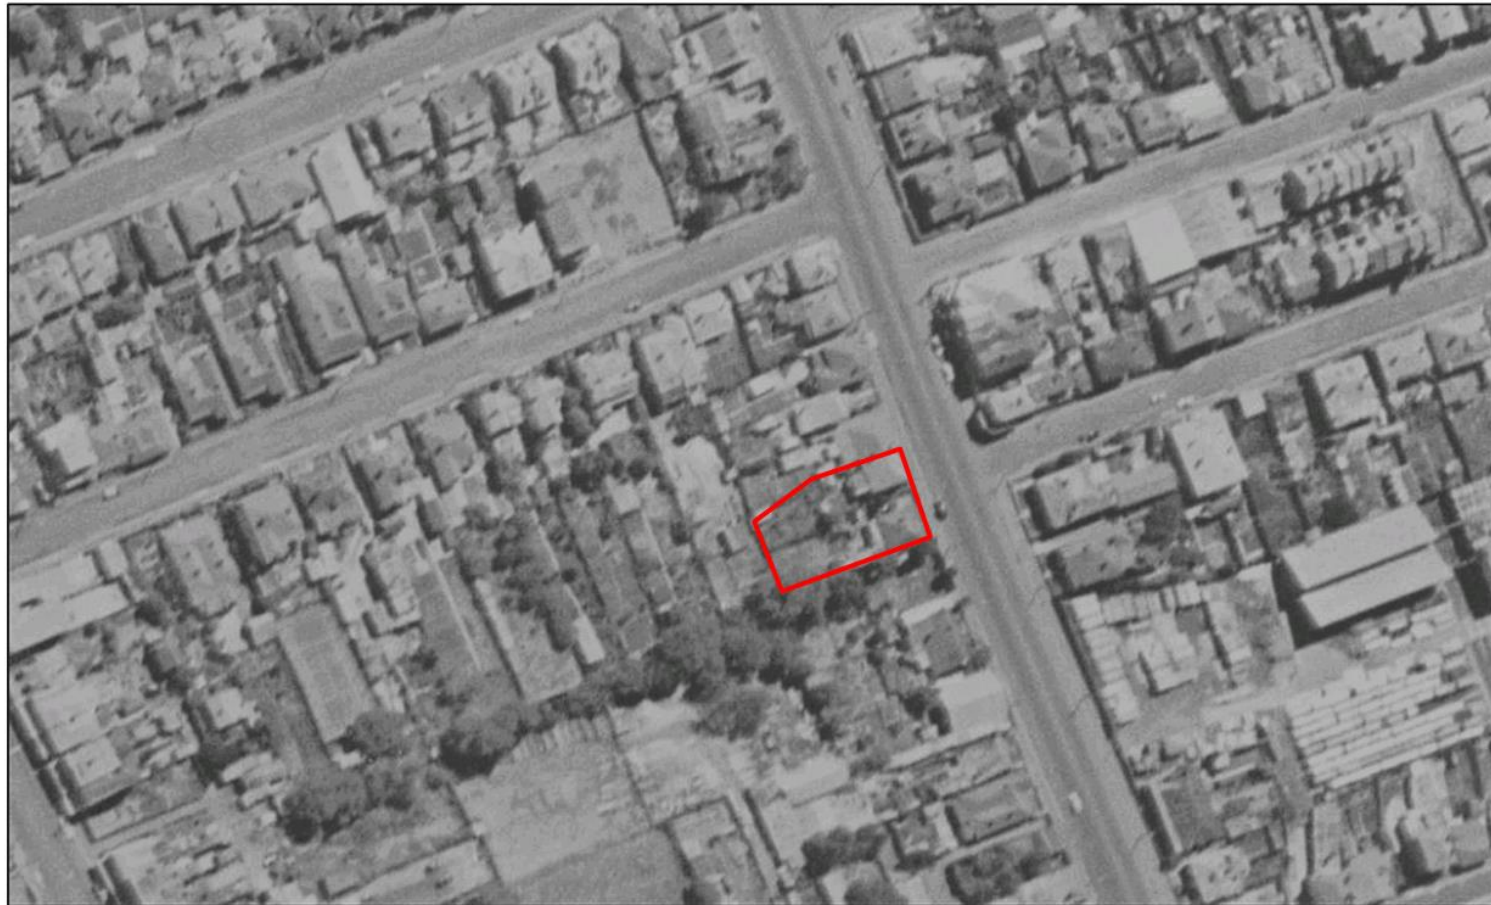
Plate 5 Historical Aerial Photograph – the Site 1957

Table 3 presents a summary of alterations to the site between photographic events and the individual aerial photographs are presented in Plate 5 to Plate 12.

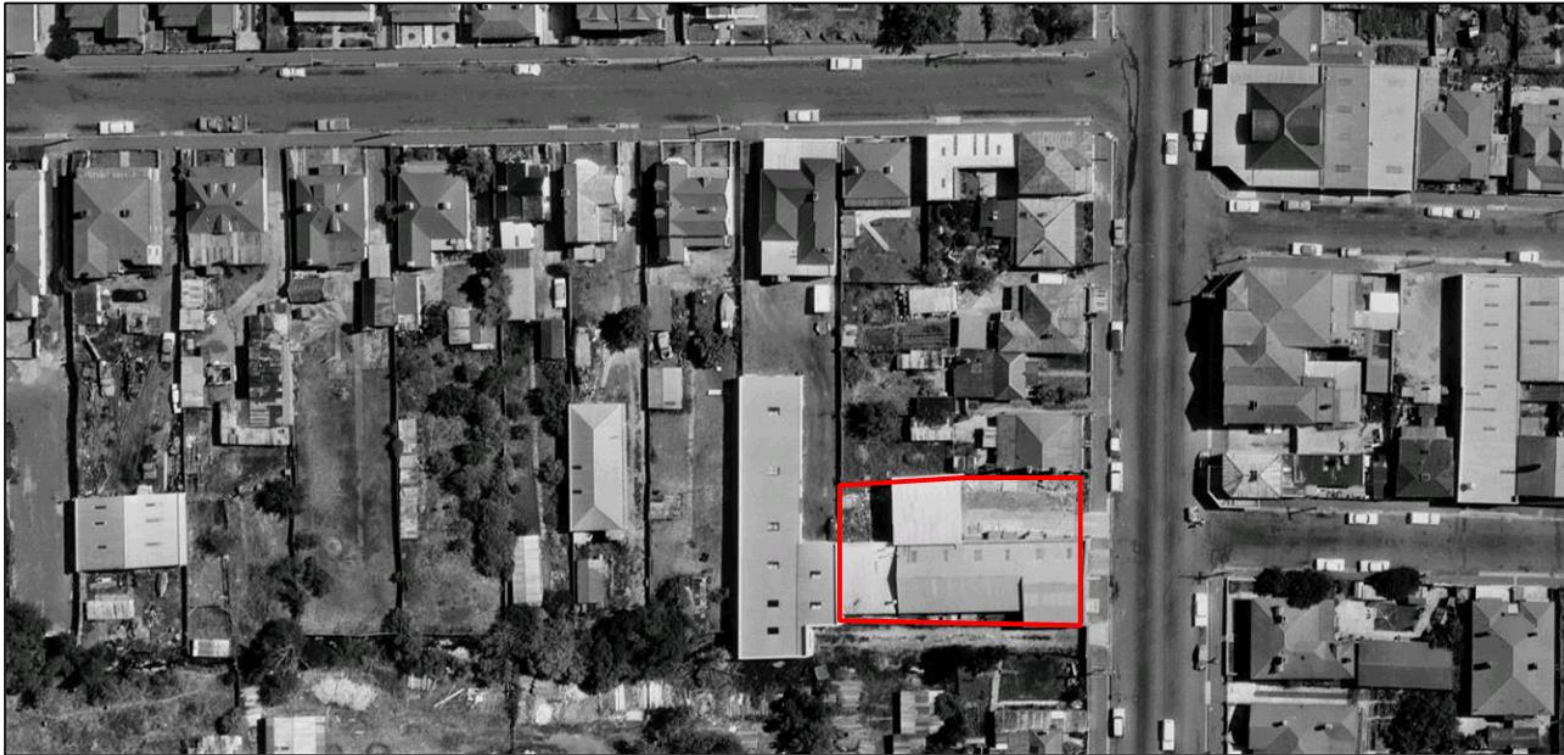
Plate 7 Historical Aerial Photograph – The site 1965

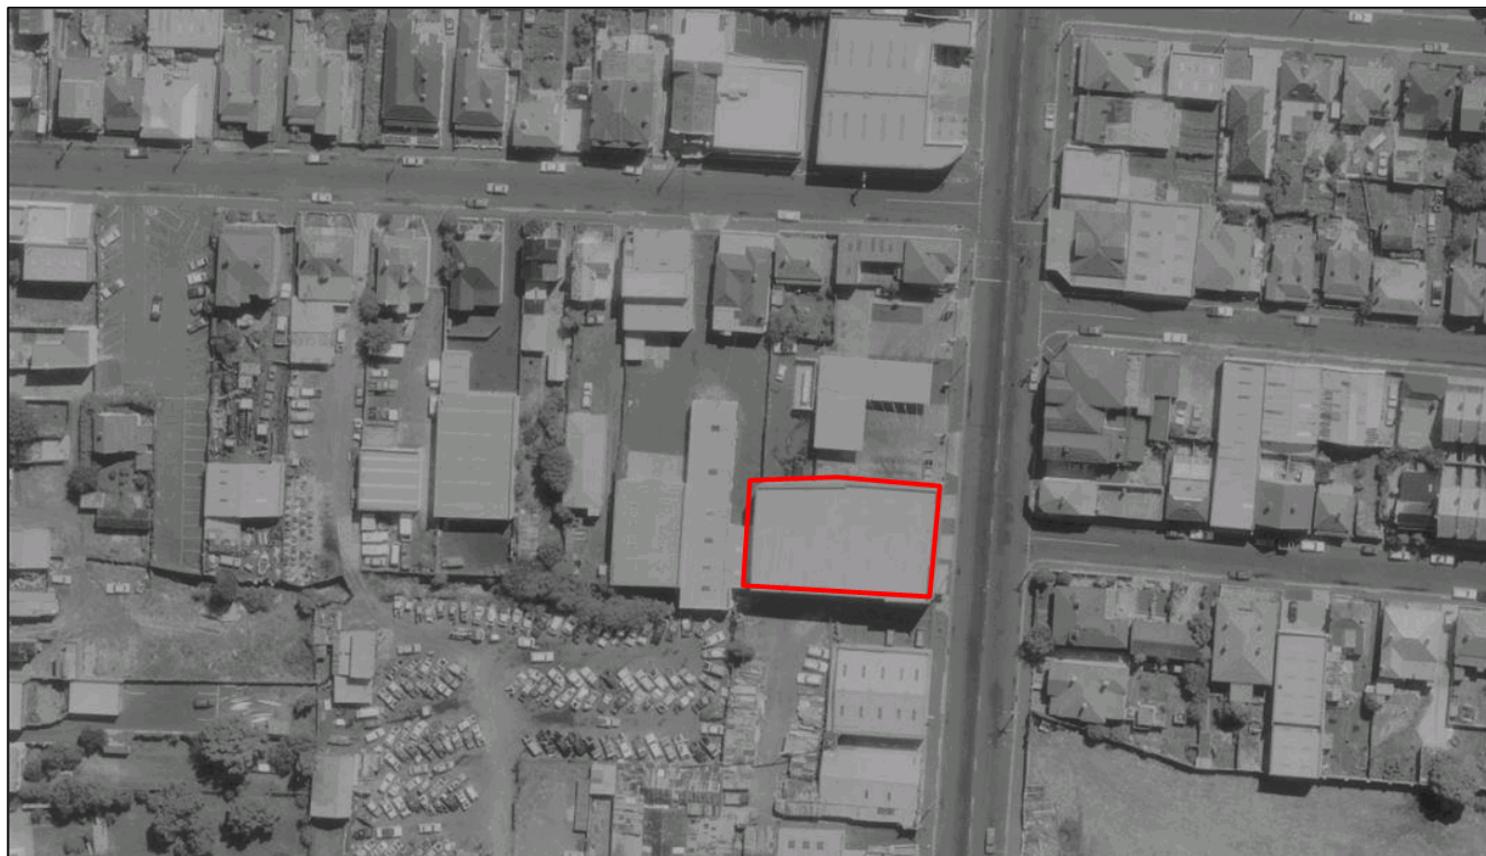
Plate 9 Historical Aerial Photograph– The site 1984

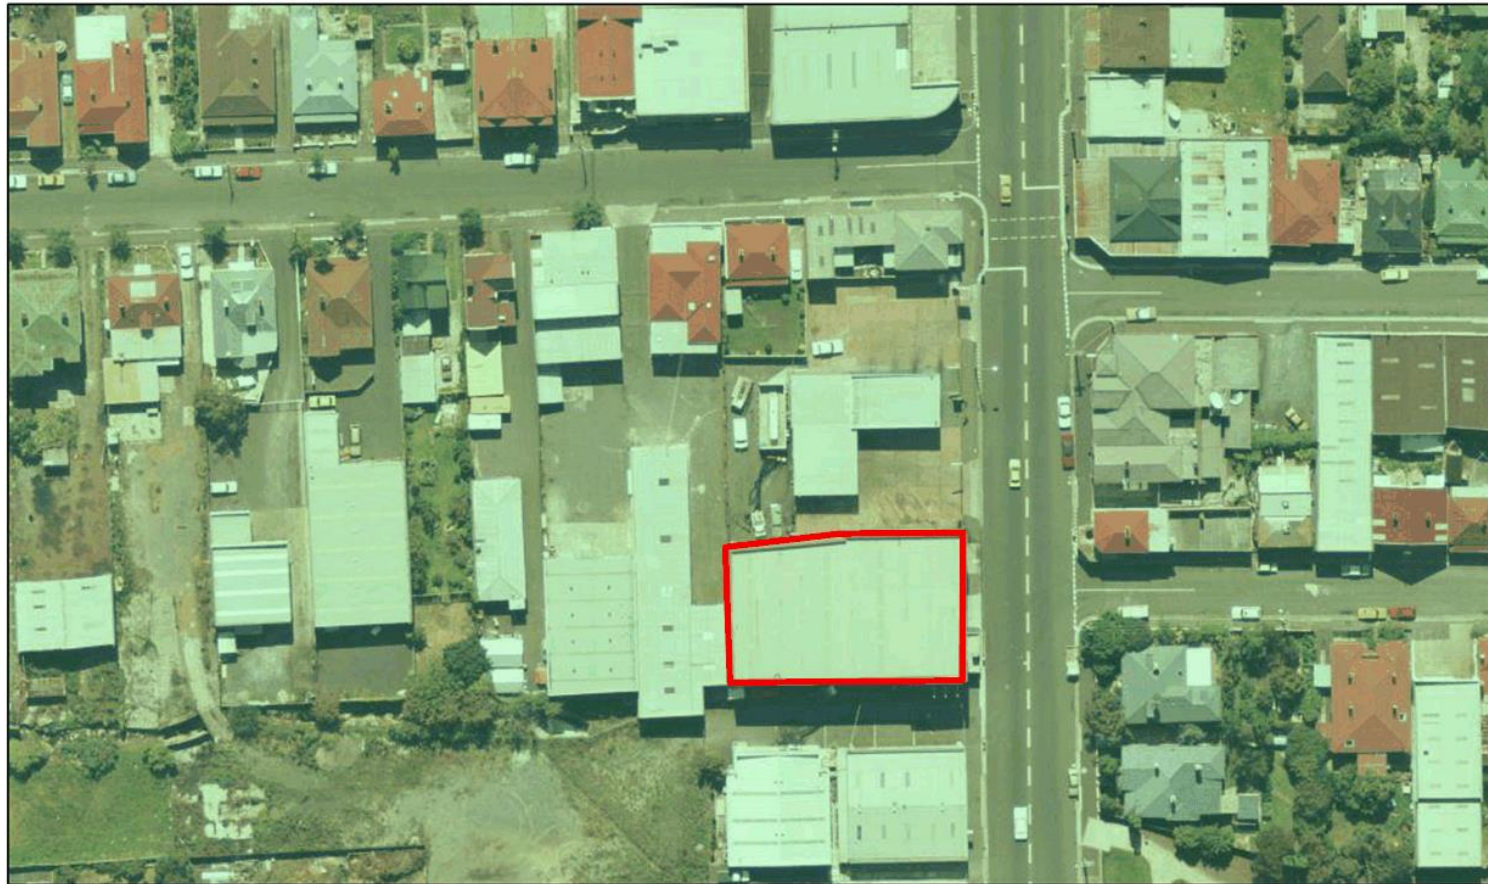
Plate 11 Historical Aerial Photograph – The site 1992

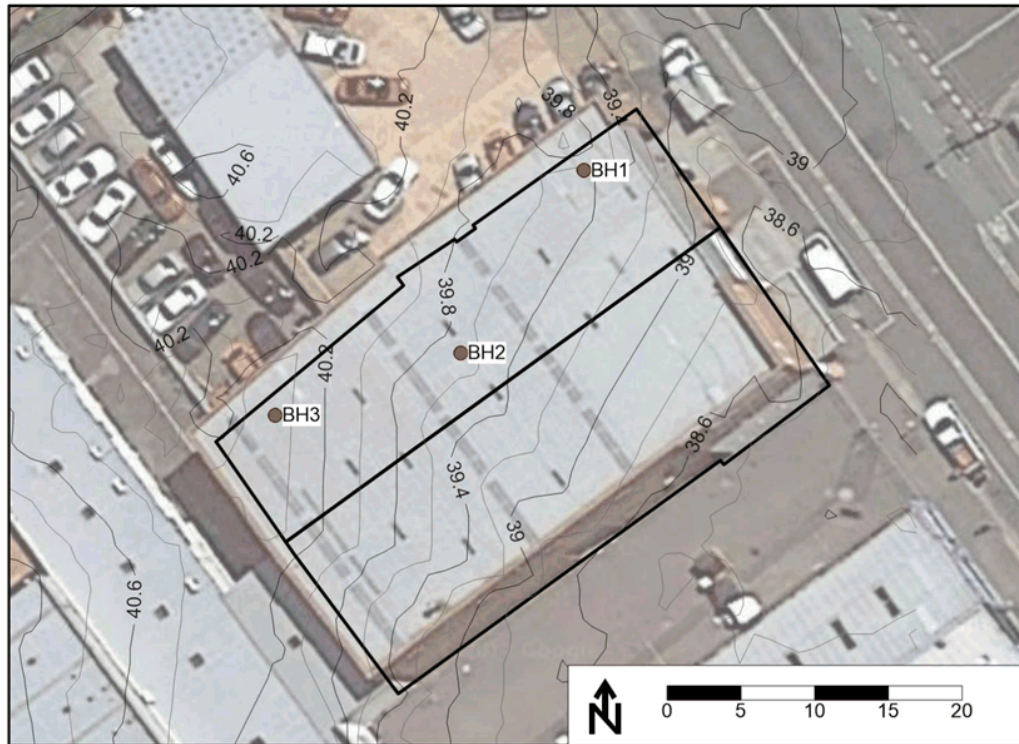
Figure 9 Borehole (BH1 to BH3) Investigation Areas

Site investigation work was conducted on the 22 June 2017 and involved the drilling of three soil bores (BH1 – BH3). Locations are presented in Figure 9.

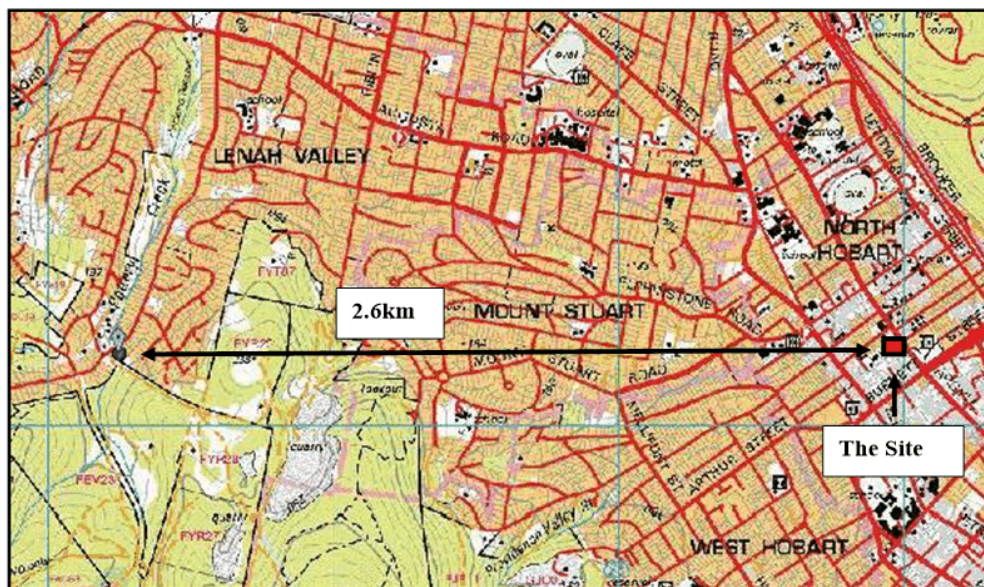
Bore location is record 41515, 2.6km West of the Site.

Figure 10 – Location of groundwater bore Record # 41515 2.6km
