CITY OF HOBART

CITY PLANNING COMMITTEE MEETING

7.1.2 125 Bathurst Street, Hobart - Partial Demolition, Alterations and
Redevelopment for General Retail and Hire, Food Services and 33 Multiple
Dwellings - PLN-18-530

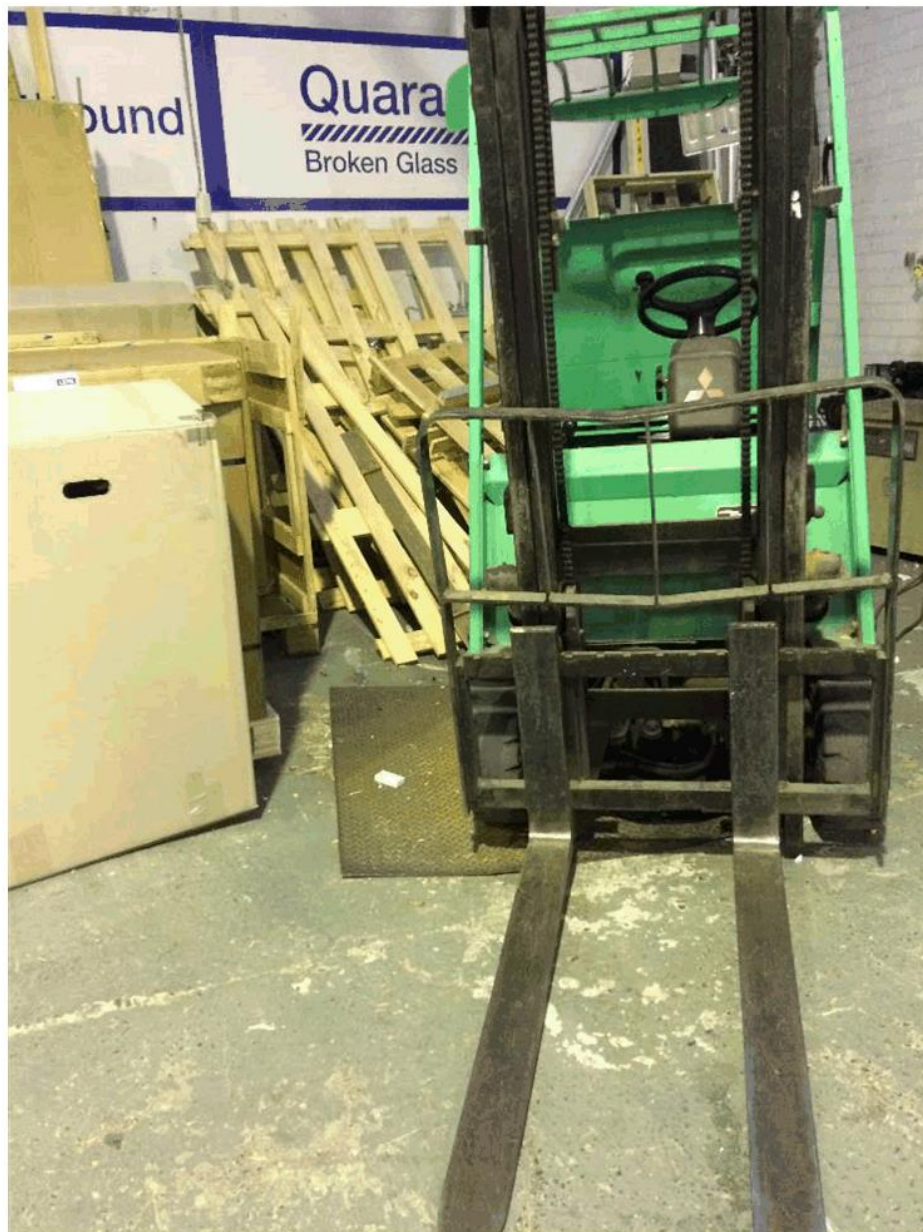
A former washdown station was located in the north-eastern corner of the warehouse. The drain into an underlying holding tank was covered with a metal plate, and a forklift was parked on top of both items (Plate 1 below). The washdown station has not been used by Windscreens O'Brien however, immediately following their occupation of the premises, they arranged for the contents of the tank to be pumped and disposed offsite (pers. comm. Mr Matt Chapman, 20 June 2018). It is understood that the washdown station was used by Avis during their occupation of the site, and no information regarding the age or design of the structure or related subfloor drainage has been identified. No evidence of fuel storage, either for vehicles or for heating etc, was observed during the inspection.

Plate 1 Former washdown area with metal plate covering drain into underlying holding tank.

The dimensions or capacity of the tank beneath the former washdown area in the warehouse were not able to be confirmed, and neither has the age or the condition of the structure been confirmed. The composition of the liquids removed from it when Windscreens O'Brien moved into the premises were not available. This structure should be further inspected to assess if it is a potential source of contamination at the site.

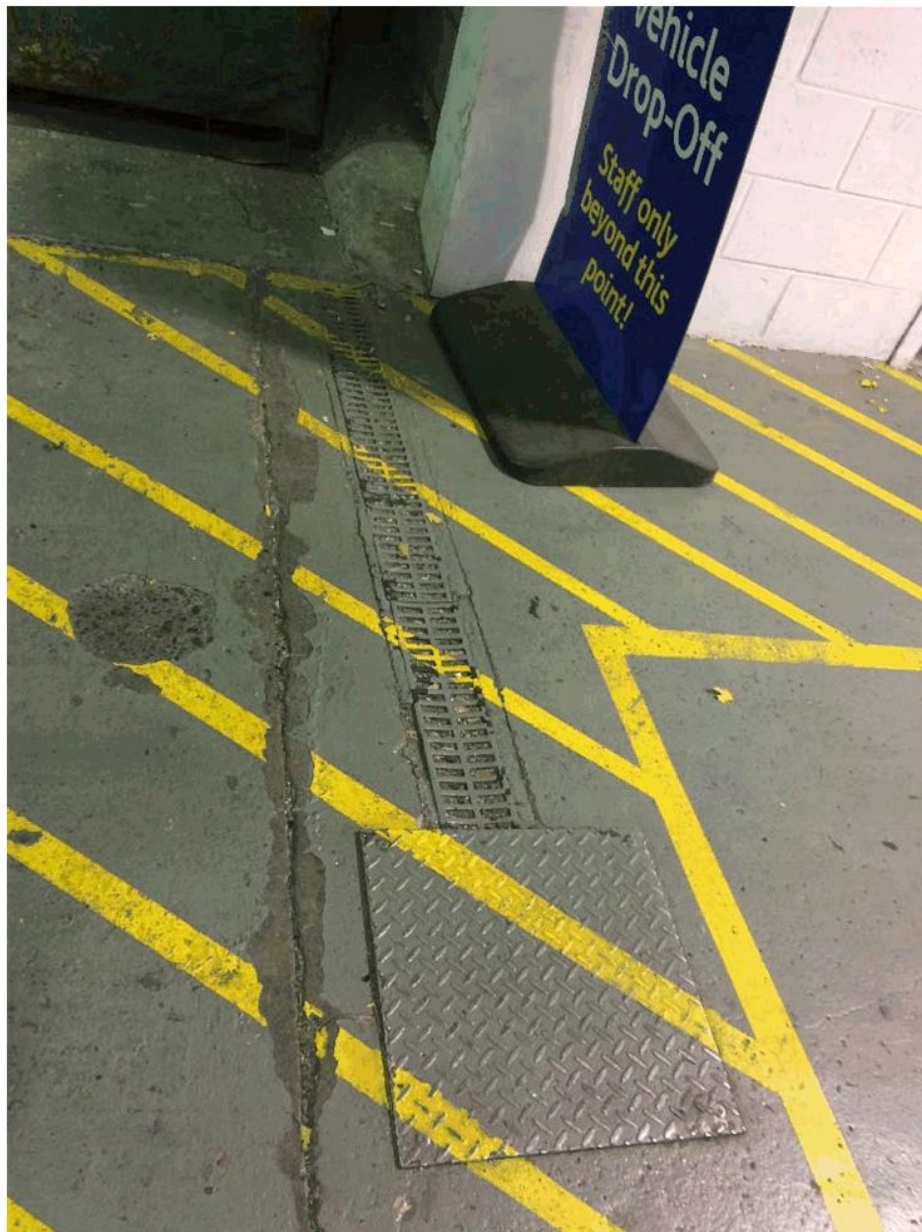
Other locations with potential evidence of access to underlying ground comprised a grate that extended across one side of the vehicle access way, adjacent the former washdown area (Plate 2), and a rectangular section of flooring towards the back of the warehouse that may have replaced previous infrastructure or an area of damaged flooring (Plate 3).

Plate 2 Partial grate across one side of vehicle access way, adjacent washdown area

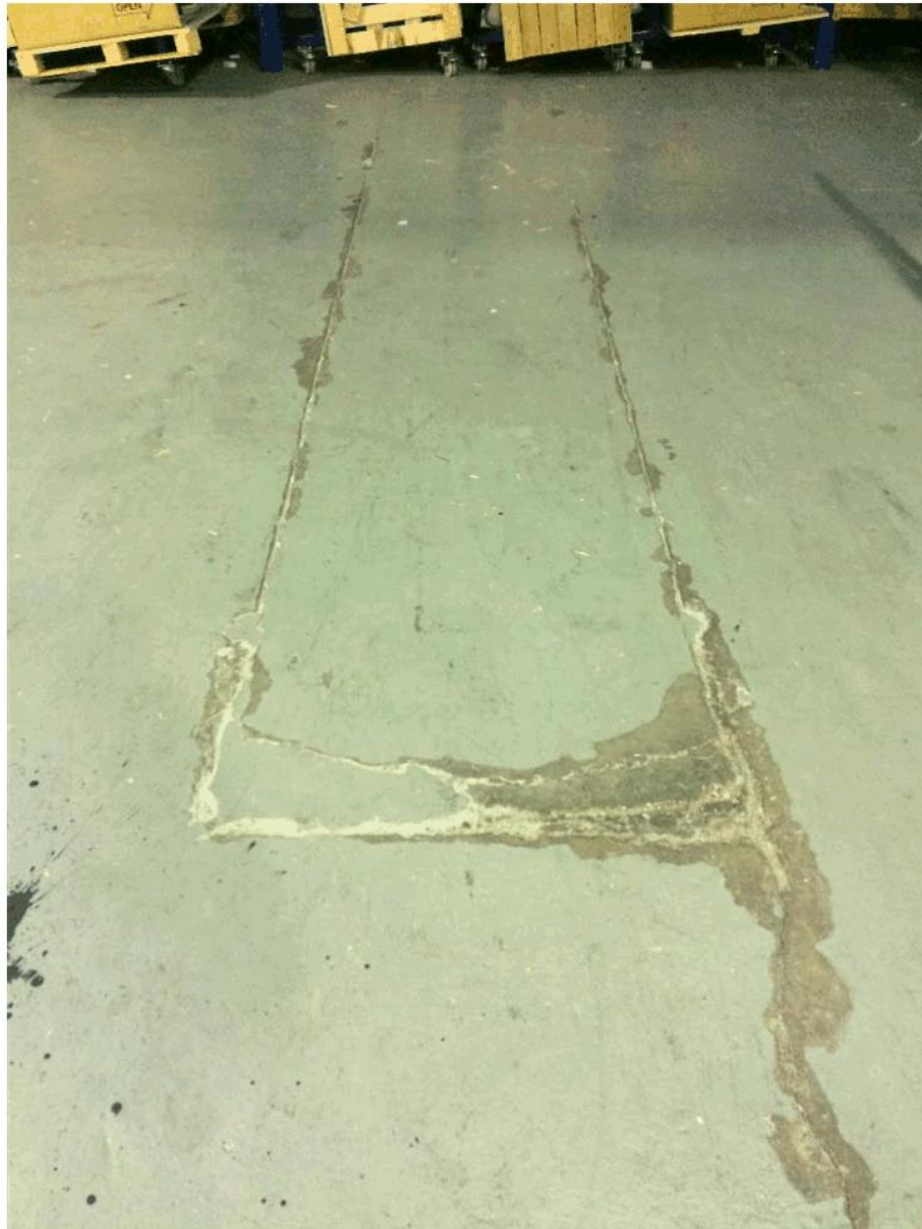
Plate 3 Rectangular section of flooring towards back of warehouse that may indicate replaced infrastructure or flooring

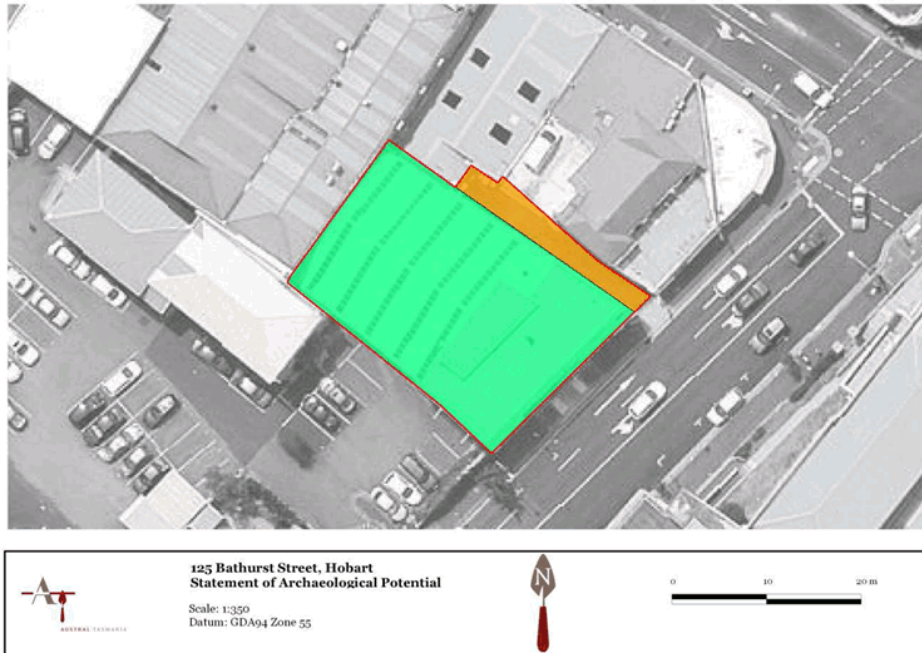
The variable archaeological potential of the place has been presented in a simplified zoning, dividing the property into areas of nil to low and moderate potential. This is shown in the following Archaeological Zoning Plan.

Archaeological Zoning Plan for 125 Bathurst Street. The zoning shows: 1. areas of nil to low (green) and 2. moderate (orange) archaeological potential (LIST Map, © State of Tasmania).

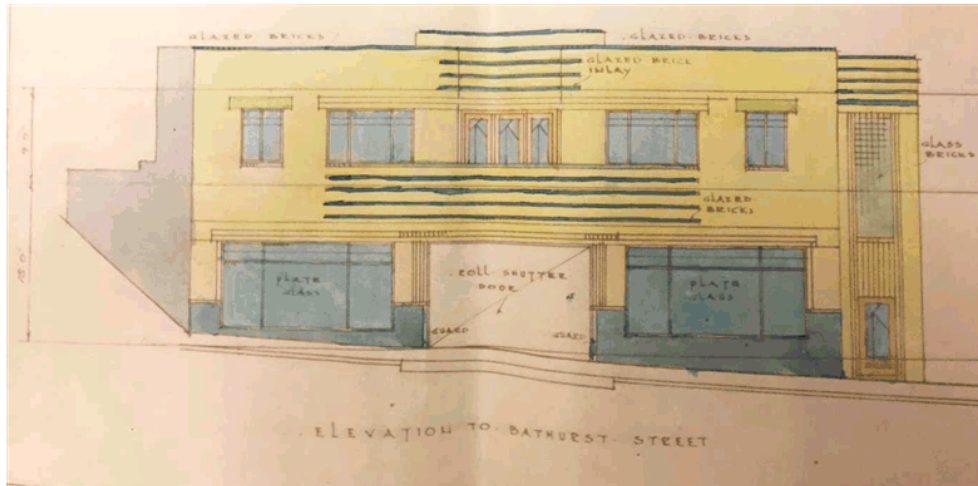
Figure 10: 1937 plan showing Bathurst Street elevation of the garage (TAHO, AE417/1/2108, 125 Bathurst Street (6871).

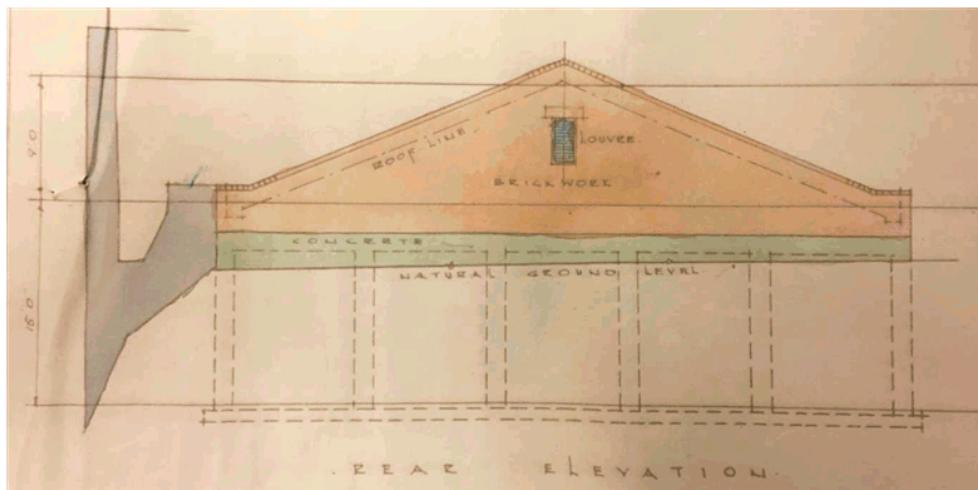
Figure 11: Rear, north western elevation on boundary with 144-160 Murray Street. Note the level of the natural ground level. Excavations in the order of some 3.3 m were required at this end of the site (TAHO, AE417/1/2108, 125 Bathurst Street (6871).

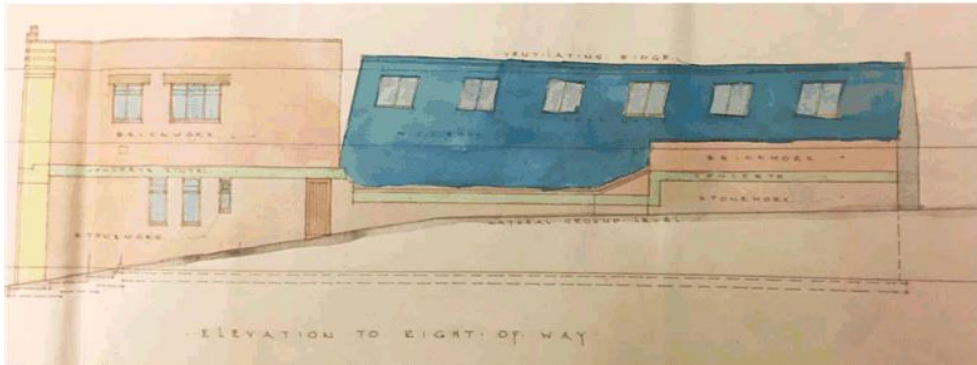
Figure 12: North eastern elevation to right of way. The right of way retained the natural ground level, but the extent of excavation for the garage floor level is shown, greater at the northern end and shallower towards Bathurst Street. North to right of figure (TAHO, AE417/1/2108, 125 Bathurst Street (6871).

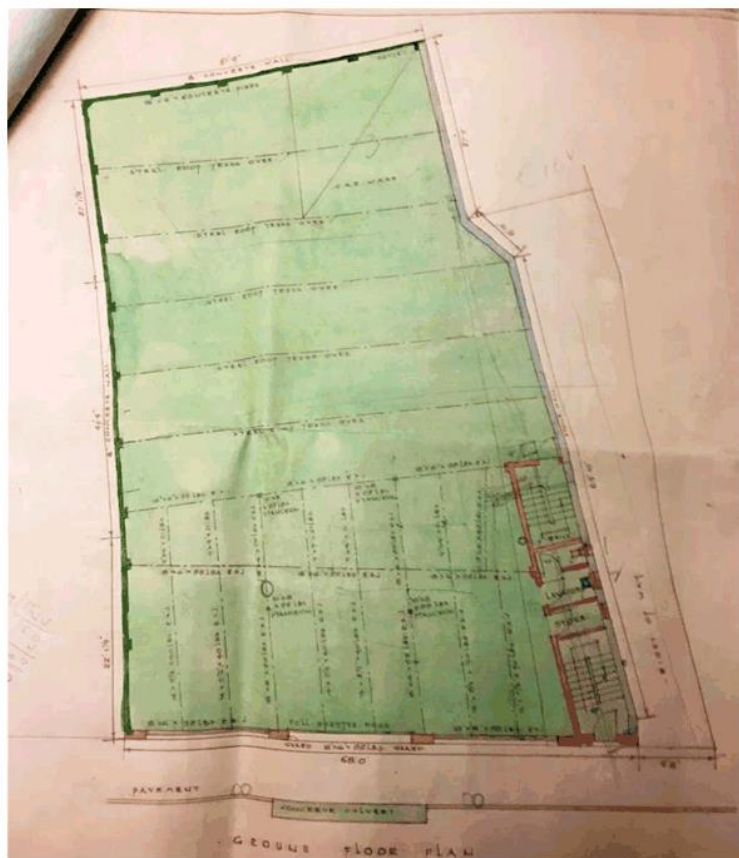
Figure 13: Ground floor plan. The green area shows the building footprint, and area of excavation. The right of way on the north eastern side is indicated (TAHO, AE417/1/2108, 125 Bathurst Street (6871).

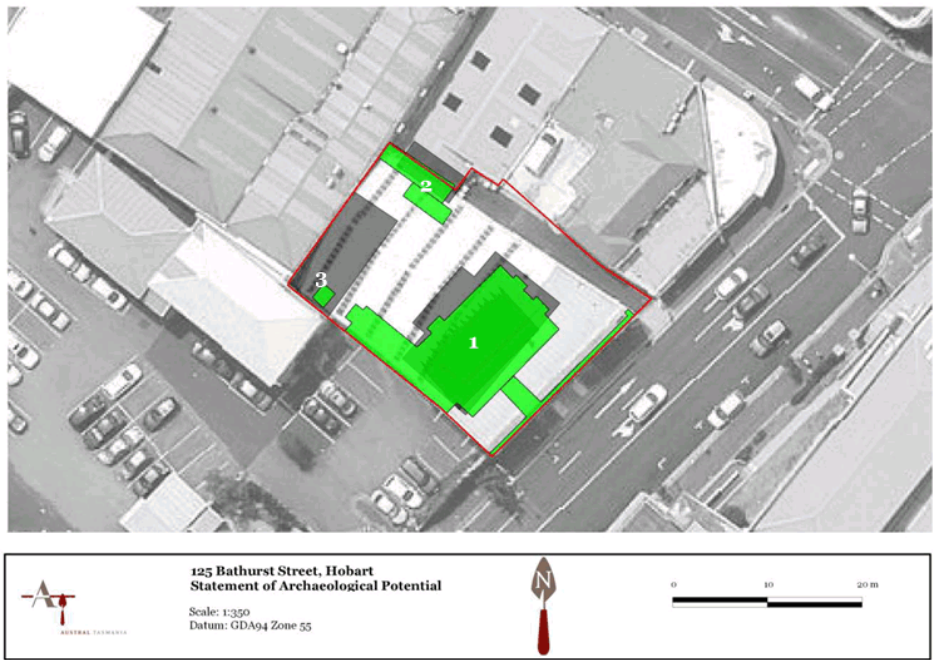
Figure 21: Overlay showing development in the study area from c.1840s-1905 (LIST Map, © State of Tasmania).

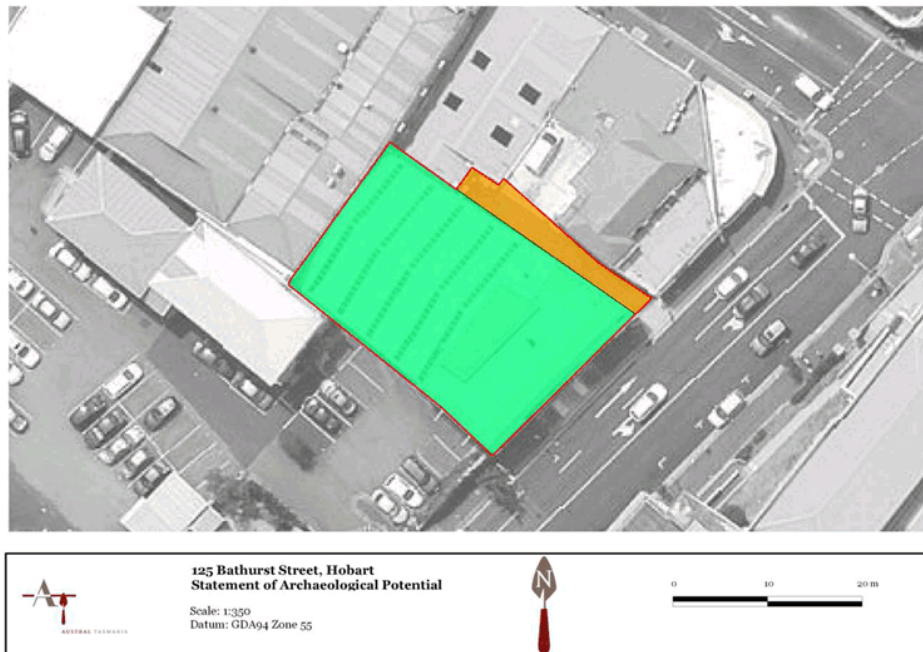
1. The area shaded **green** is zoned as having nil to low archaeological potential. This zoning relates to the 1937-38 garage building and covers an area of approximately 585 m².
2. The area shaded **orange** relates to a zone of moderate archaeological potential and covers approximately 65 m². This zoning relates to the right of way along the north eastern lot boundary with 126 Murray Street.

Figure 23: Archaeological Zoning Plan for 125 Bathurst Street. The zoning shows: 1. areas of nil to low (green) and 2. moderate (orange) archaeological potential (LIST Map, © State of Tasmania).
