PLANNING REF: PLN-22-790  
THC WORKS REF: 8058  
REGISTERED PLACE NO: 12028  
APPLICANT: University of Tasmania  
DATE: 25 January 2023

## NOTICE OF HERITAGE DECISION

Registered Place: Crisp & Gunn offices and workshop, and Forestry Tasmania dome, 79-83 Melville Street, 83 Melville Street and 80 Brisbane Street, Hobart.  
Proposed Works: New pedestrian bridge and landscaping work.

# University of Tasmania Forestry / Timber Yards Pedestrian Bridge Planning Report

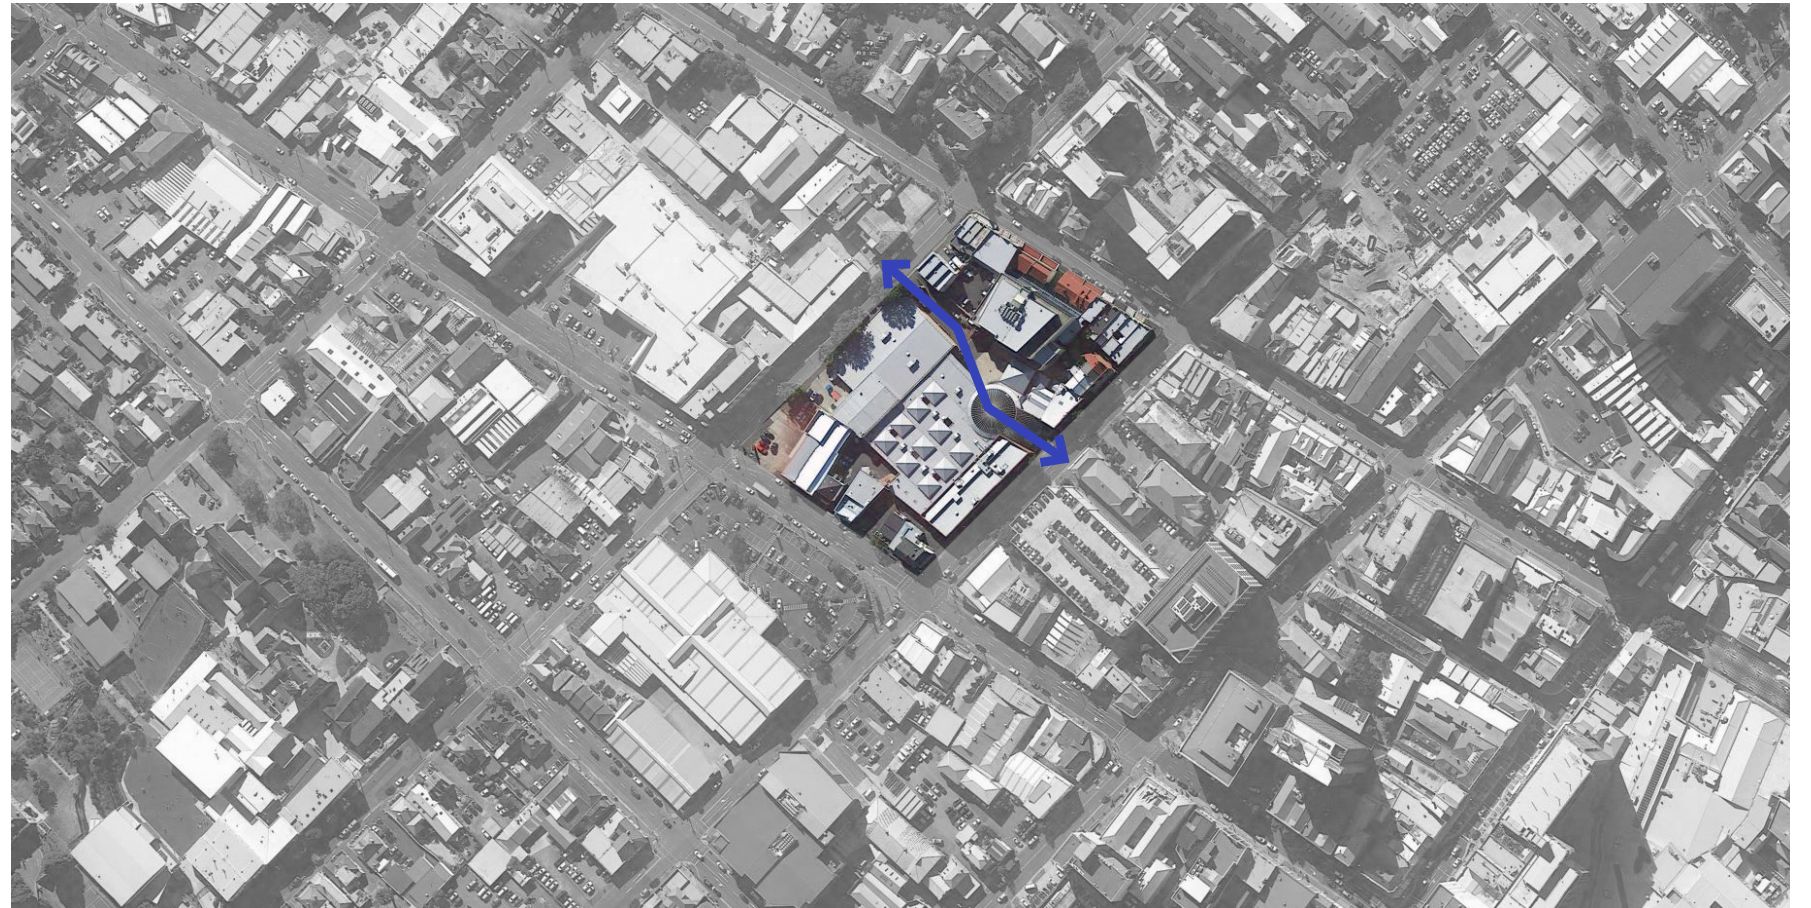
Site plan showing key connection from Melville Street to Brisbane Street

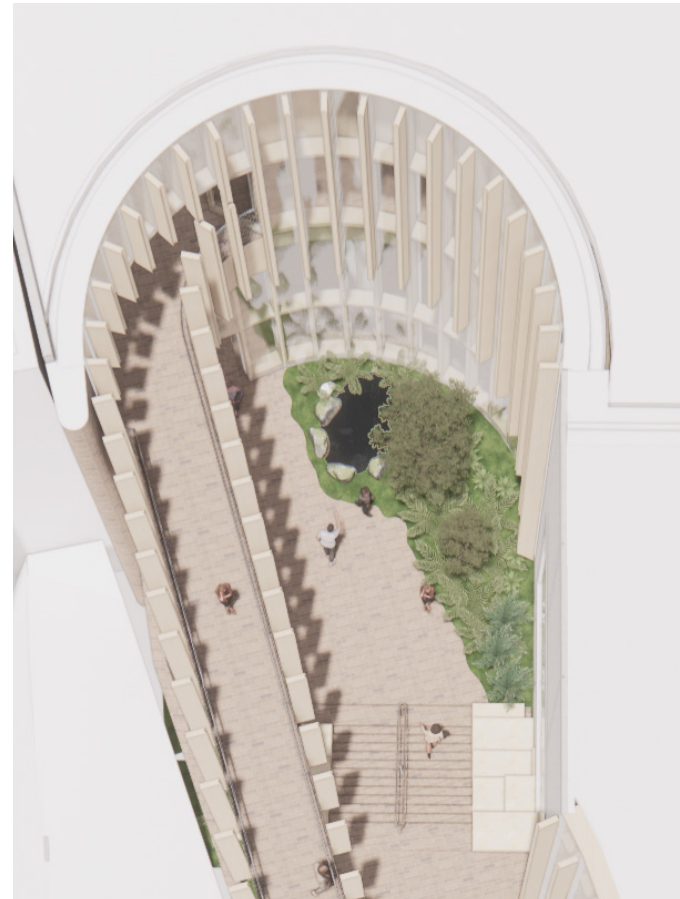
Brisbane Street entry showing new glazing and mass timber fins

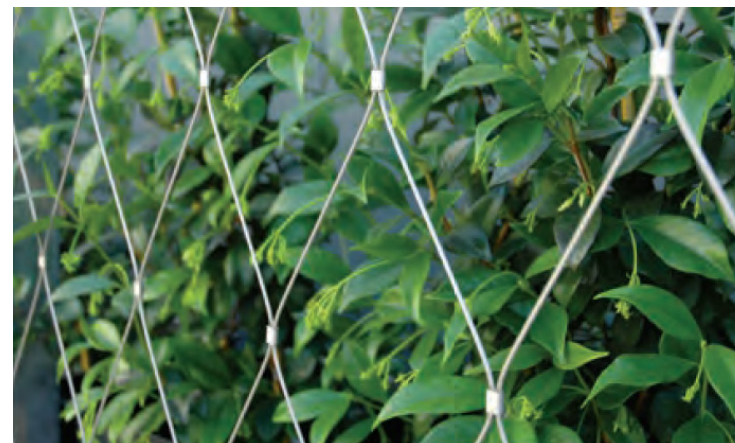
Stainless steel mesh - built example showing detailing

The use of mesh to form a skin to the balustrade balances a lightweight, delicate aesthetic that encourages permeation while connecting to the found condition of the original bridge.

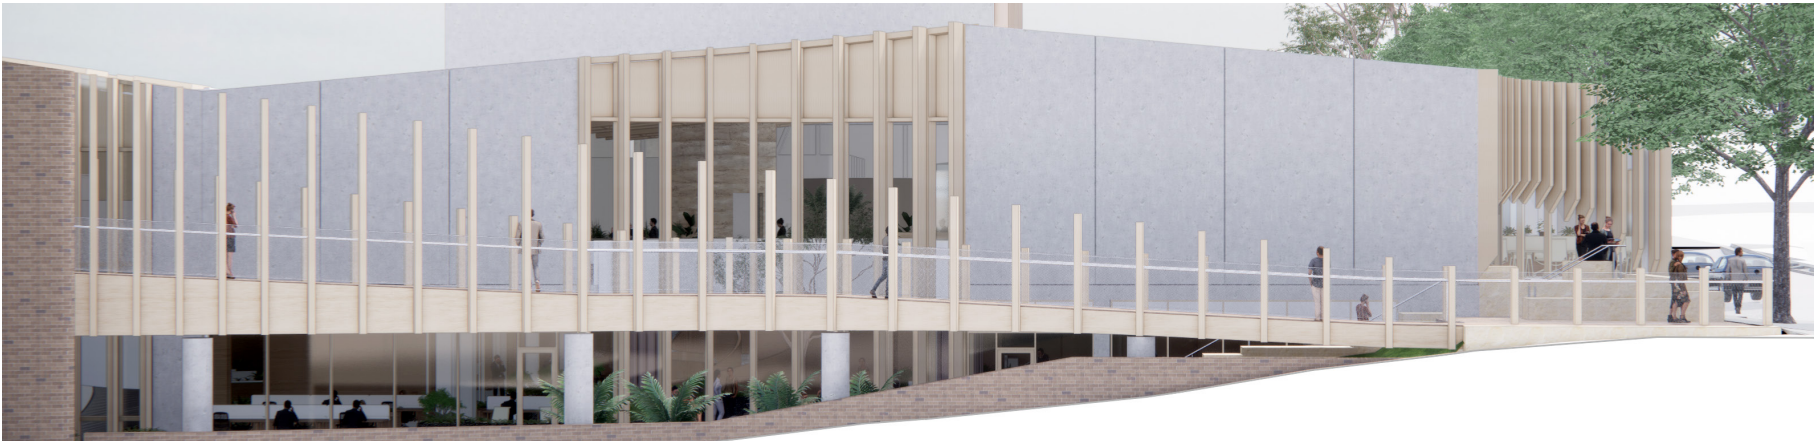
Diagrammatic elevation showing consistent facade treatment unifying the building and bridge

The built fabric of the bridge is also an extension of the building. The paving treatment throughout the public areas of the building is patterned brick, locally sourced and carbon neutral. The horizontal surface of the bridge is an extension of this groundplane. The bridge balustrade structure is mass timber fins, consistent with the unifying facade treatment. The metal mesh stretched between the fins is intended to be lightweight and visually permeable. Timber is the key new material used externally, and the bridge celebrates this.

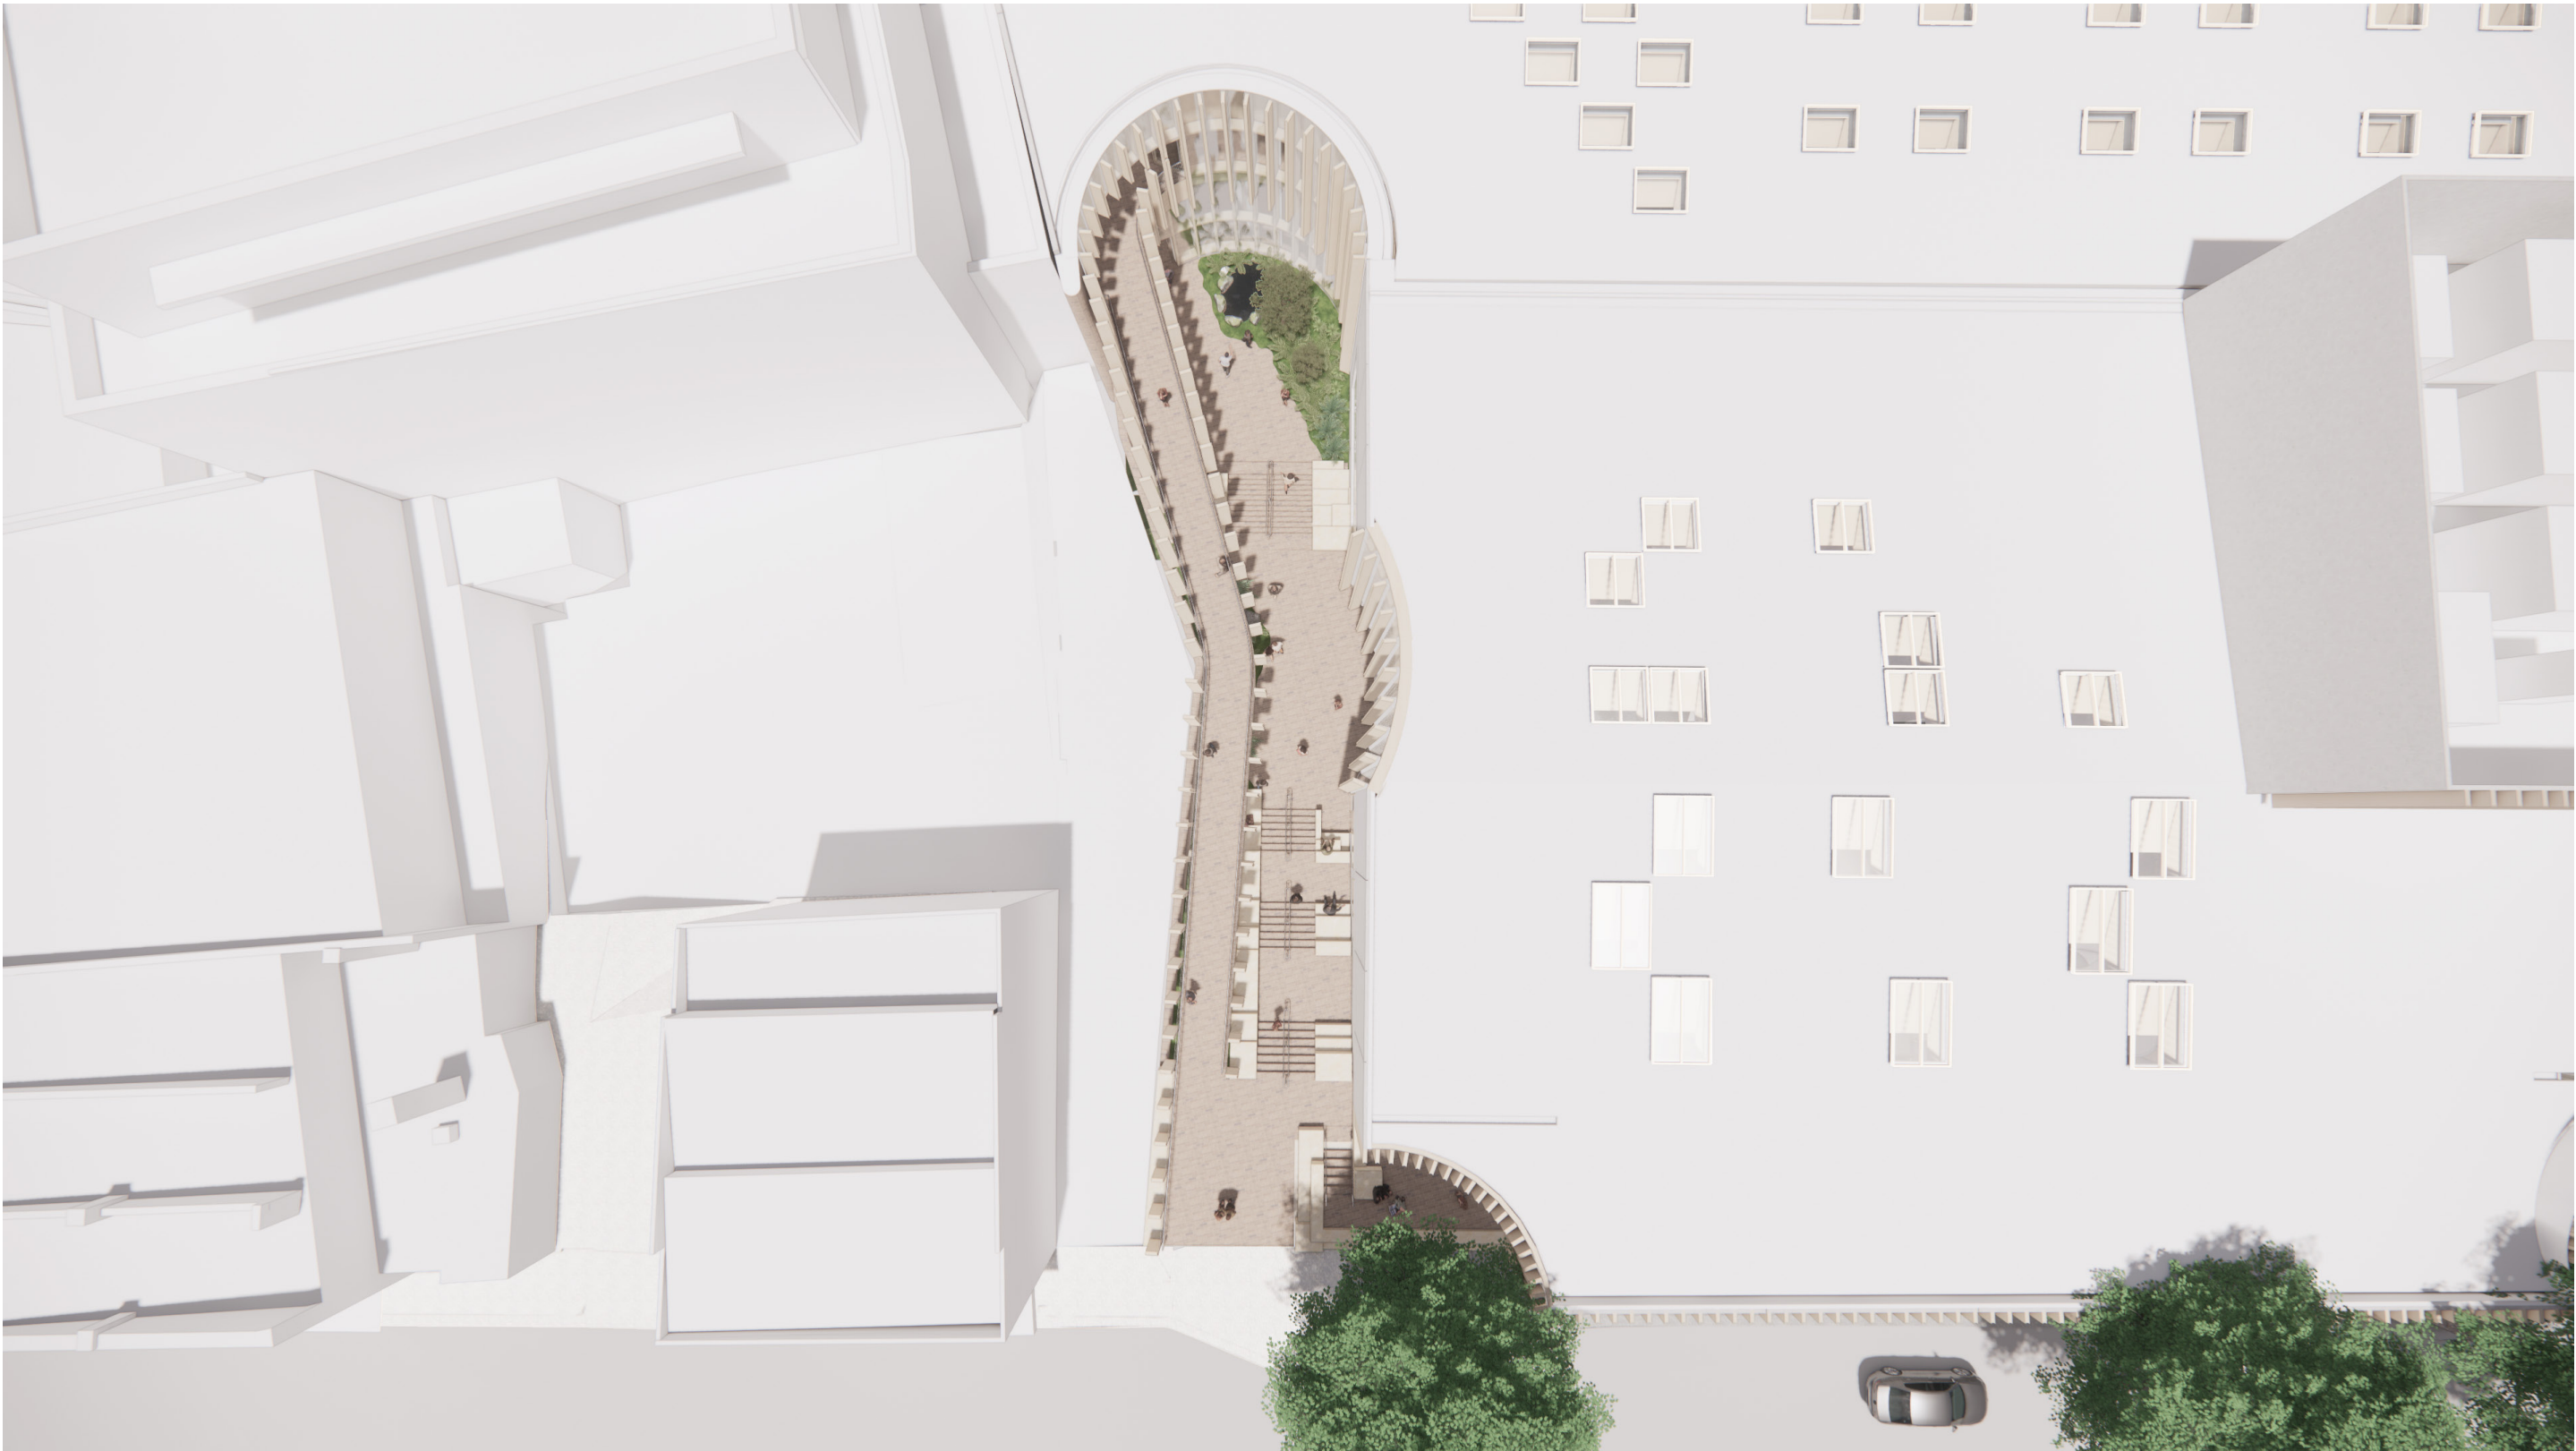
Aerial view of the pedestrian bridge

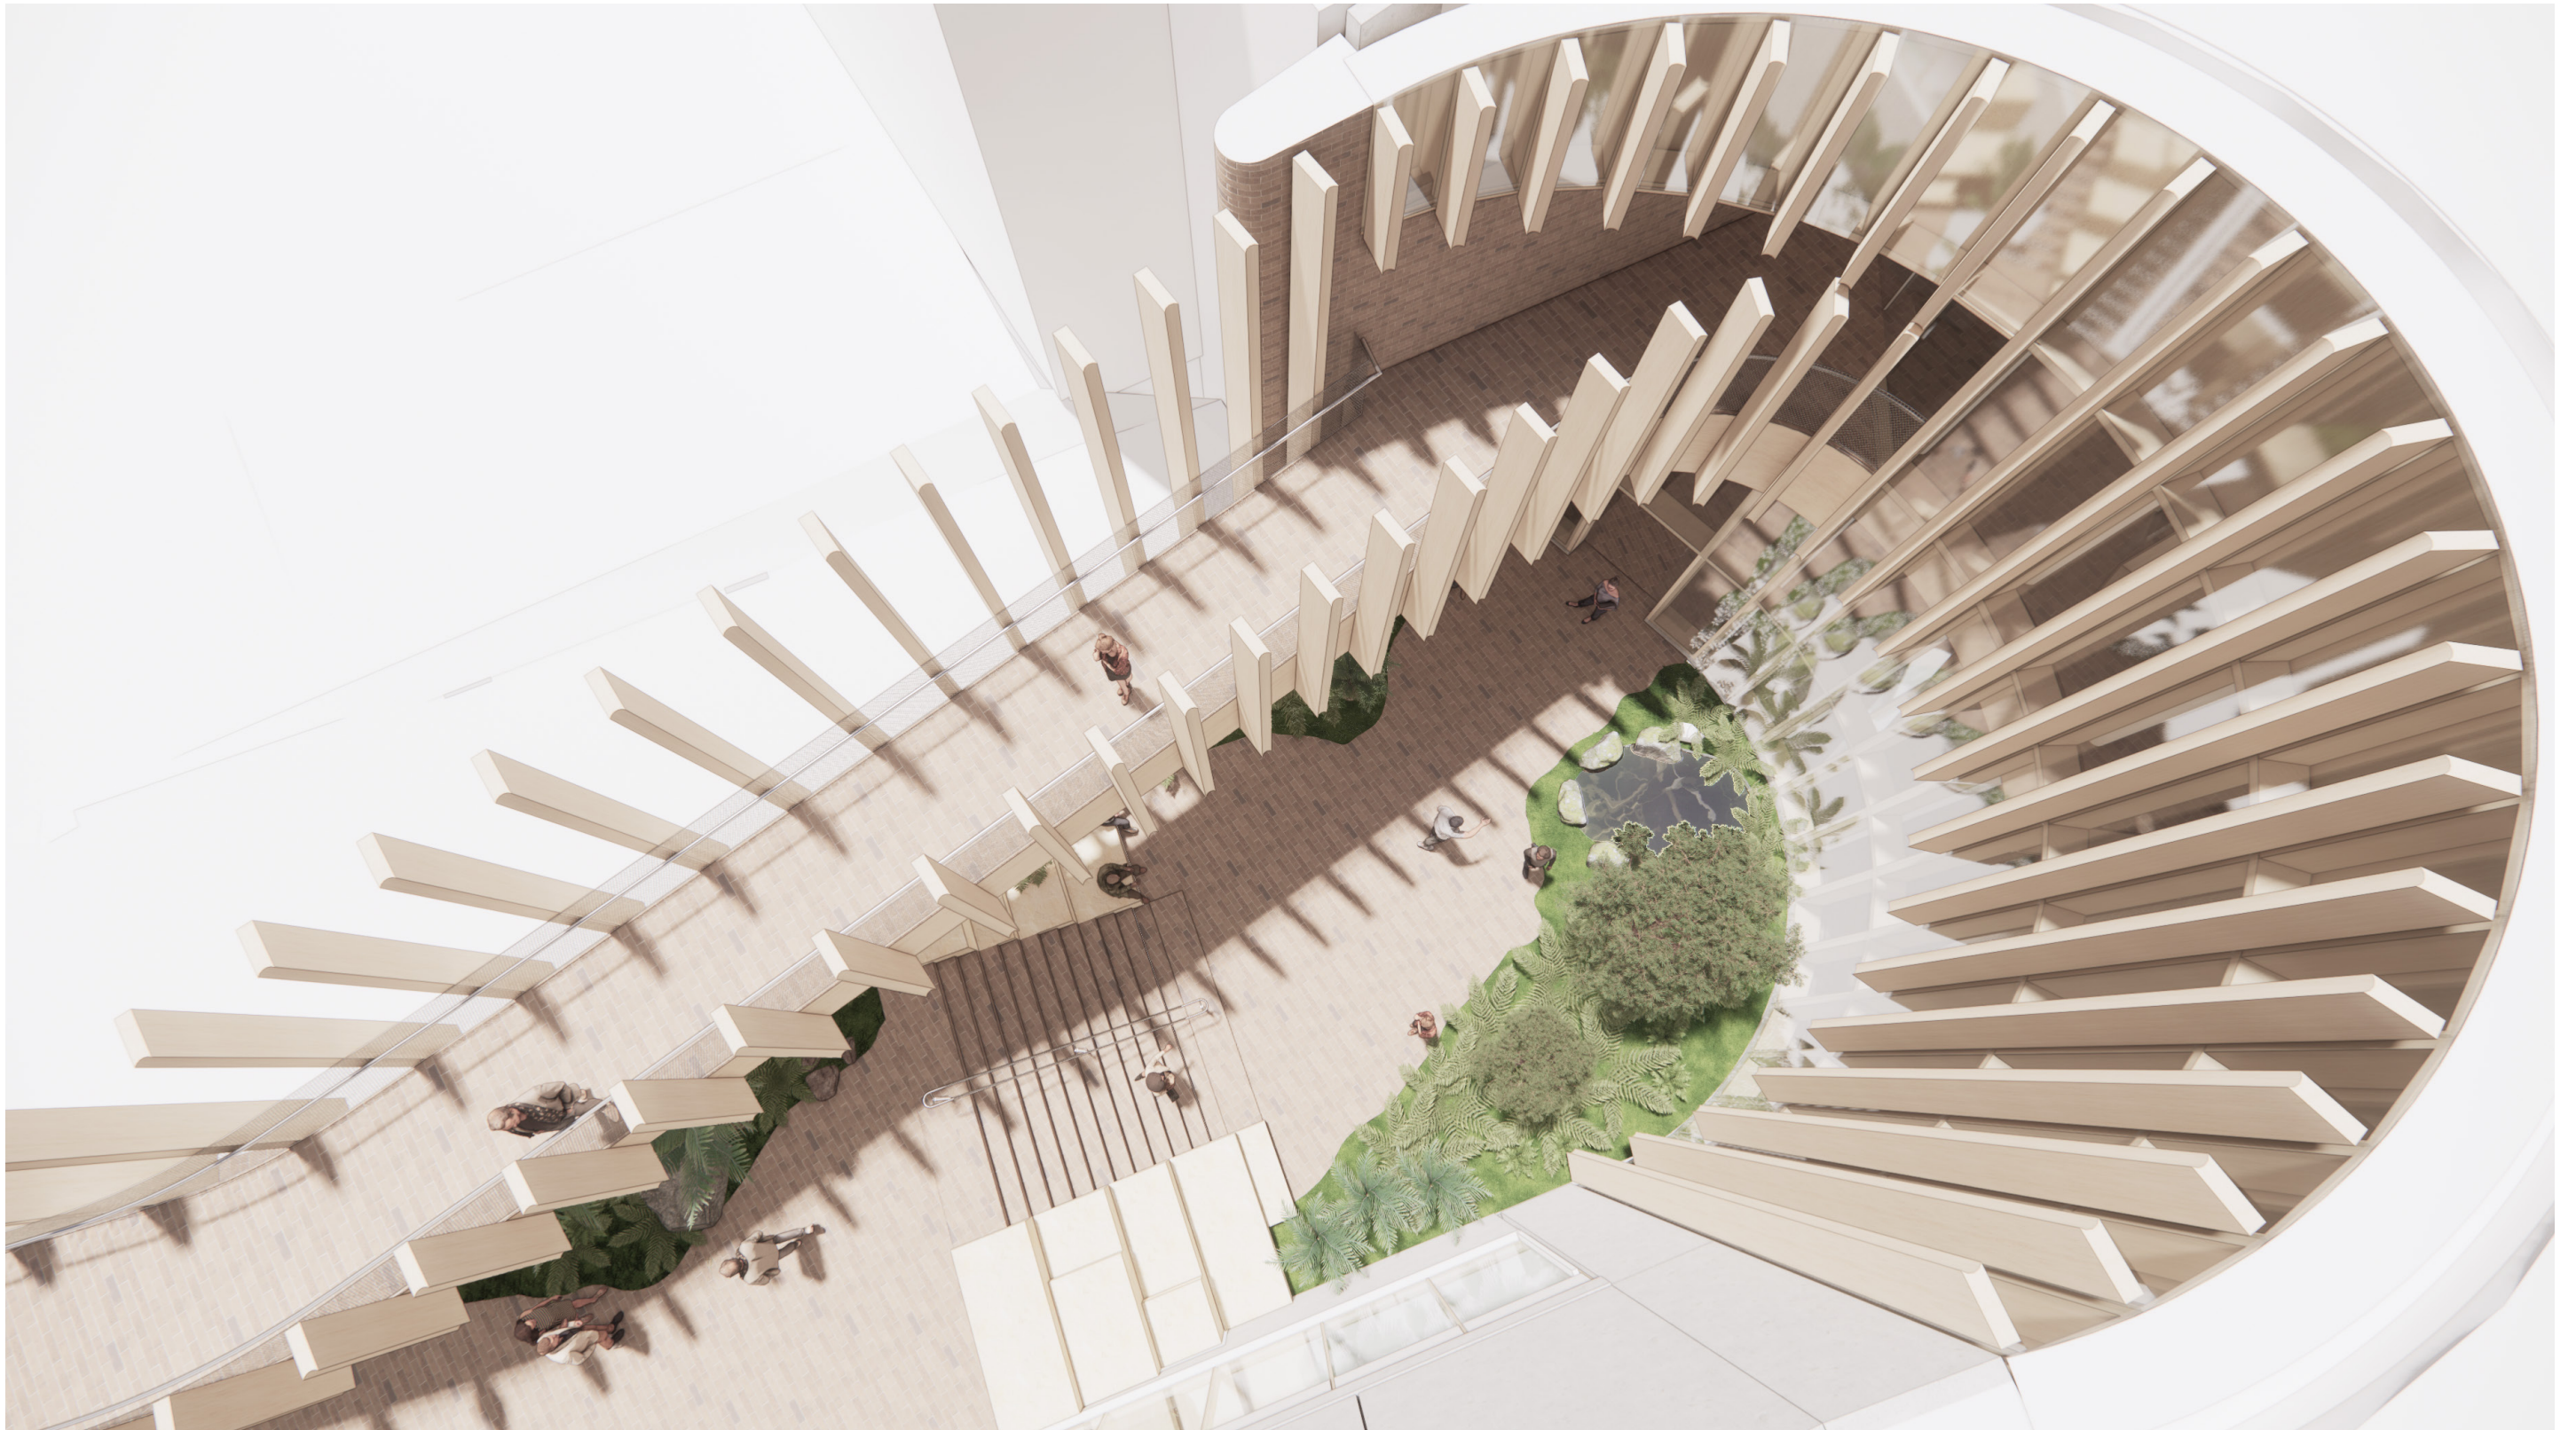
Building facade unwrapping to create the structure of the pedestrian bridge

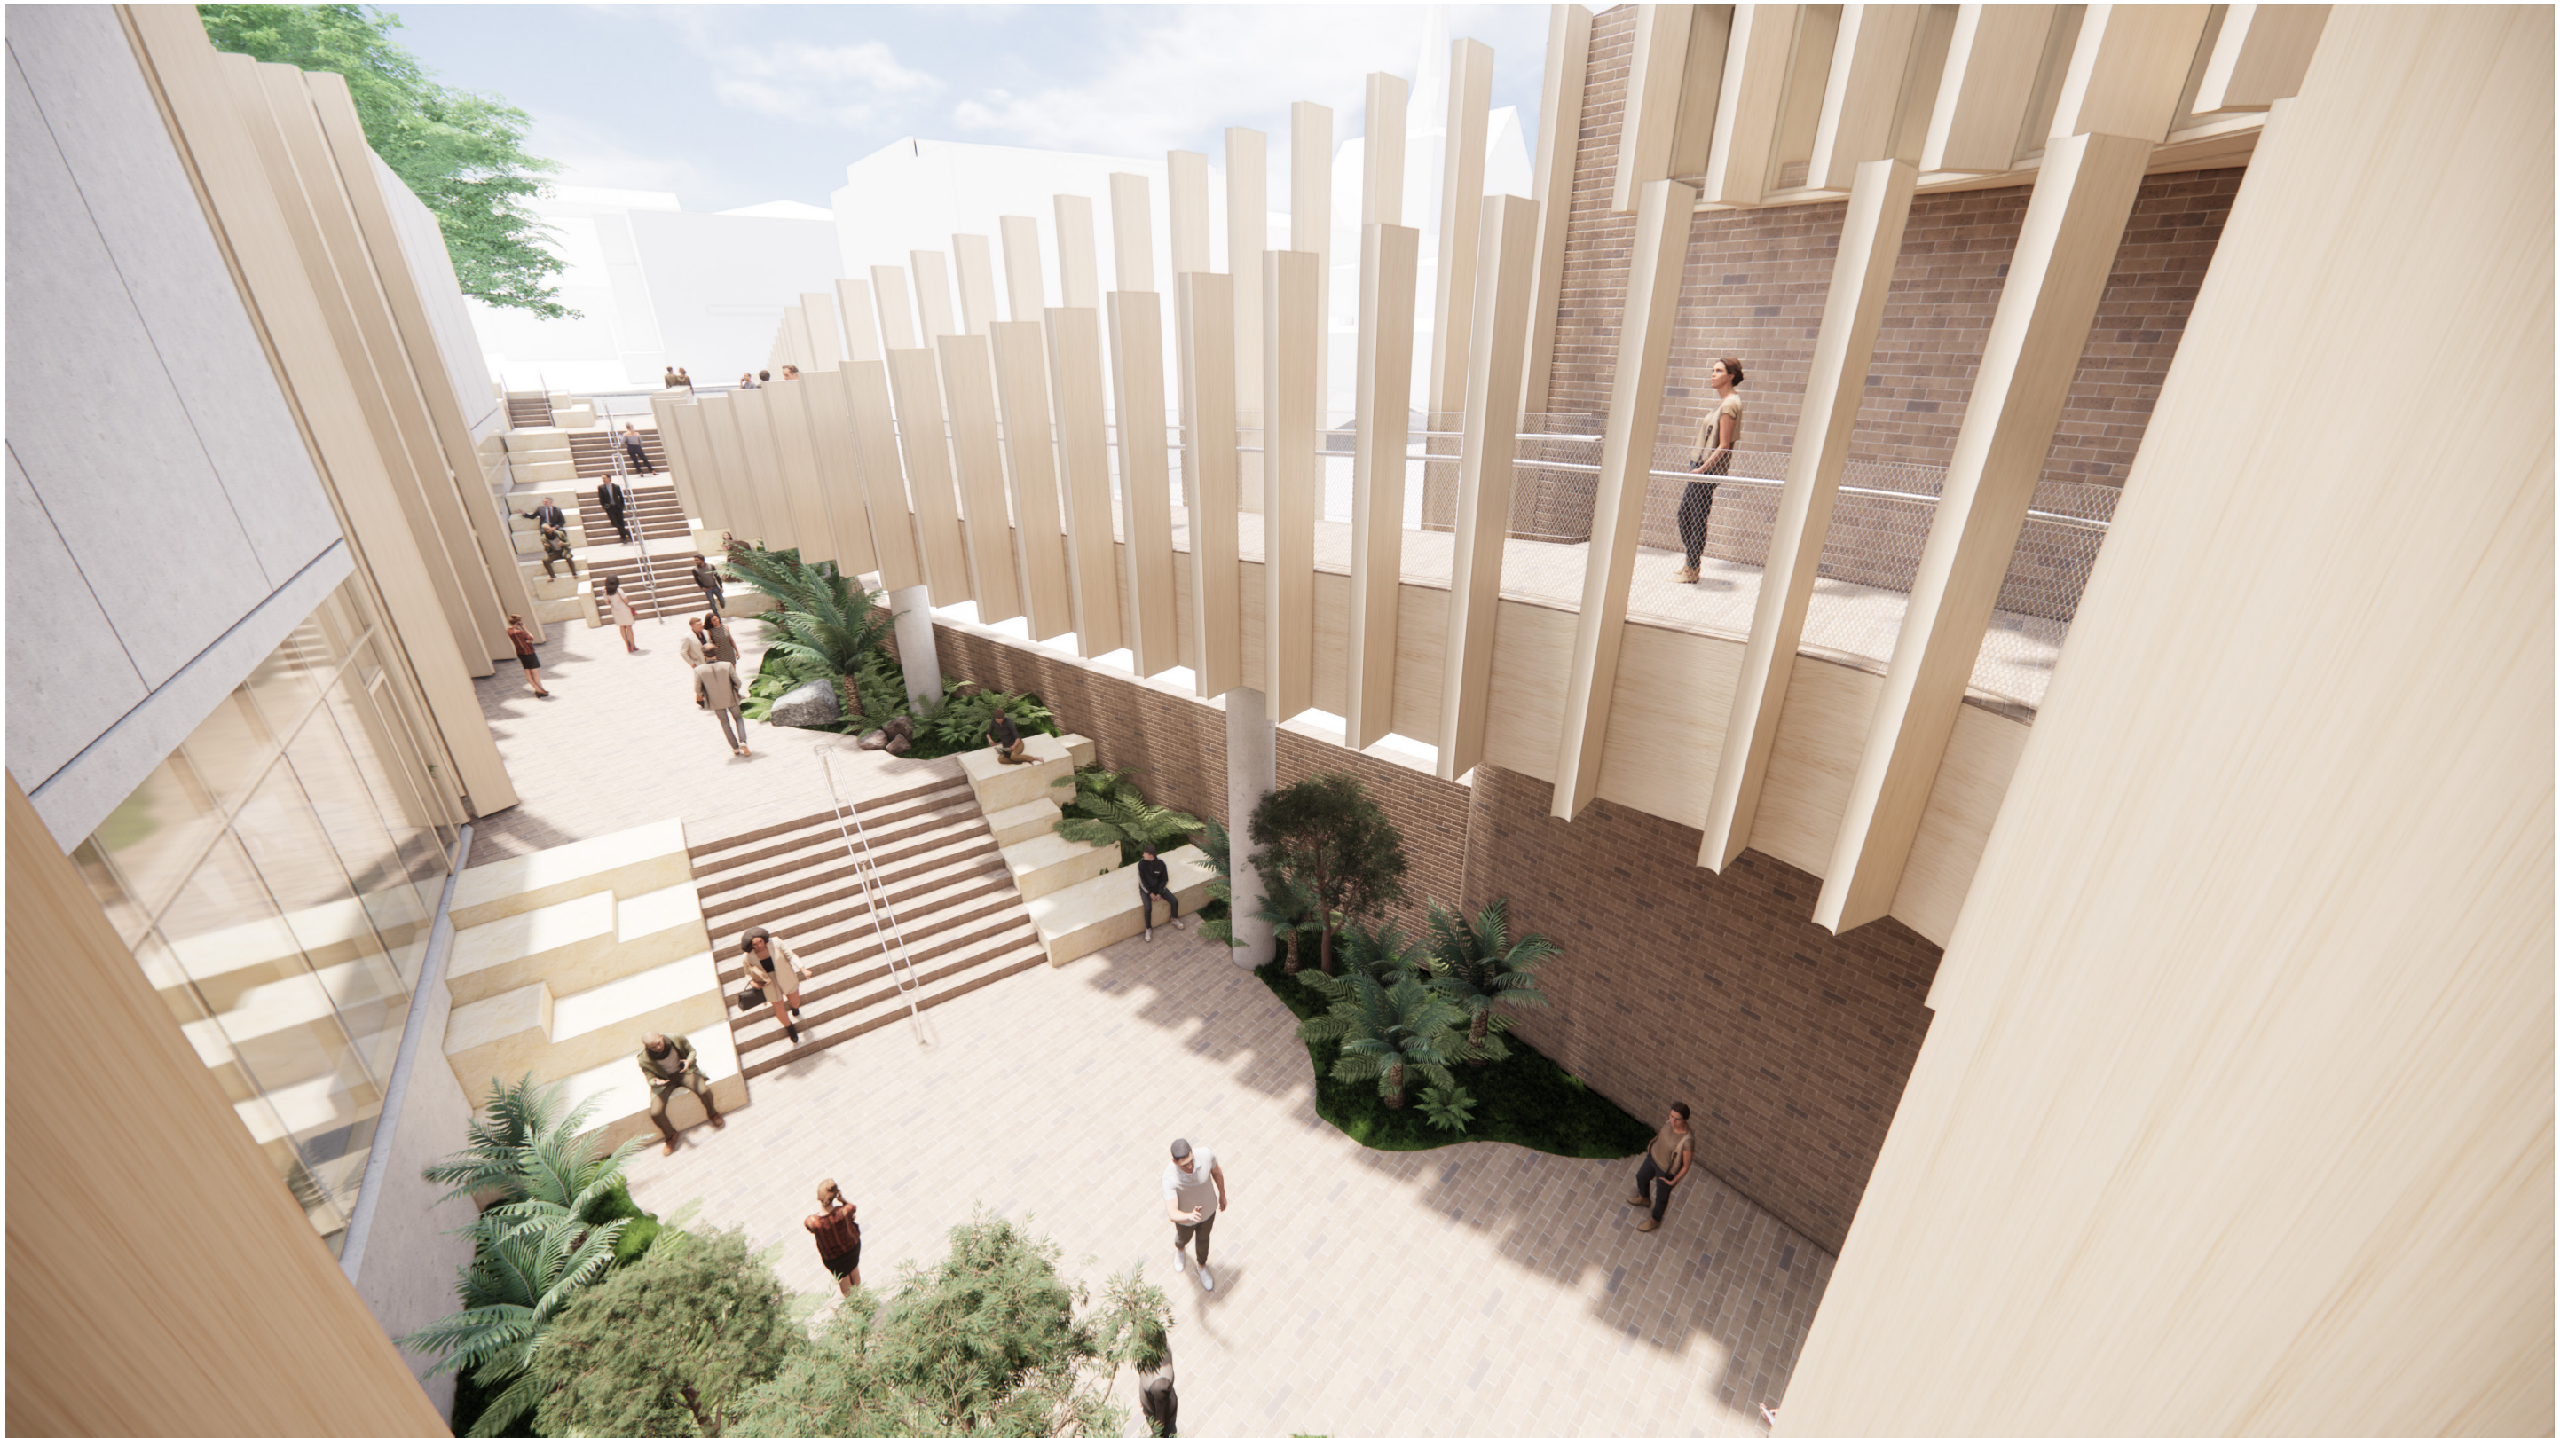
View from Forestry

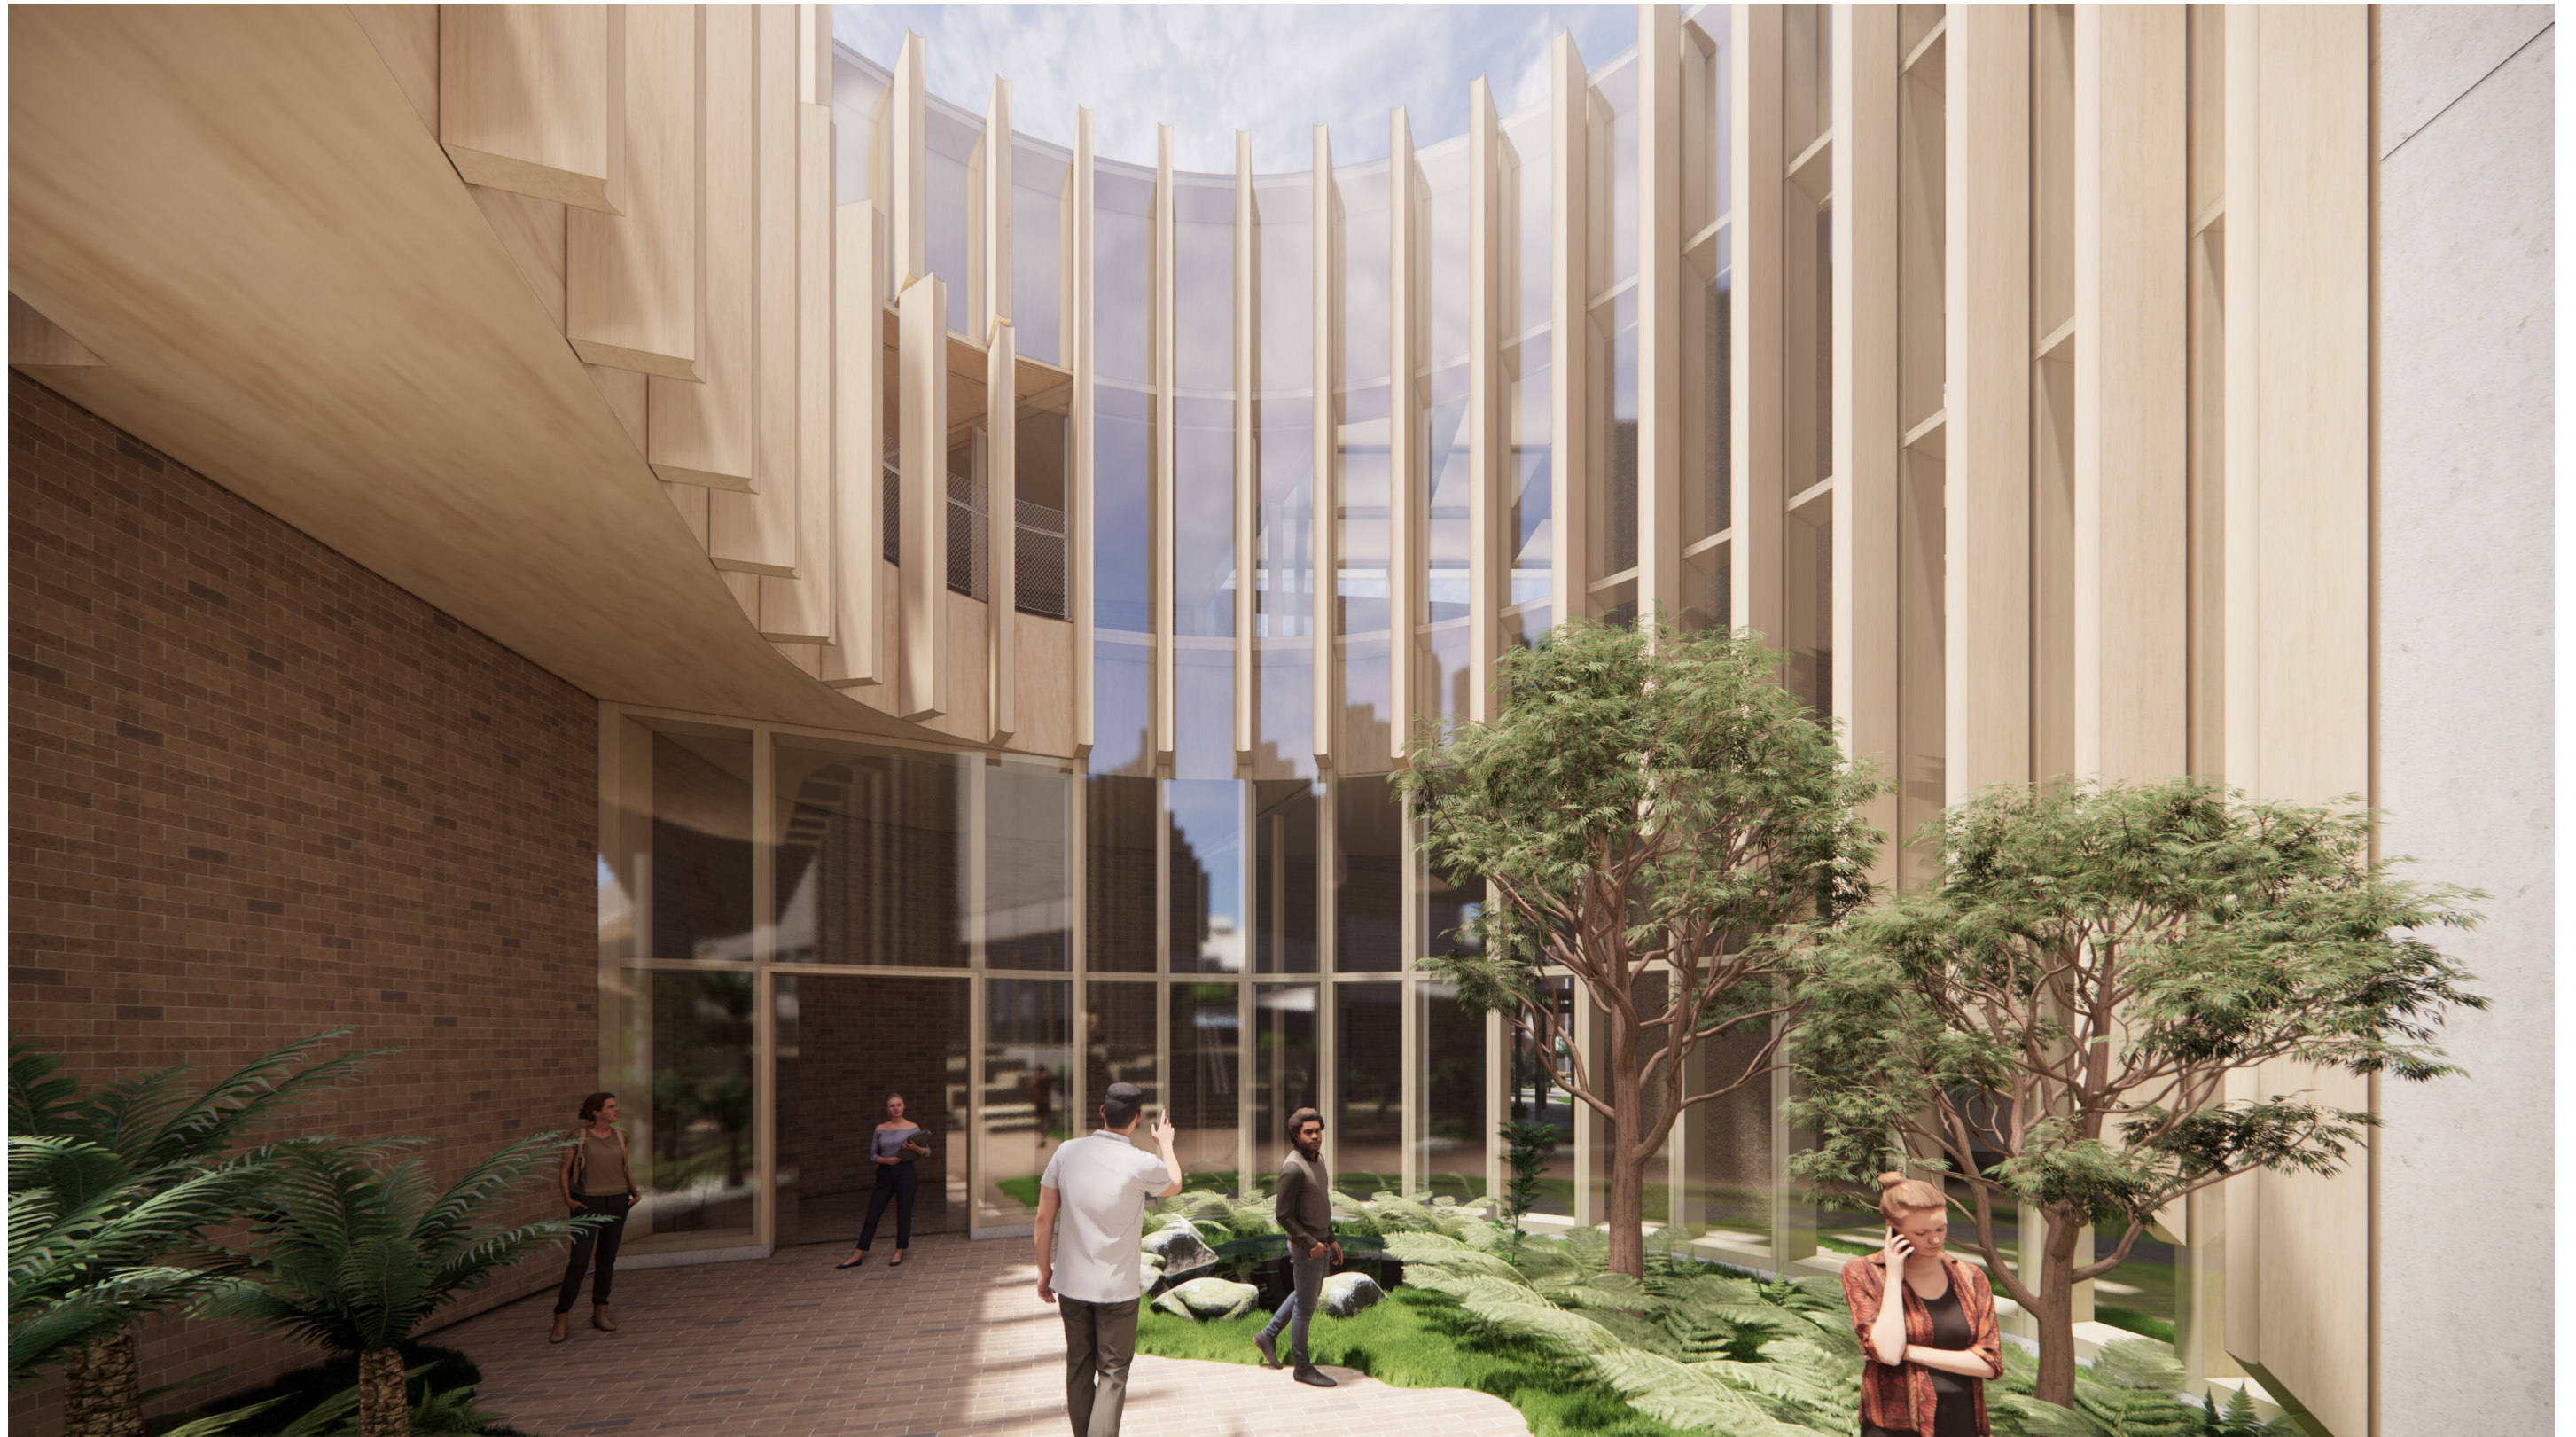
Lower entry into Forestry through landscaped connection from Brisbane Street

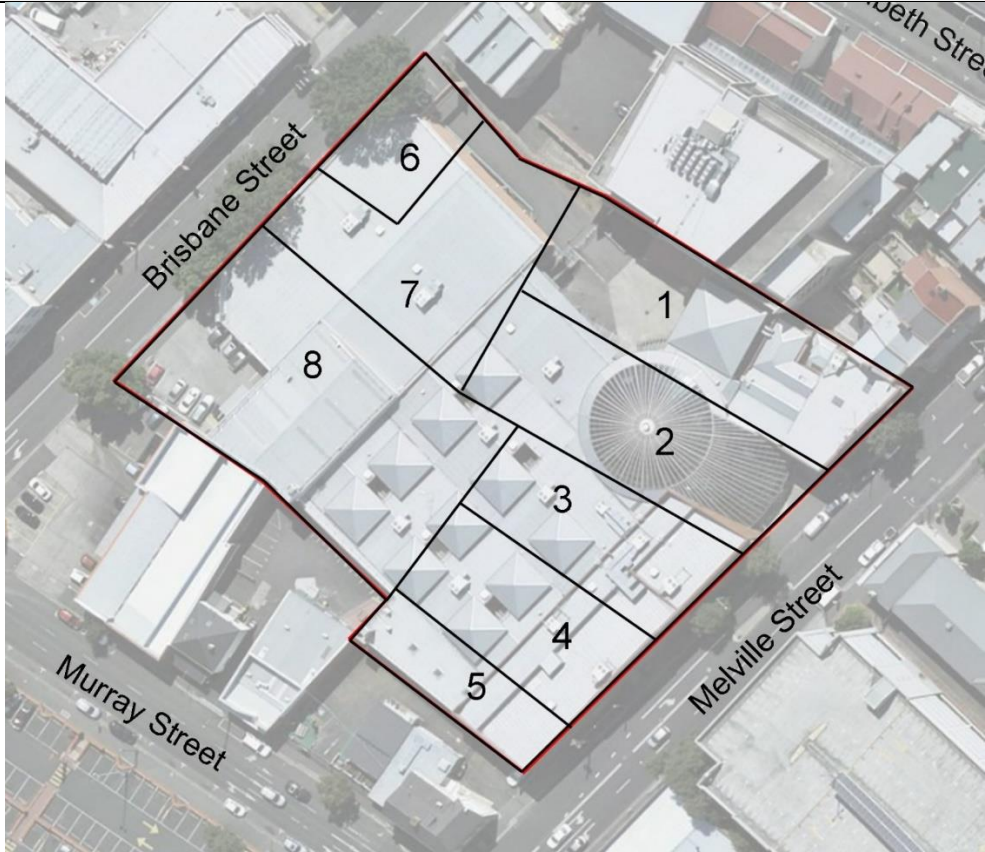
**Figure 3.1 – Configuration of early land grants comprising the subject site, showing the early tenure of parcels comprising the subject site (largely based on Sprent’s c1845 survey).**

The subject site is comprised of eight early grants – for the sake of the early history of the site (at least) the narrative will follow each of those grants, as their dates of development, later subdivision and functional uses all vary. Following the 1886 Crisp and Gunn acquisition, these were progressively adhered – as the narrative further below will follow. Figure 3.1 provides this arrangement:

<b>1</b>	1 rood, 7 perches	Originally granted to Joseph Bowden, recorded as being owned by Thomas Priest prior to 1833.
<b>2</b>	1 rood, 6.5 perches	Originally granted to Thomas Hoskisson, gained by debtors judgment by William Lindsay in 1833.
<b>3</b>	25 2/10 perches	Originally located to John Swan, formally granted to Andrew Bent in 1828.
<b>4</b>	31 perches	In 1838 Joseph Barker addigend the land to his daughter Elizabeth Ibbotson, and granted to Henry Wilks as trustee for Ibbotson in 1840.
<b>5</b>	15 perches	Claimed by William Morgan prior to 1857, not formally granted until 1924 to Crisp and Gunn.
<b>6</b>	17 perches	Granted to Joseph Molloy pre-1845.
<b>7</b>	27 & 6/10 Perches	Claimed by William Willet and Bryant Webb pre-1845. Not formally granted until 1919 when granted to Emma and Frederick Crisp.
<b>8</b>	1 rood, 37 perches	Originally granted to Lewis Riley in 1867 apparently after an earlier claim by Joseph Bowden that was cancelled in 1846.

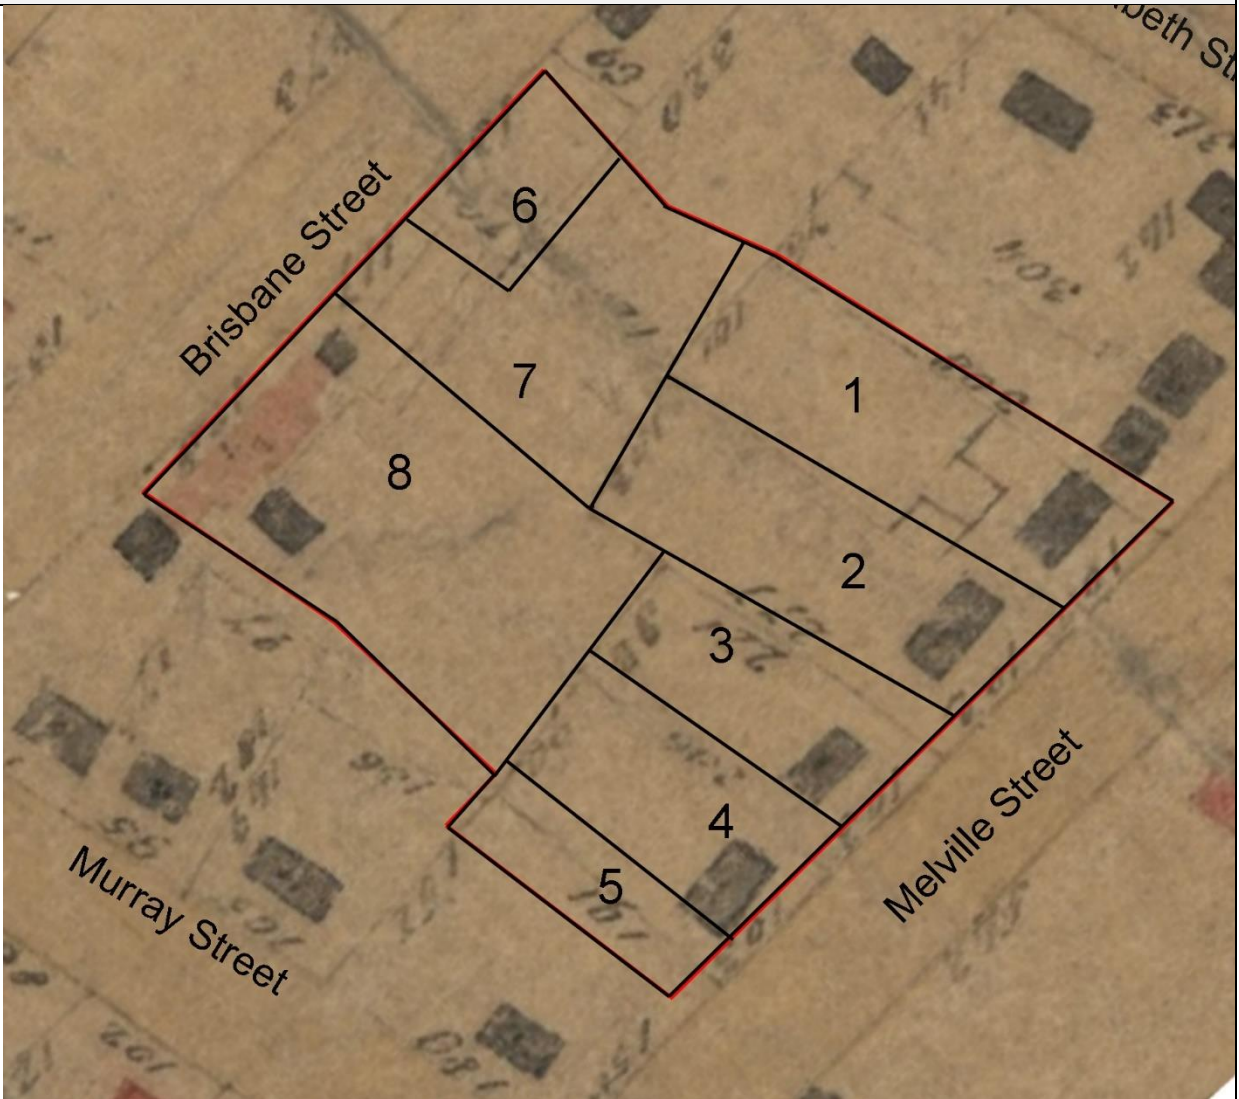
Figure 3.2 - C1832 survey of Hobart – Hobart H5

This survey shows four substantial timber buildings fronting Melville Street, as well as a larger masonry building with timber additions fronting the western frontage of Brisbane Street. The interior of the site appears undeveloped, however this survey is known to only show major buildings. The accuracy of this survey is dubious in terms of precise boundaries and buildings, however, is generally accurate in depicting the general presence of buildings. The grey shading depicts timber buildings, and the pink shading depicts masonry buildings.

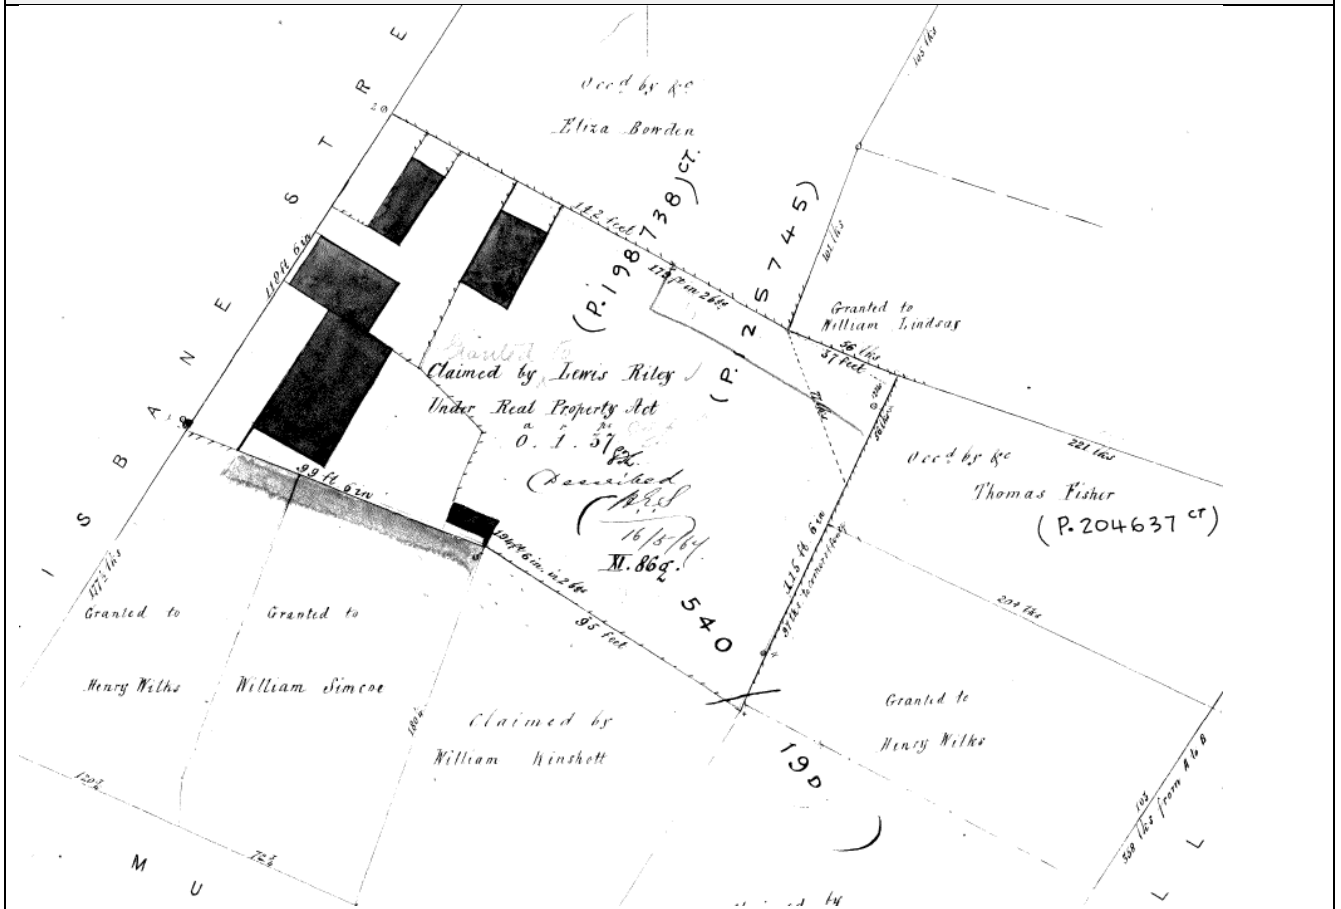
Figure 3.5 – Layout of the Riley (formerly Bowden) lot (Area 8) in 1867 DPIWPE The LIST PG11/86.

This survey plan shows the pre-1832 larger building fronting Brisbane Street of unknown function, as well as an adjacent building shown on that early map also. Another rear building shown on the 1832 map has been removed by this time and another rear building added to the north. This again shows the internal portion of the site as vacant.
