PLANNING REF: PLN-22-790  
THC WORKS REF: 8058  
REGISTERED PLACE NO: 12028  
APPLICANT: University of Tasmania  
DATE: 25 January 2023

## NOTICE OF HERITAGE DECISION

Registered Place: Crisp & Gunn offices and workshop, and Forestry Tasmania dome, 79-83 Melville Street, 83 Melville Street and 80 Brisbane Street, Hobart.  
Proposed Works: New pedestrian bridge and landscaping work.

# University of Tasmania Forestry / Timber Yards Pedestrian Bridge Planning Report

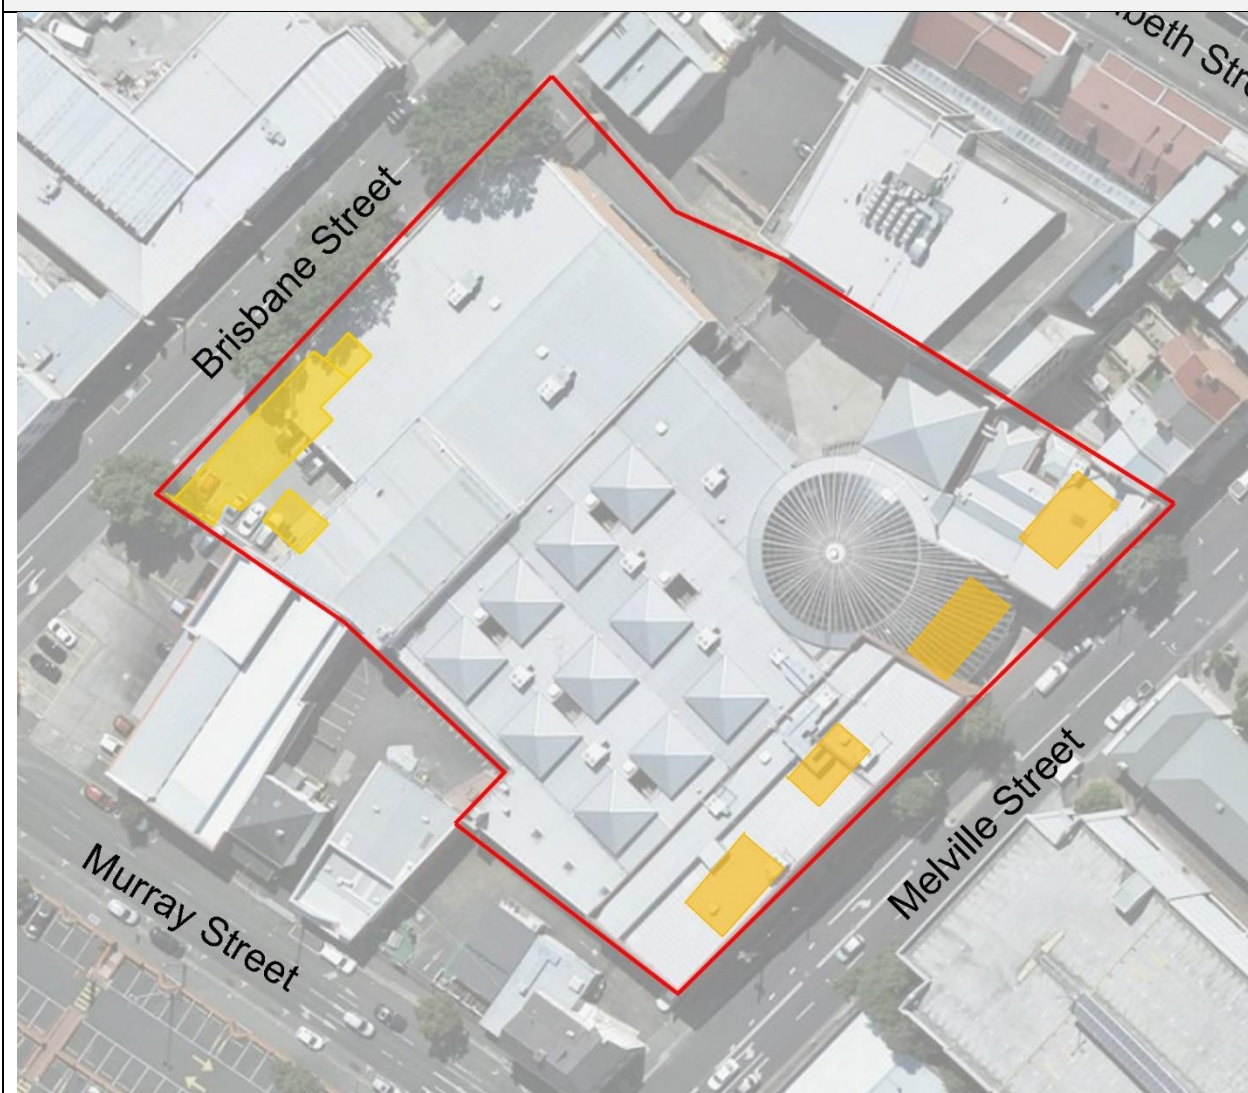
**Figure 3.7 – Locations of pre-1832 buildings, based on the 1832 survey over a recent aerial photograph.**

The orange areas represent the presence of buildings on the c1832 survey of Hobart. This survey is known to not be highly accurate in terms of the precise size and location of building but is generally accurate in the depiction of the presence of buildings – therefore is likely to reliably depict the presence of a building on each lot at that time. That survey also did not necessarily pick up all minor site features (e.g. sheds, privies etc.). What this does show however is that development was likely concentrated on the Melville and Brisbane Street frontages.

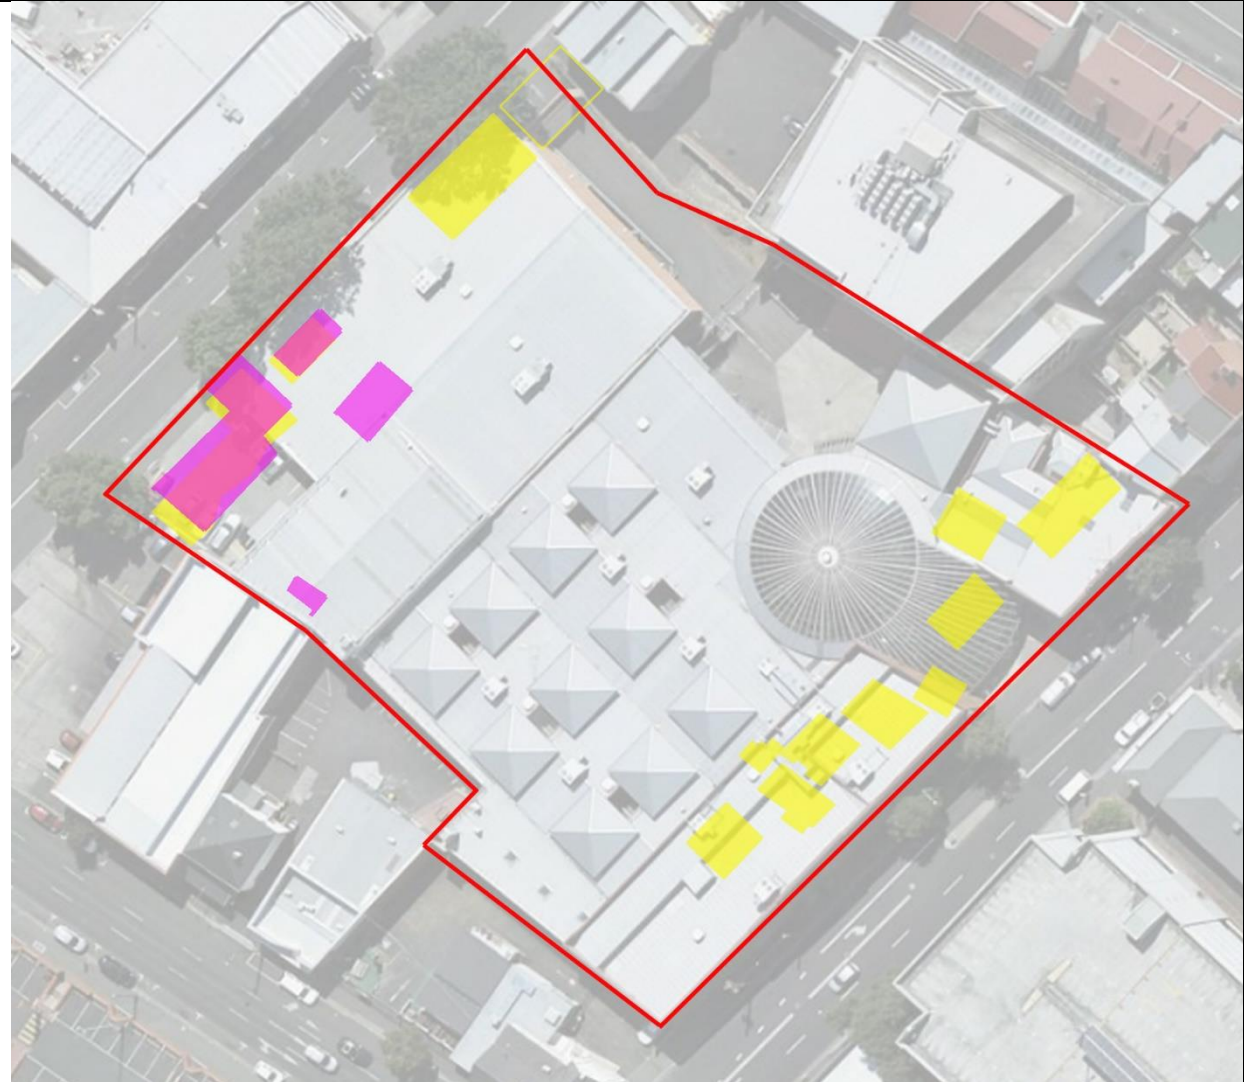
**Figure 3.8 – Locations of pre-c1843 buildings, based on the Sprent survey over a recent aerial photograph.**

The yellow areas depict the location of building footprints as per the c1843 Sprent survey, which is known to be a very accurate, yet possibly incomplete depiction of the development of the site by that time. Again, this indicates that development was concentrated on the Melville and Brisbane Street frontages. The above has been supplemented by the 1867 Riley survey in the north-western corner of the subject site (purple).

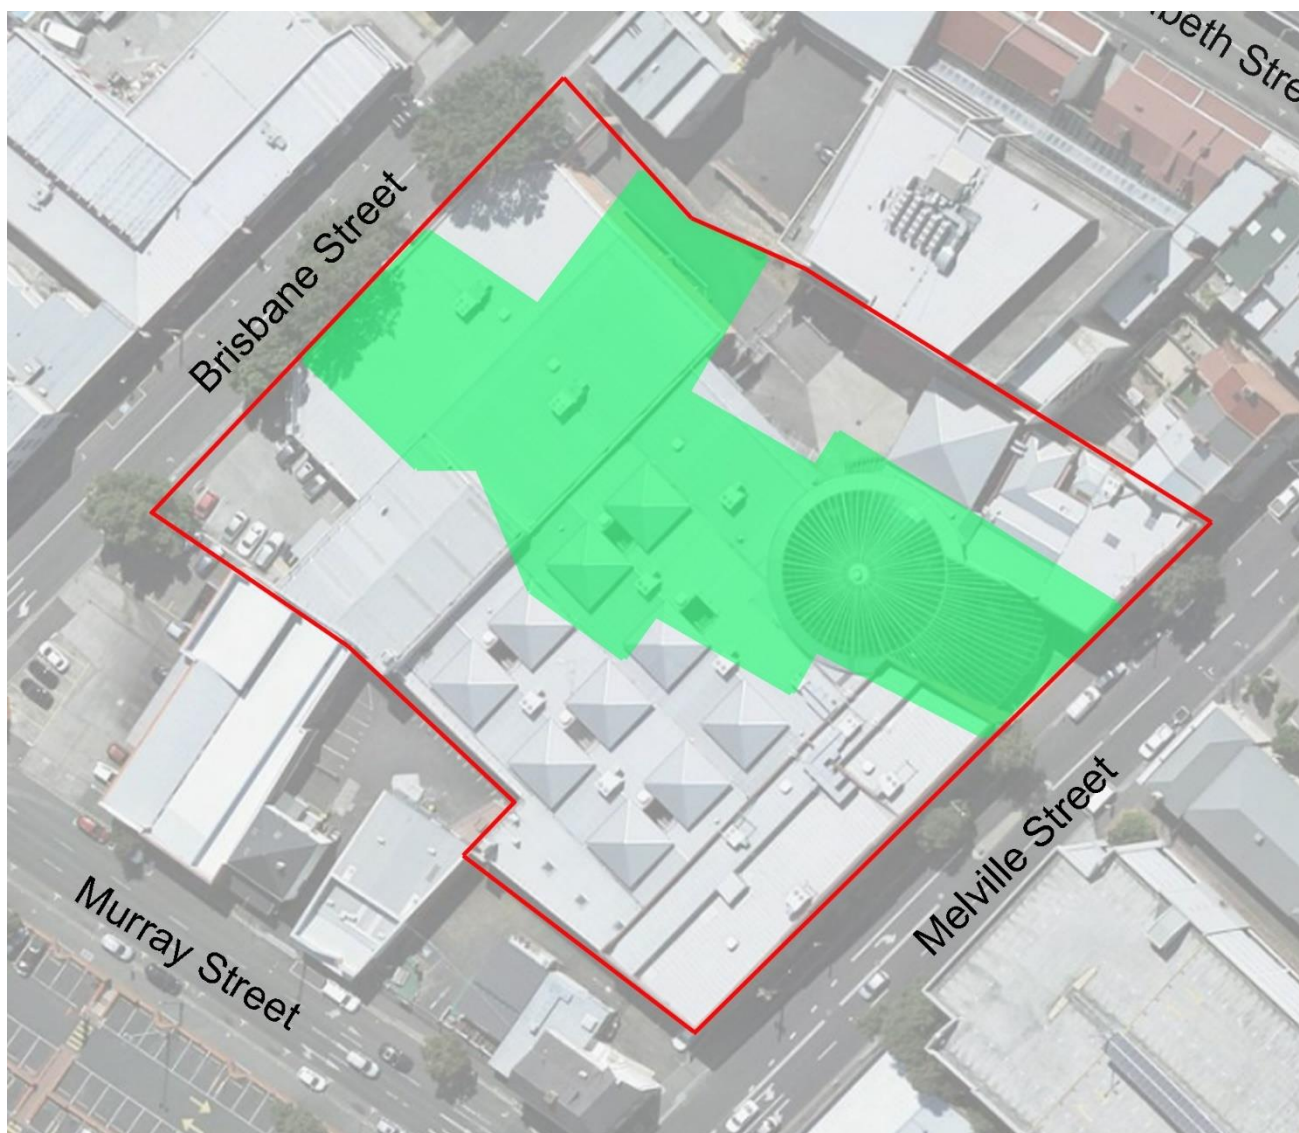
Figure 3.14 – The c1900 Crisp-occupied parts of the subject site. Note that Crisp’s ownership was wider, however it seems that his earlier occupation phase retained many of the residential buildings and small backyards, whilst the timber yard operations filled excess backyard spaces.

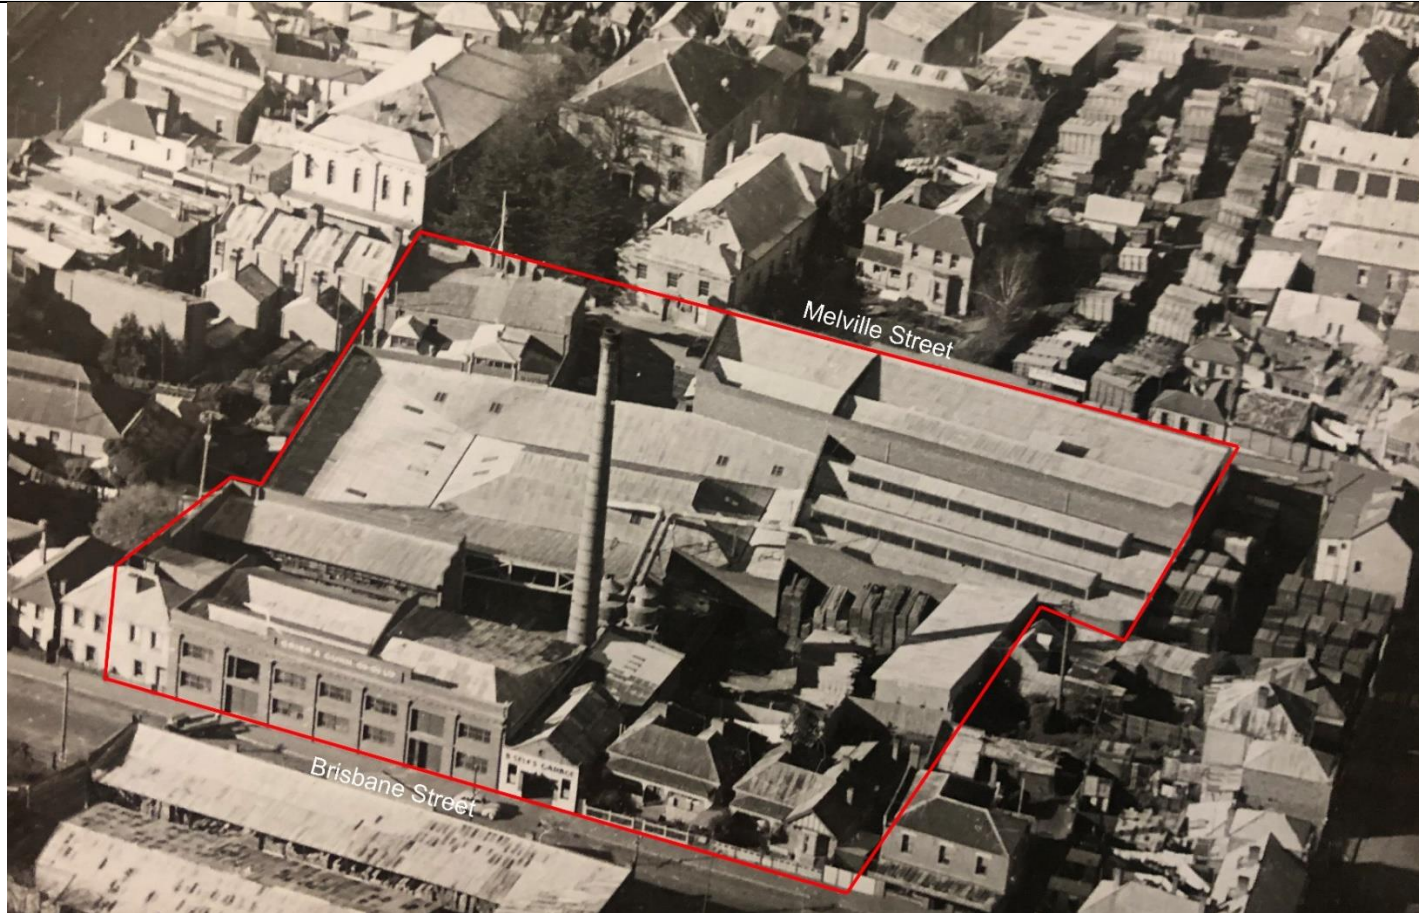
Figure 3.19 – Oblique aerial photograph from the north-west 1940s. Tasmanian Archive and Heritage Office NS3826/1/88.

An excerpt from a 1946 panorama of Hobart clearly shows the layout of the site at that time, with the 1923 warehouse, store and office fronting Melville, a similarly styled building fronting Brisbane Street (built c1922 – no plans for this building were found) and several remaining early residential properties fronting Brisbane Street. The central portion of the site including a post-1923 series of large sheds, the chimney (which survived the fire) and open yard space.

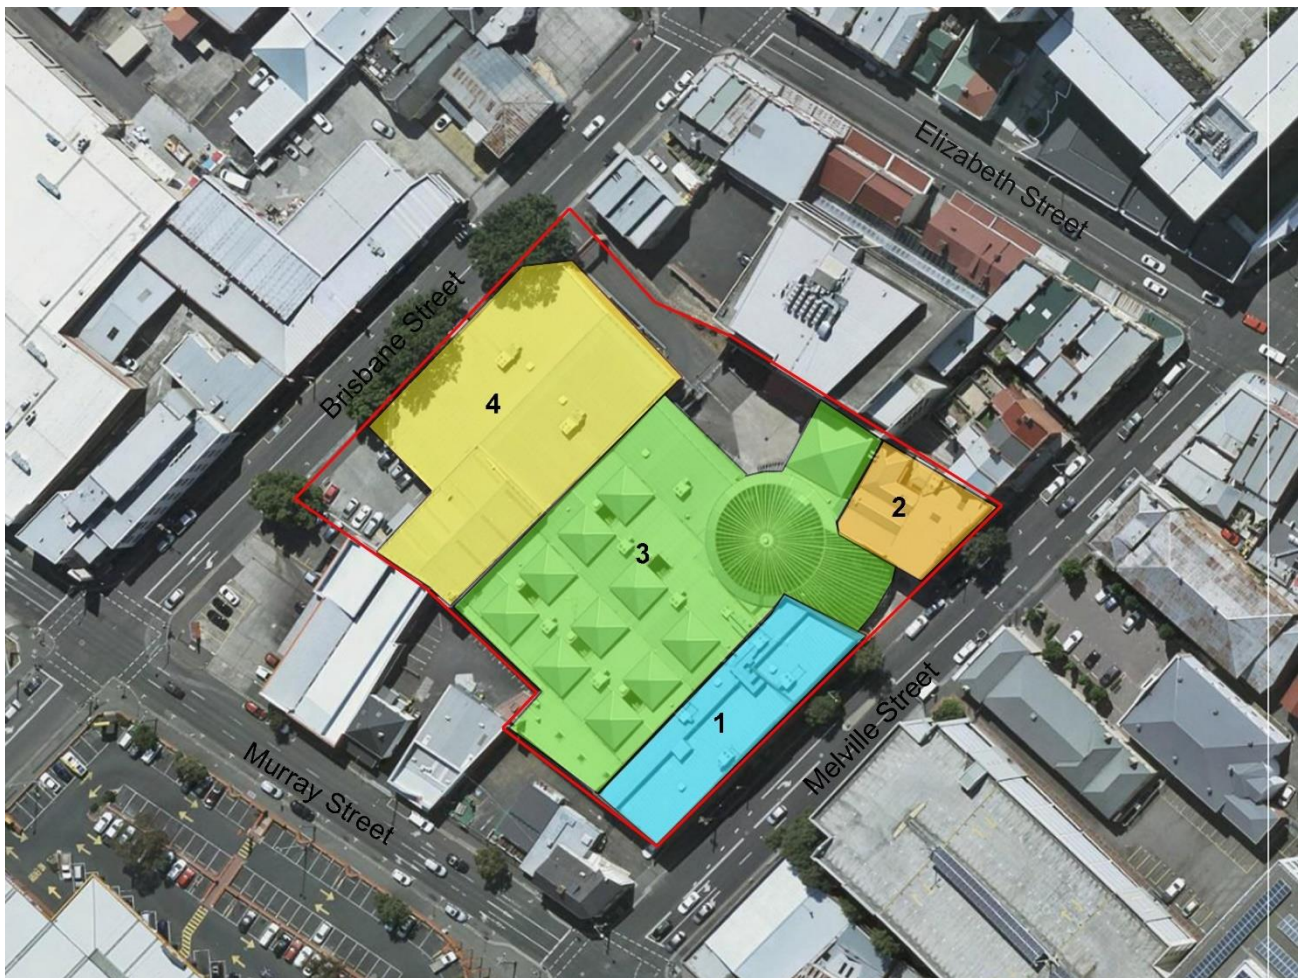
1. The former Crisp and Gunn workshops, 1923.
2. The former Crisp and Gunn offices, 1923.
3. The former Forestry dome and offices, 1997
4. The Freedom building, 1997. Not described here as no heritage listings apply to that place (apart from possible underlying archaeology).

Figure 4.1 – Main built features of the subject site ([www.thelist.tas.gov.au](http://www.thelist.tas.gov.au))

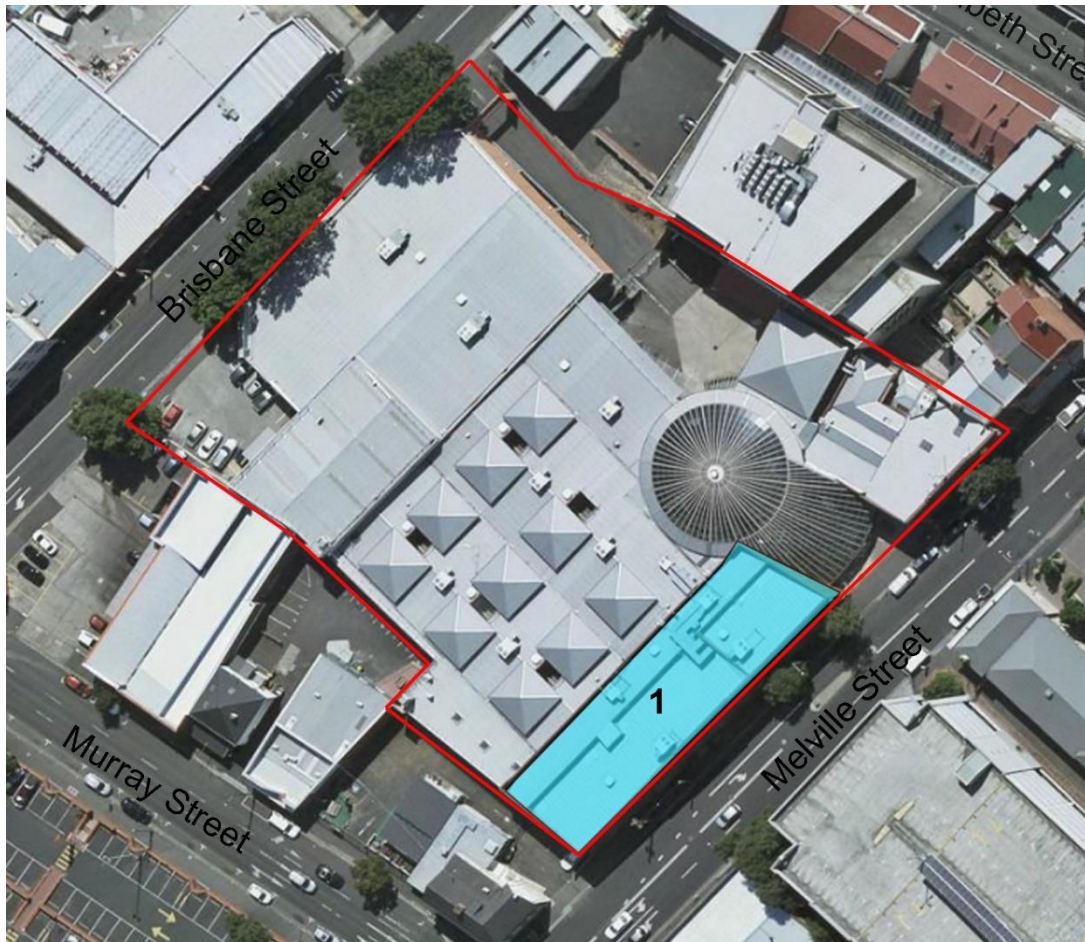
Figure 4.2 – The former Crisp and Gunn workshops and store footprint. Adapted from [www.thelist.tas.gov.au](http://www.thelist.tas.gov.au)

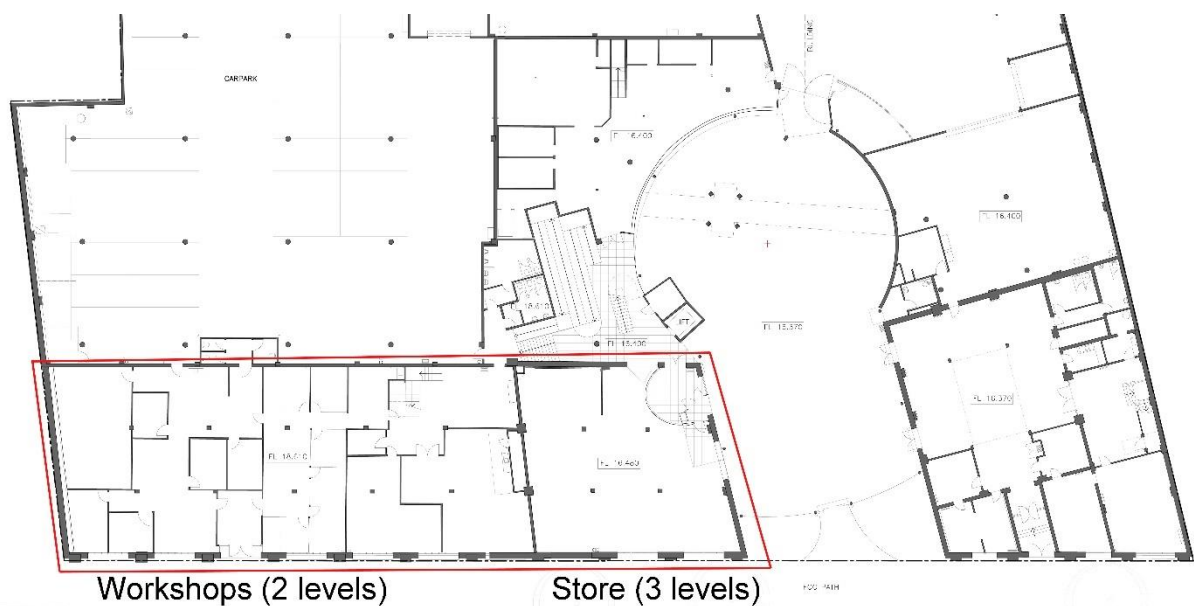
Figure 4.3 – Distinct areas of the workshops and store (adapted from Morrison Breytenbach Architects as-existing drawing, supplied by UTas).

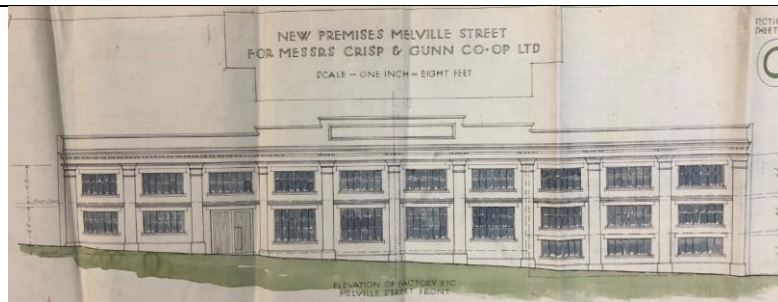
Southern	The southern elevation is the principal street frontage of the building and is a simply yet effectively detailed treatment of the elevation utilising brick. The elevation features an upper floor row of ten windows, each corresponding with one or two windows below (noting that the eastern end is three storey and the western end two). Each bay of windows are separated by a brick engaged column with simple

<p>brick bases and capitals. There is a brick stringcourse between the major floors and a more substantial capital course beneath the parapet. The centre of the parapet is heightened to include a brick-framed signboard. There is one original door opening in this elevation towards the western end – formerly timber ‘barn’ doors this is now a recessed glazed entrance.</p>

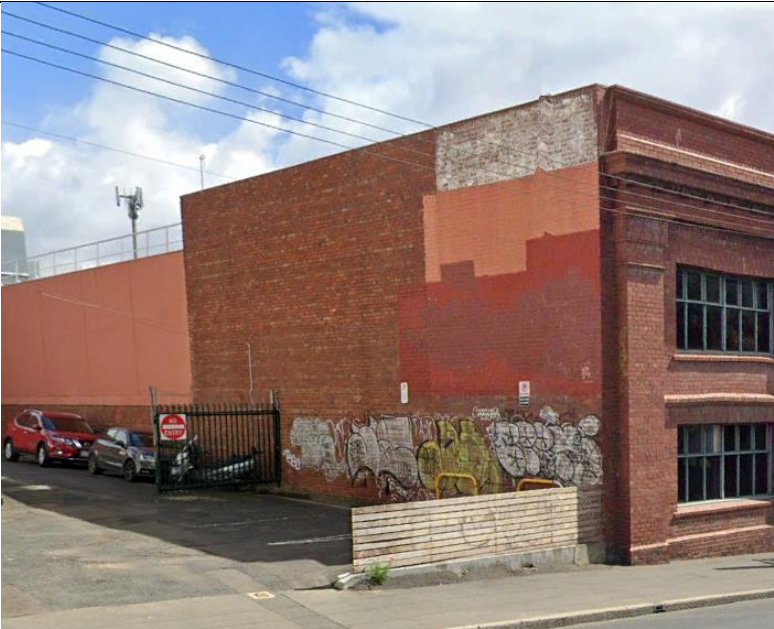
<p>Western</p>	<p>The western elevation is a completely blank and unarticulated brick party wall .</p>

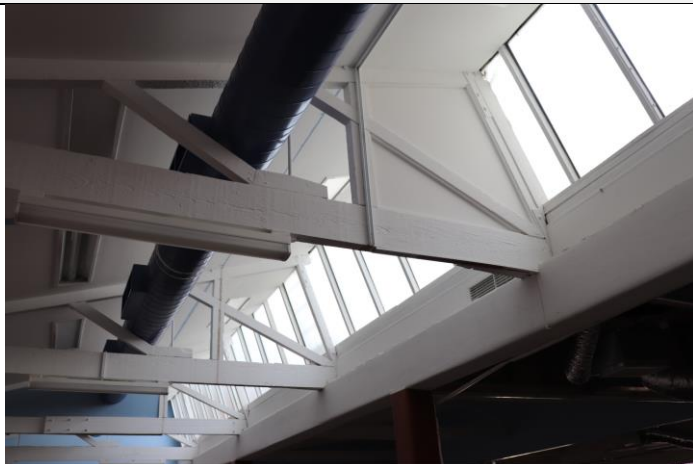
Roof		
Form	The roof retains its original simple sawtooth form with two ‘teeth’ – the front one being a larger span than the rear.

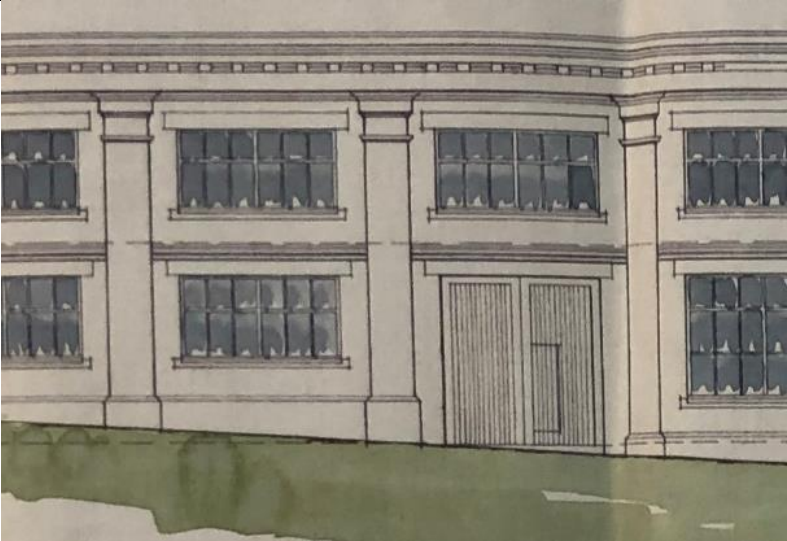
Exterior doors and windows		
Exterior doors	The original 'barn' doors leading to Melville Street have been removed (probably c1968) and replaced with a recessed and glazed porch.

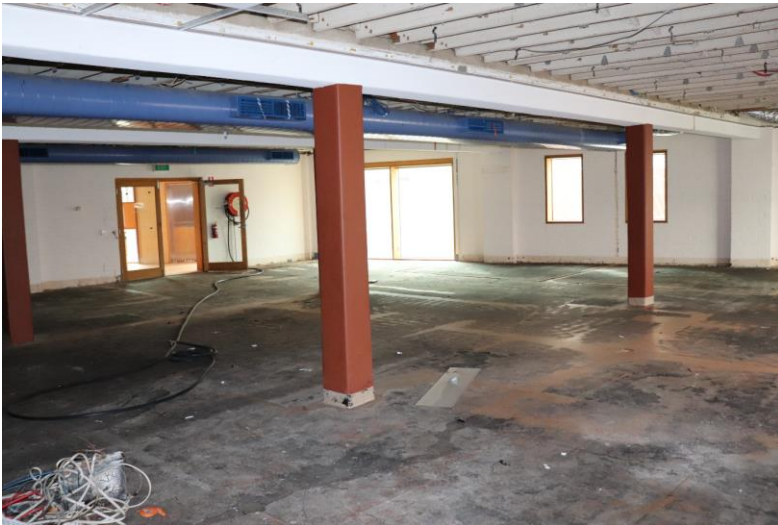
INTERIOR DESCRIPTION		
Element	Description	Image
<b>Eastern end semi-basement</b>		
Form/spaces	This is a large single room as it originally was as part of the hardware store.

Ceilings/finishes	The ceiling is the underside of the timber flooring of the first floor.	
Walls/finishes	The walls are unlined painted brick.	
Floors	The floors were concreted in 1964.	
Joinery	The room is generally devoid of joinery as per the utilitarian original nature. Any detailed joinery appears to be post-1960s. Many of the timber posts on this level have been replaced with concrete.

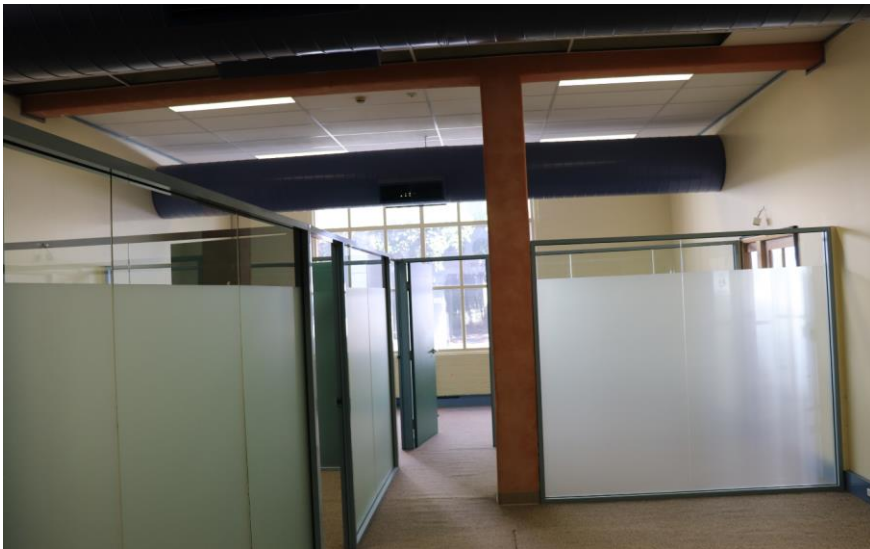
Element	Description	Image
<b>Ground floor</b>		
Form/spaces	The eastern end of the building (the former hardware store) is a single large room as it originally was. The larger western end (former workshop) has been partitioned into a large number of rooms, hallways etc. as well as an entrance hall.

Ceilings/finishes	The ceilings have all been plastered and/or false ceilings added, obscuring the original lack-of ceiling configuration.	
Walls/finishes	Generally, the inside of the exterior walls remain as painted brick, however some linings have been added as part of office partitioning.	
Floors	The floor was concreted in 1964.	
Joinery	The room is generally devoid of joinery as per the utilitarian original nature. Any detailed joinery appears to be post-1960s. Many of the timber posts on this level have been replaced with concrete.

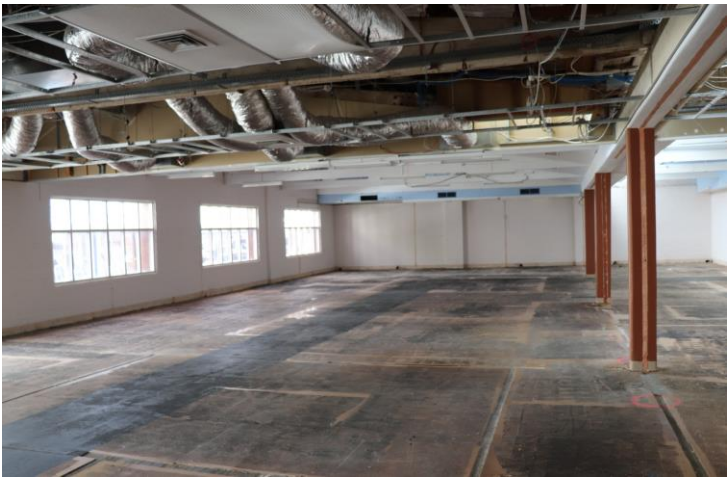
Element	Description	Image
<b>First floor</b>		
Form/spaces	Both the eastern and western ends of the building remain as large rooms (although the western end has been partitioned, with these having been removed).

Ceilings/finishes	The ceilings have had a range of false ceilings added (to obscure ducting) and subsequently removed. Some ceilings have been installed between trusses. Generally, the sawtooth roof form and open trusses are legible.	
Walls/finishes	Generally the inside of the exterior walls remain as painted brick, however some linings have been added as part of office partitioning.	
Floors	The timber floors appear to be all original and largely intact (although obscured by a range of floorcoverings). There is evidence of earlier openings (lifts, hoists etc.).	
Joinery	The room is generally devoid of joinery as per the utilitarian original nature. Any detailed joinery appears to be post-1960s.

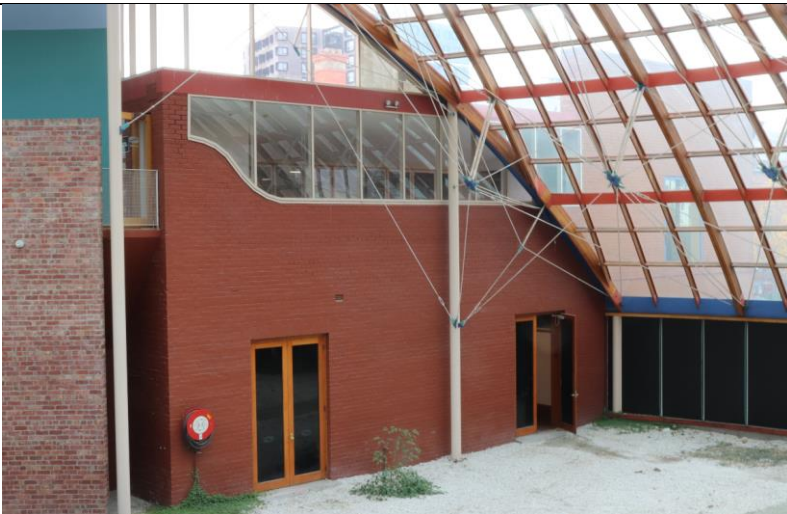
Western	The western elevation has been heavily modified with a pair of double doors on the ground level and a large and modern window on the upper floor spanning the original 1920s and 1980s portions of that floor.

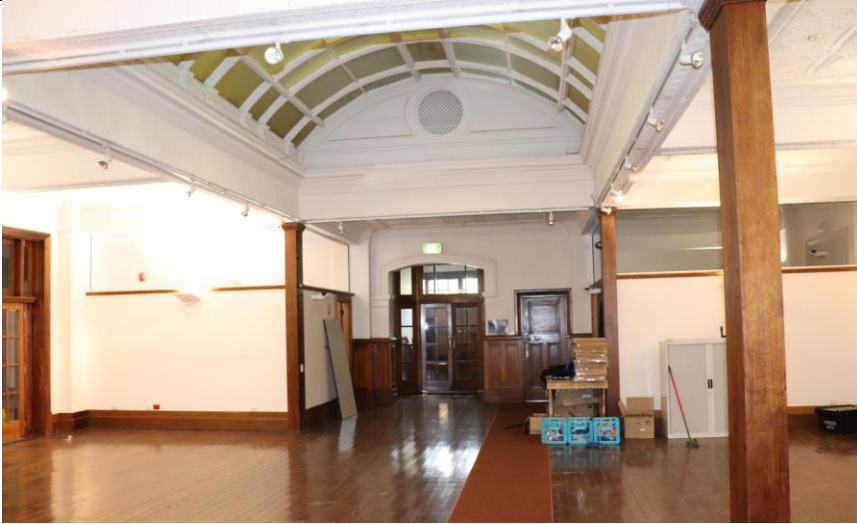
Ground floor main chamber		
Form/spaces	The main chamber was formerly a single large room, however two smaller offices have been partitioned off the front section. Doors have been added to link this room with the dome and the workshops at rear.

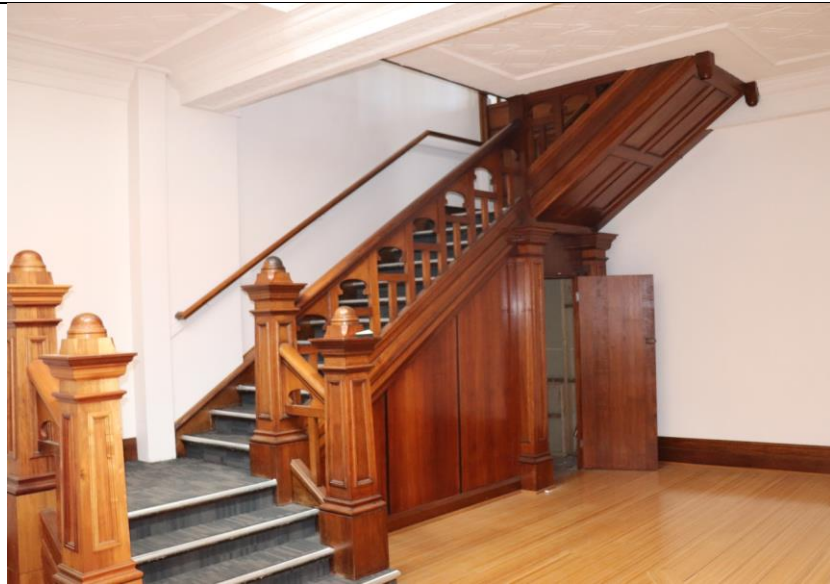
Ground floor stair foyer		
Form/spaces	This room retains its original form, entered via a single door from one of the front offices and by double doors from the main chamber. A later door to the rear store has been added.	
Ceilings/finishes	The ceiling is elaborate pressed tin with a roof lantern.	
Walls/finishes	The walls are hard plaster rendered onto the masonry.	
Floors	The floors are the original Tasmanian Oak boards with a modern floating floor installed.

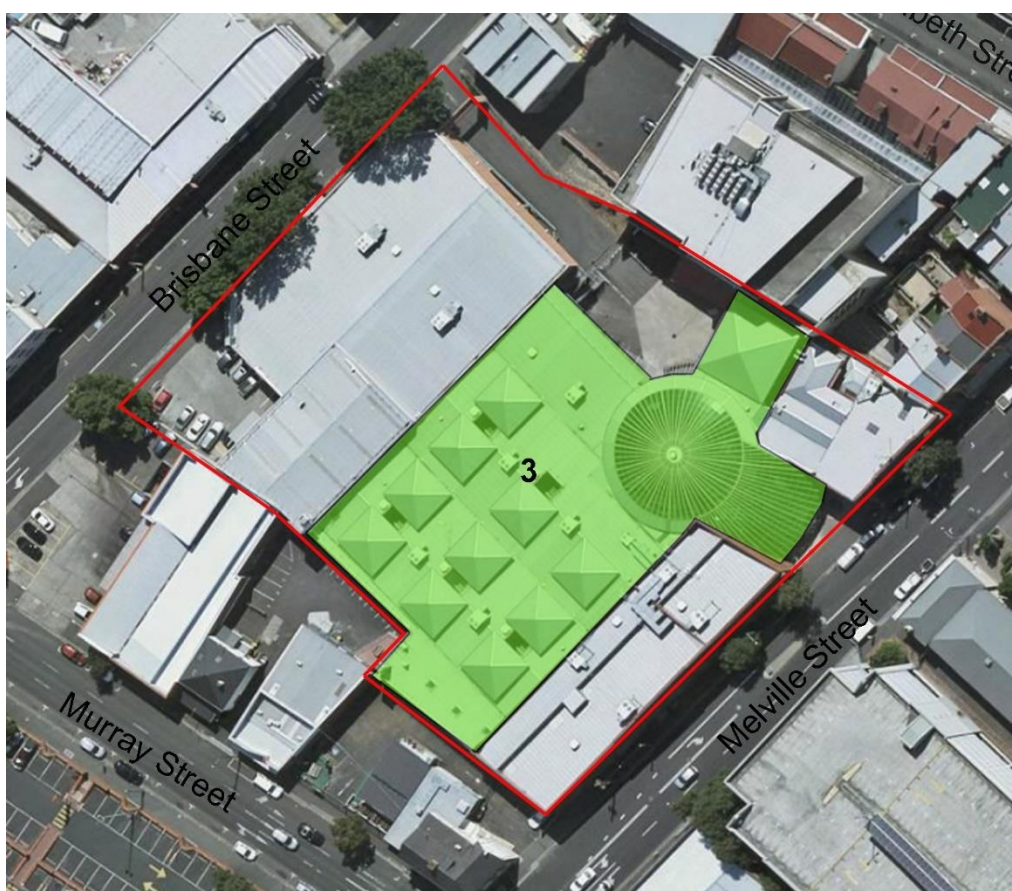
Figure 4.7 – The 1997 Forestry building footprint. Adapted from [www.thelist.tas.gov.au](http://www.thelist.tas.gov.au)

GENERAL FORM, EVOLUTION AND DESCRIPTION	
Development phase	Description, integrity etc.
1997 -	The dome and associated office building are generally as per their 1997 construction, although the plantings of the dome have recently been removed.

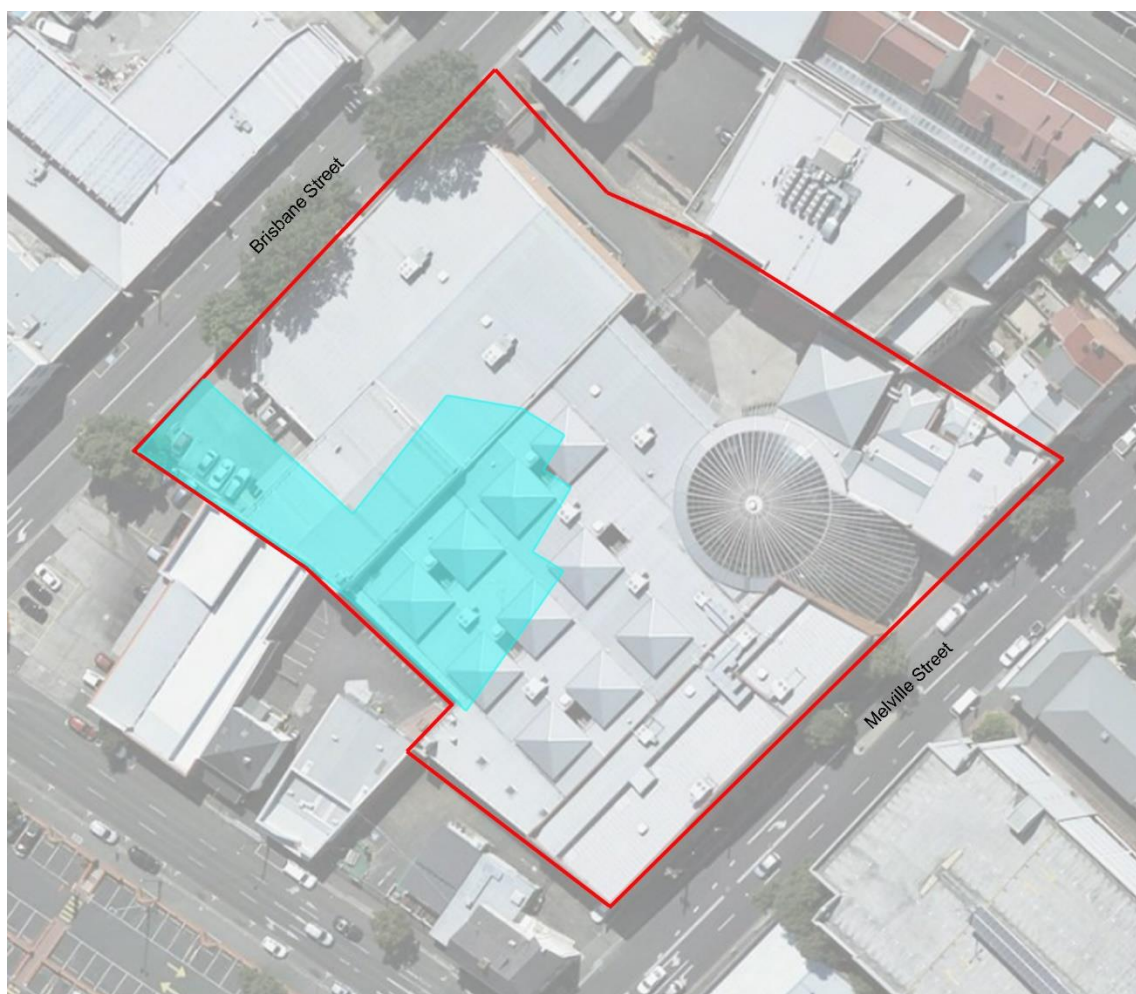
A 1964 plan for alterations to the Crisp and Gunn workshops is held by the Tasmanian Archive and Heritage Office which depicts excavation of the central (western) portion of the site for those workshops, and also includes specifications for retaining walls (600mm high) along the western edge of that part of the site. This would indicate widespread and moderately deep bulk excavation at the time, affecting the area depicted in the figure below:

Figure 7.3 – Area affected by bulk excavation and grading, 1964 (blue), as depicted on TAHO AE417/4/97.

Note that the above area of 1964 works would have been further excavated and impacted as part of the 1997 works.

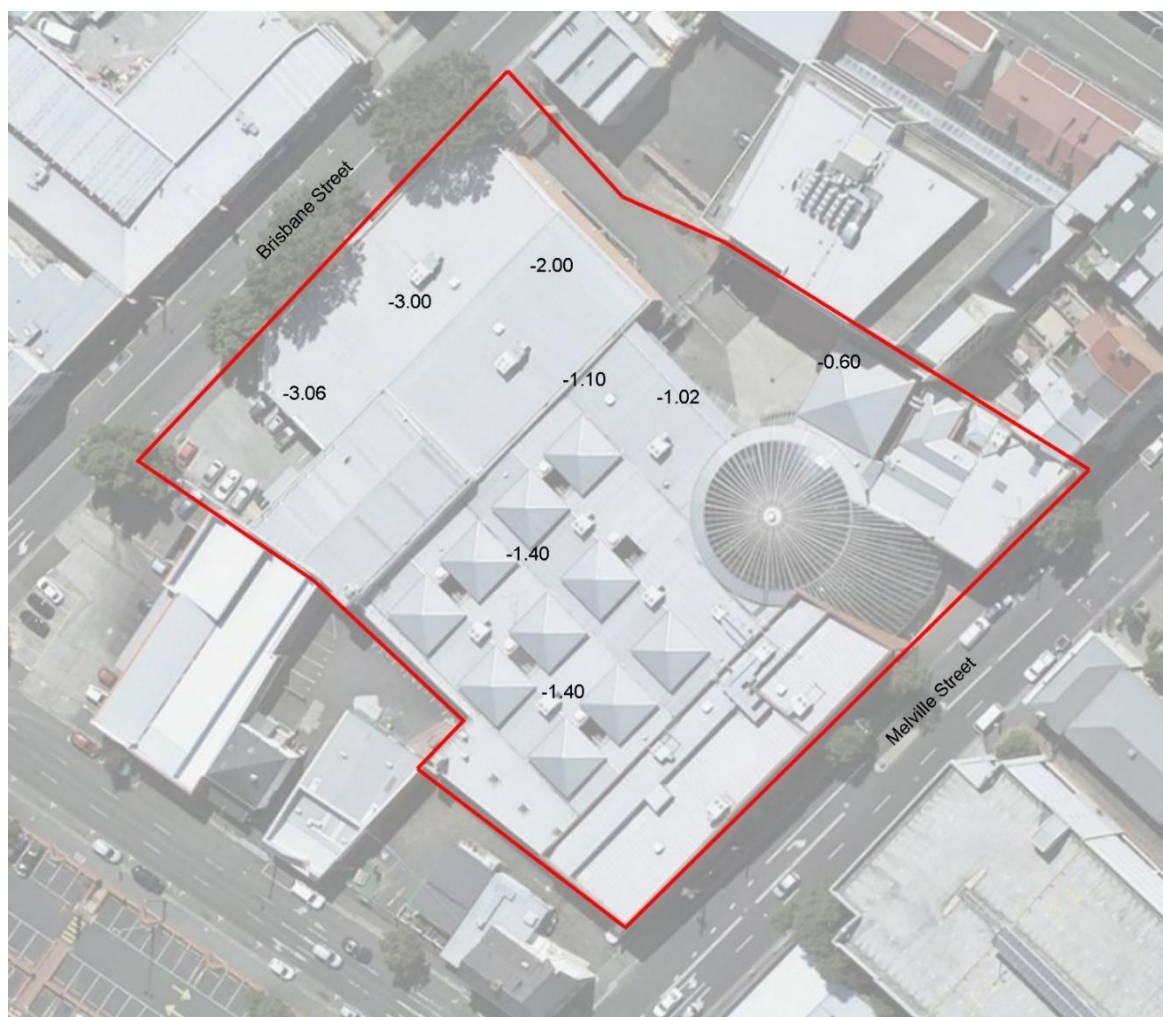
The figure below depicts the depth of bulk excavation undertaken in certain locations to form the basement as part of the 1997 works as depicted on those drawings (noting that the finish level depicts carpark surface – excavation would have been to a greater depth to prepare for that finished surface). Generally, it appears that the Brisbane Street frontage was excavated by around 2.5-3.5 metres, grading down to 1.0-2.0 metres further southward (i.e. following the natural slope of the land).

Figure 7.4 – Sampling of depth of excavation occurring as part of the 1990s redevelopment of the site (metres).

Site observations in the current basement parking area indicate that there has been a substantial degree of disturbance as per the levels indicated in Figure 7.4, with what appears to be an earlier wall (used as a retaining wall) having been underpinned by approximately a metre, suggesting that excavation in the late 1990s has exceeded historic ground level. Similarly, the edge of the driveway of the Freedom building to the west has been excavated to the sub-soil shale stone which is typical of sterile ground within some areas of the Hobart CBD:

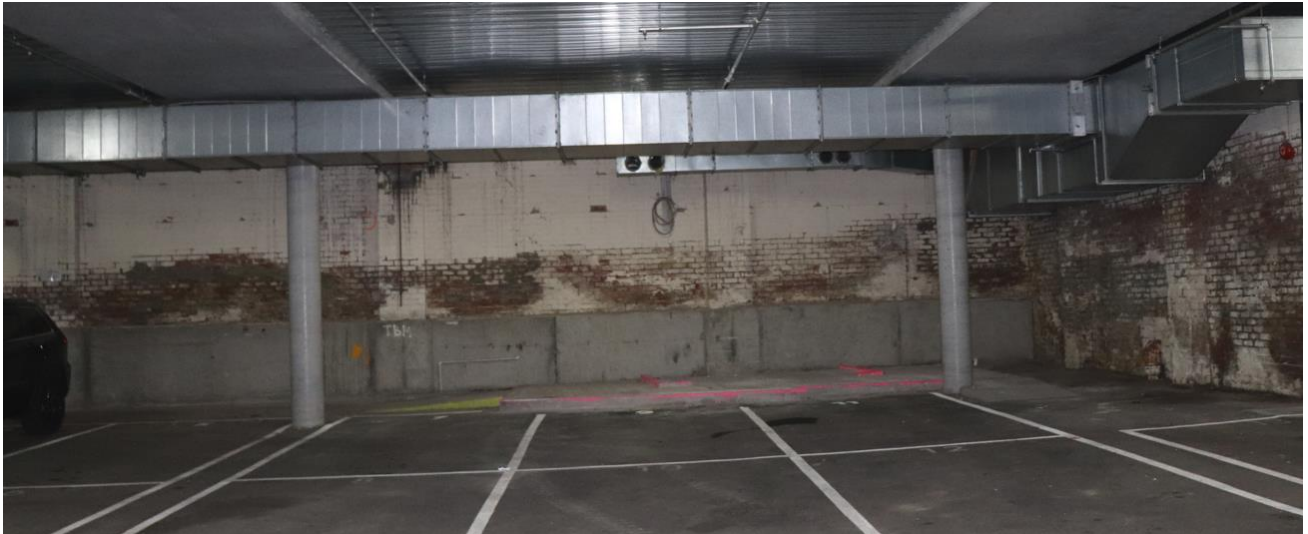
Figure 7.7 – Underpinned earlier wall in the basement carpark.

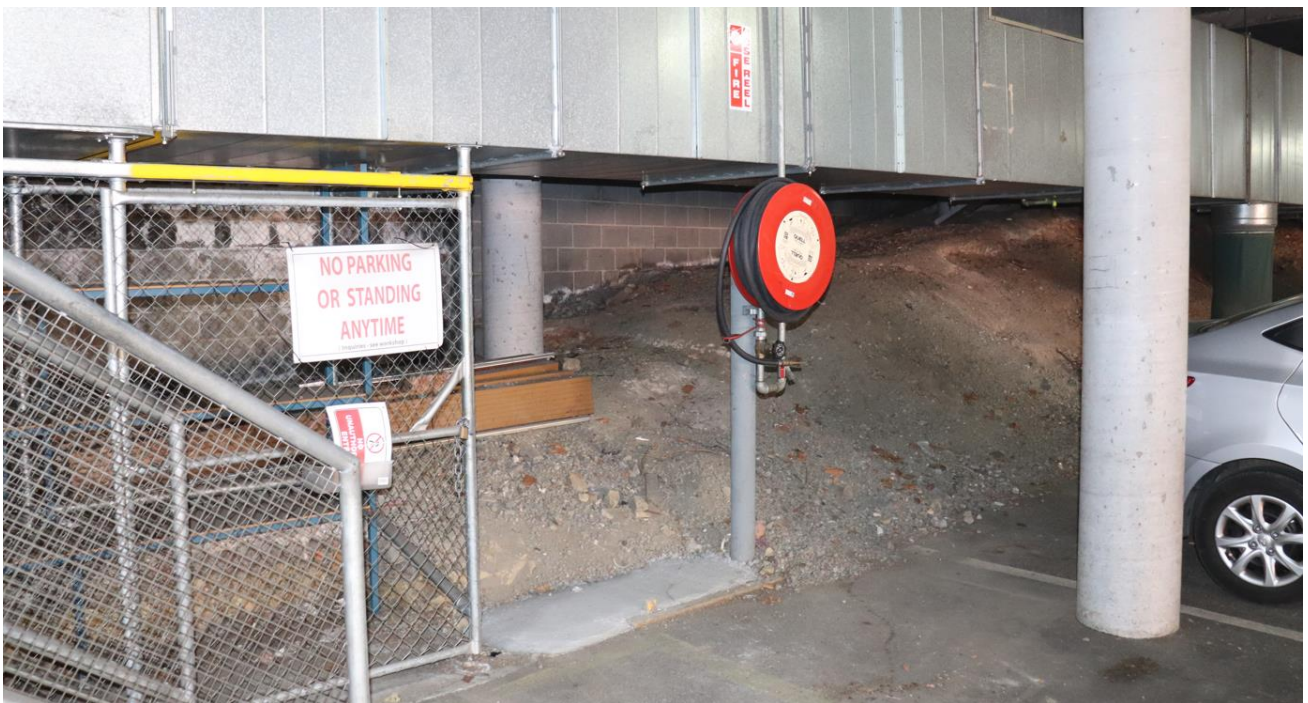
Figure 7.8 – Sterile shale stone ground on the western edge of the Brisbane Street portion of the site.

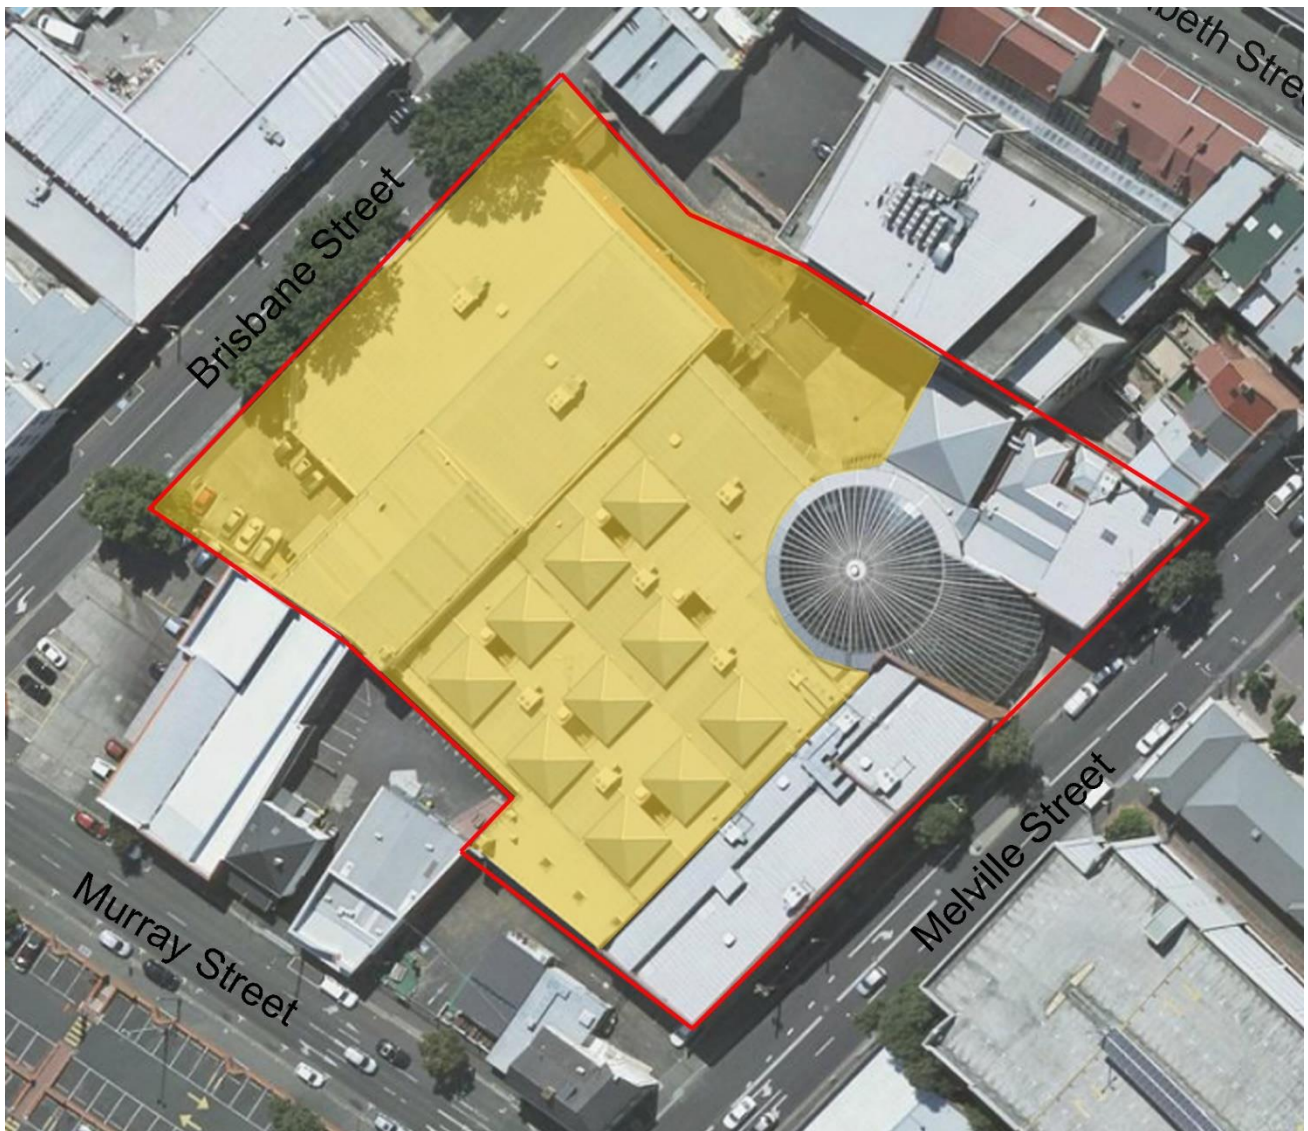
Figure 7.9 – Areas of the site that appear to have been substantially disturbed.
