PLANNING REF: PLN-22-790  
THC WORKS REF: 8058  
REGISTERED PLACE NO: 12028  
APPLICANT: University of Tasmania  
DATE: 25 January 2023

## NOTICE OF HERITAGE DECISION

Registered Place: Crisp & Gunn offices and workshop, and Forestry Tasmania dome, 79-83 Melville Street, 83 Melville Street and 80 Brisbane Street, Hobart.  
Proposed Works: New pedestrian bridge and landscaping work.

# University of Tasmania Forestry / Timber Yards Pedestrian Bridge Planning Report

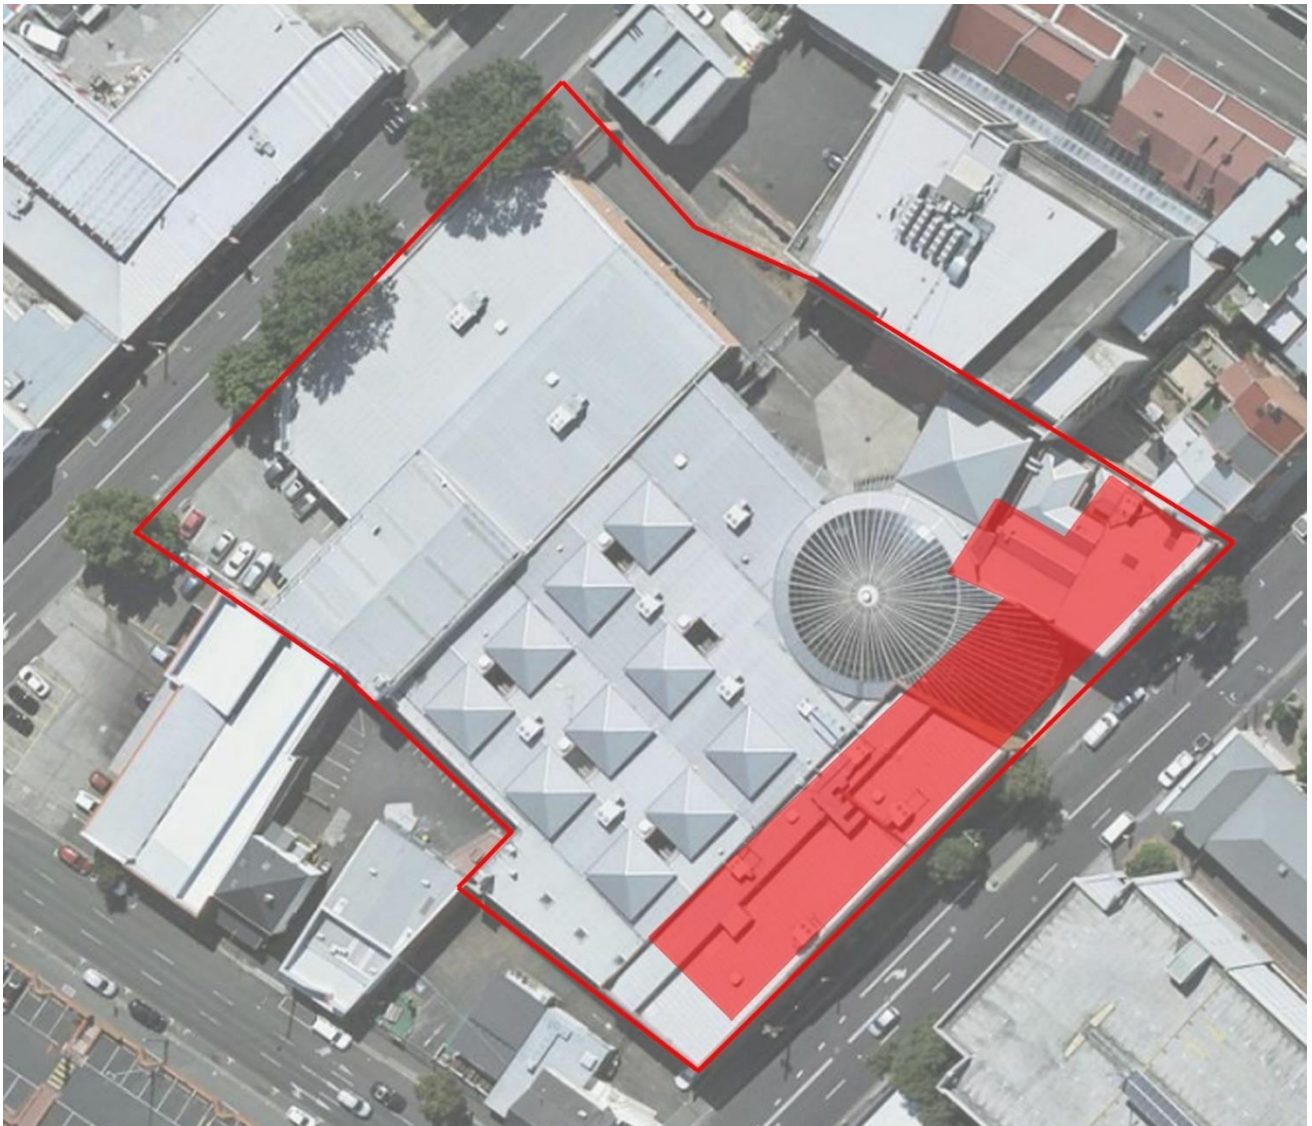
Figure 7.4 depicts the areas of archaeological potential as per the above discussion:

Figure 7.10 – Archaeological zoning of the subject site, as per the table below (note that the non-shaded areas are considered to have low/no archaeological potential). Adapted from [www.thelist.tas.gov.au](http://www.thelist.tas.gov.au)

Area	General level of archaeological potential	Management policy
<b>General policies</b>		Where possible, the preference is to not disturb archaeological remains, however it is acknowledged that the feasible redevelopment of the site may not be possible without doing so. Consideration should be given to any development design to minimise potential impact, however if this is not feasible the above policies (and implementation of method statements pursuant to those policies) are considered sufficient to yield the archaeological potential of the site. An archaeologist should be included in the project design team in order to manage archaeology as part of an iterative process between the client, archaeologist, designer(s) and permit authorities.
		Consideration should be given in any redevelopment of the site to incorporate archaeological remains (e.g. as interpretation) however this should not inhibit the feasible redevelopment of the site.

Remainder of site	Low/no	All works crew involved in excavation elsewhere on the site must be brief for precautionary 'call-in' provisions for the site in the event that any unanticipated archaeological remains are present – e.g. wells, cesspits, drains, undocumented outbuildings etc. If any such possible remains are found, works must cease in that area (may continue elsewhere) and an archaeologist called-in to assess significance and manage as per the policies and directions of this document.
-------------------	--------	--

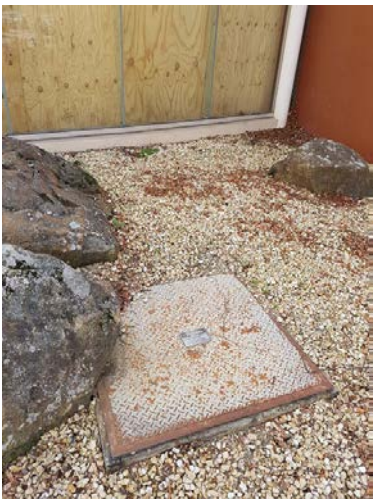
Manhole cover in vicinity of removed UST in front of Atrium
2

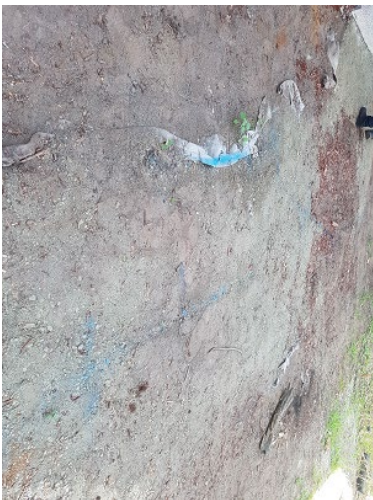
Geo-fabric coming to surface in Atrium
3

There was evidence of geo-fabric used in the development of the forest in the atrium coming to the surface (Plate 2). This was observed throughout the right side of the atrium.

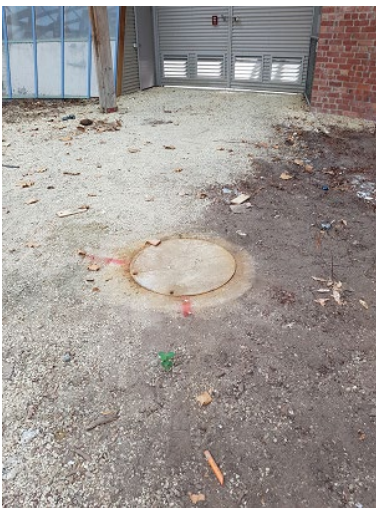
An example of the sewage line gatic covers throughout the site

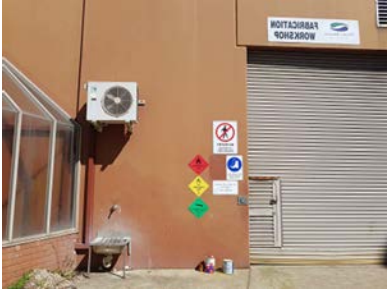
A photograph of the exterior wall of a building. On the left is a window with a white air conditioning unit mounted above it. To the right of the window, there are several safety signs: a red diamond-shaped gas warning sign, a yellow diamond-shaped flammable sign, and a blue circular sign with a white flame symbol. Above these signs is a small white rectangular sign with the text 'HAZCHEM' and 'W01TADIRBA' and 'W01EADOW'.	Gas signage outside the Fabrication Workshop
5

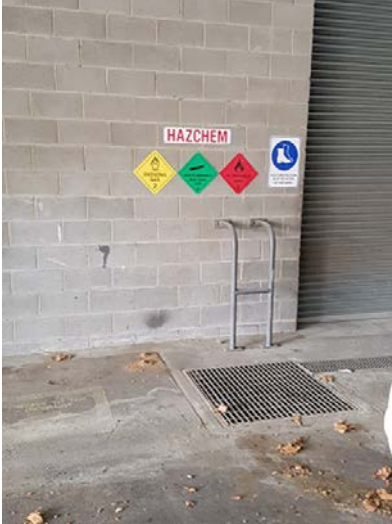
A photograph of a grey concrete block wall. On the wall, there are several safety signs: a red diamond-shaped gas warning sign, a yellow diamond-shaped flammable sign, a red diamond-shaped flammable sign, and a blue circular sign with a white flame symbol. Above these signs is a small white rectangular sign with the text 'HAZCHEM'.	Gas and HAZCHEM signage outside of the Operations Workshop

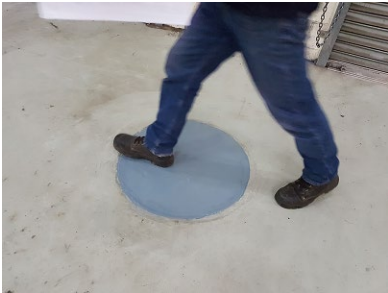
A photograph showing a person's legs and feet standing on a large, circular, light blue metal cap that covers an oil sump. The person is wearing blue jeans and dark shoes.	Capped Oil Sump in Operations Workshop
7

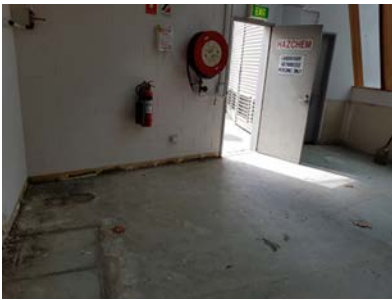
A photograph of an interior room. On the left wall, there is a red fire extinguisher and a red fire alarm pull station. In the center, there is a white door with a 'HAZCHEM' sign on it. The floor is concrete and there is some debris on it.	HAZCHEM signage on Laboratory door

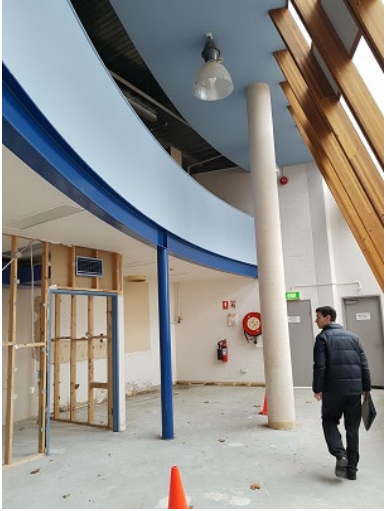
Laboratory has been gutted
9

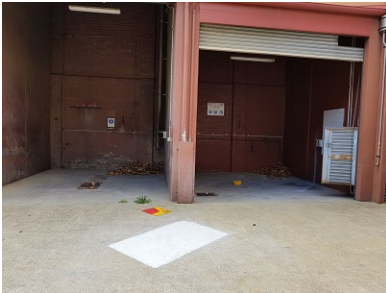
Open garages/wash down area in Service Yard (there are three bays)
10

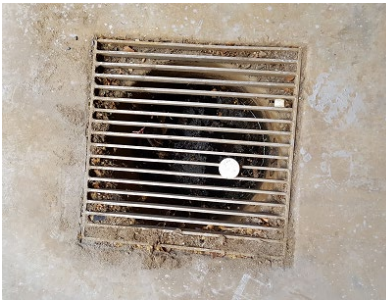
Close up of drain in Garage in Service Yard

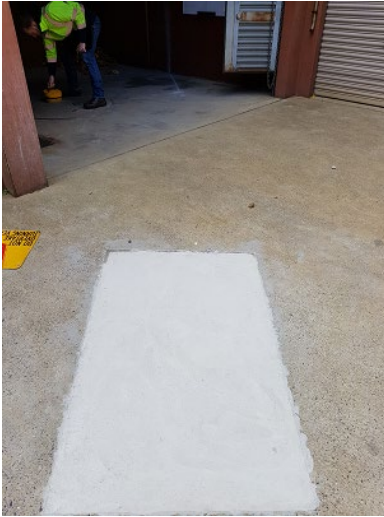
Section of concrete surface in Service Yard replaced
14

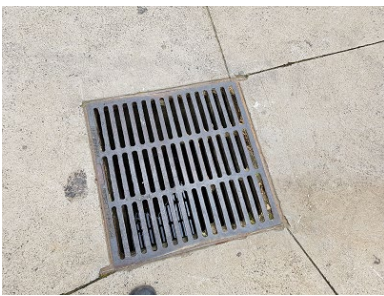
Drain in centre of Service Yard

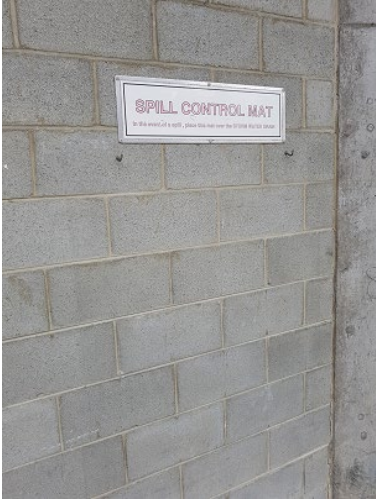
On outside of Operations Workshop within the Service Yard
16

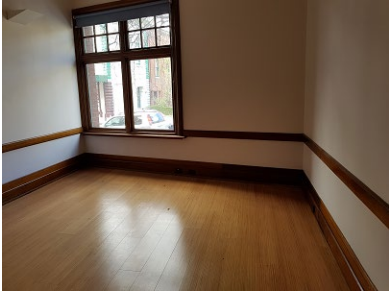
An example of the condition of the ground floor of the eastern redbrick warehouse
17

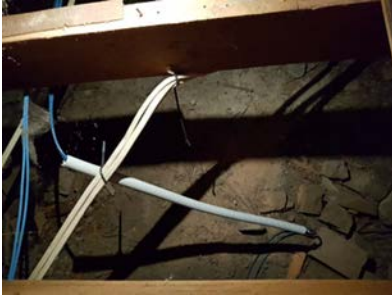
View through the floorboards in the western redbrick warehouse
18

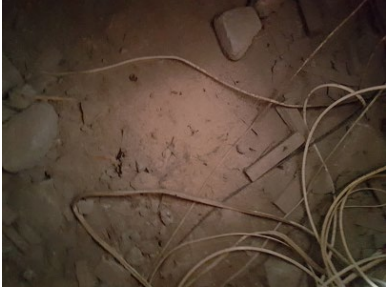
View through the floorboards in the western redbrick warehouse (different hole in floor)
19

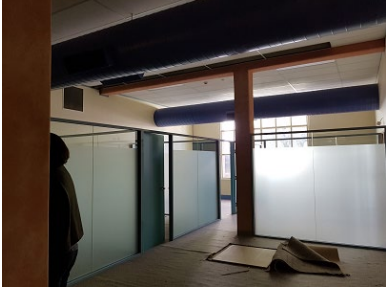
Office partitions and section of floor removed in western redbrick warehouse.

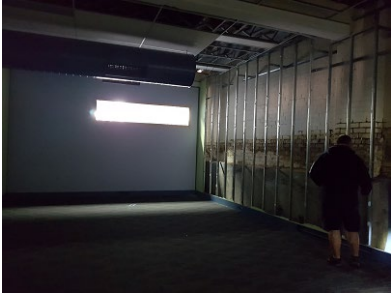
Section of western redbrick warehouse with wall removed
21

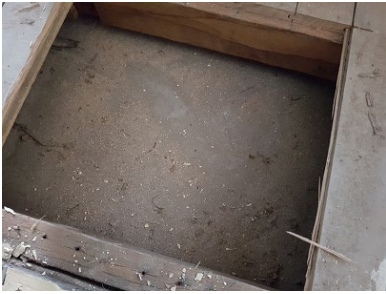
Slab beneath the floorboard in eastern redbrick warehouse.
22

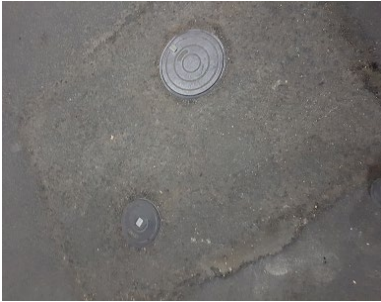
Gatic covers in underground car park
23

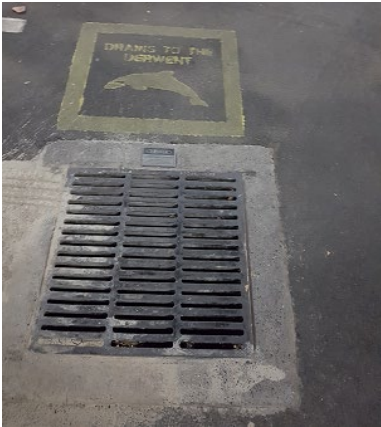
Stormwater drain to the Derwent

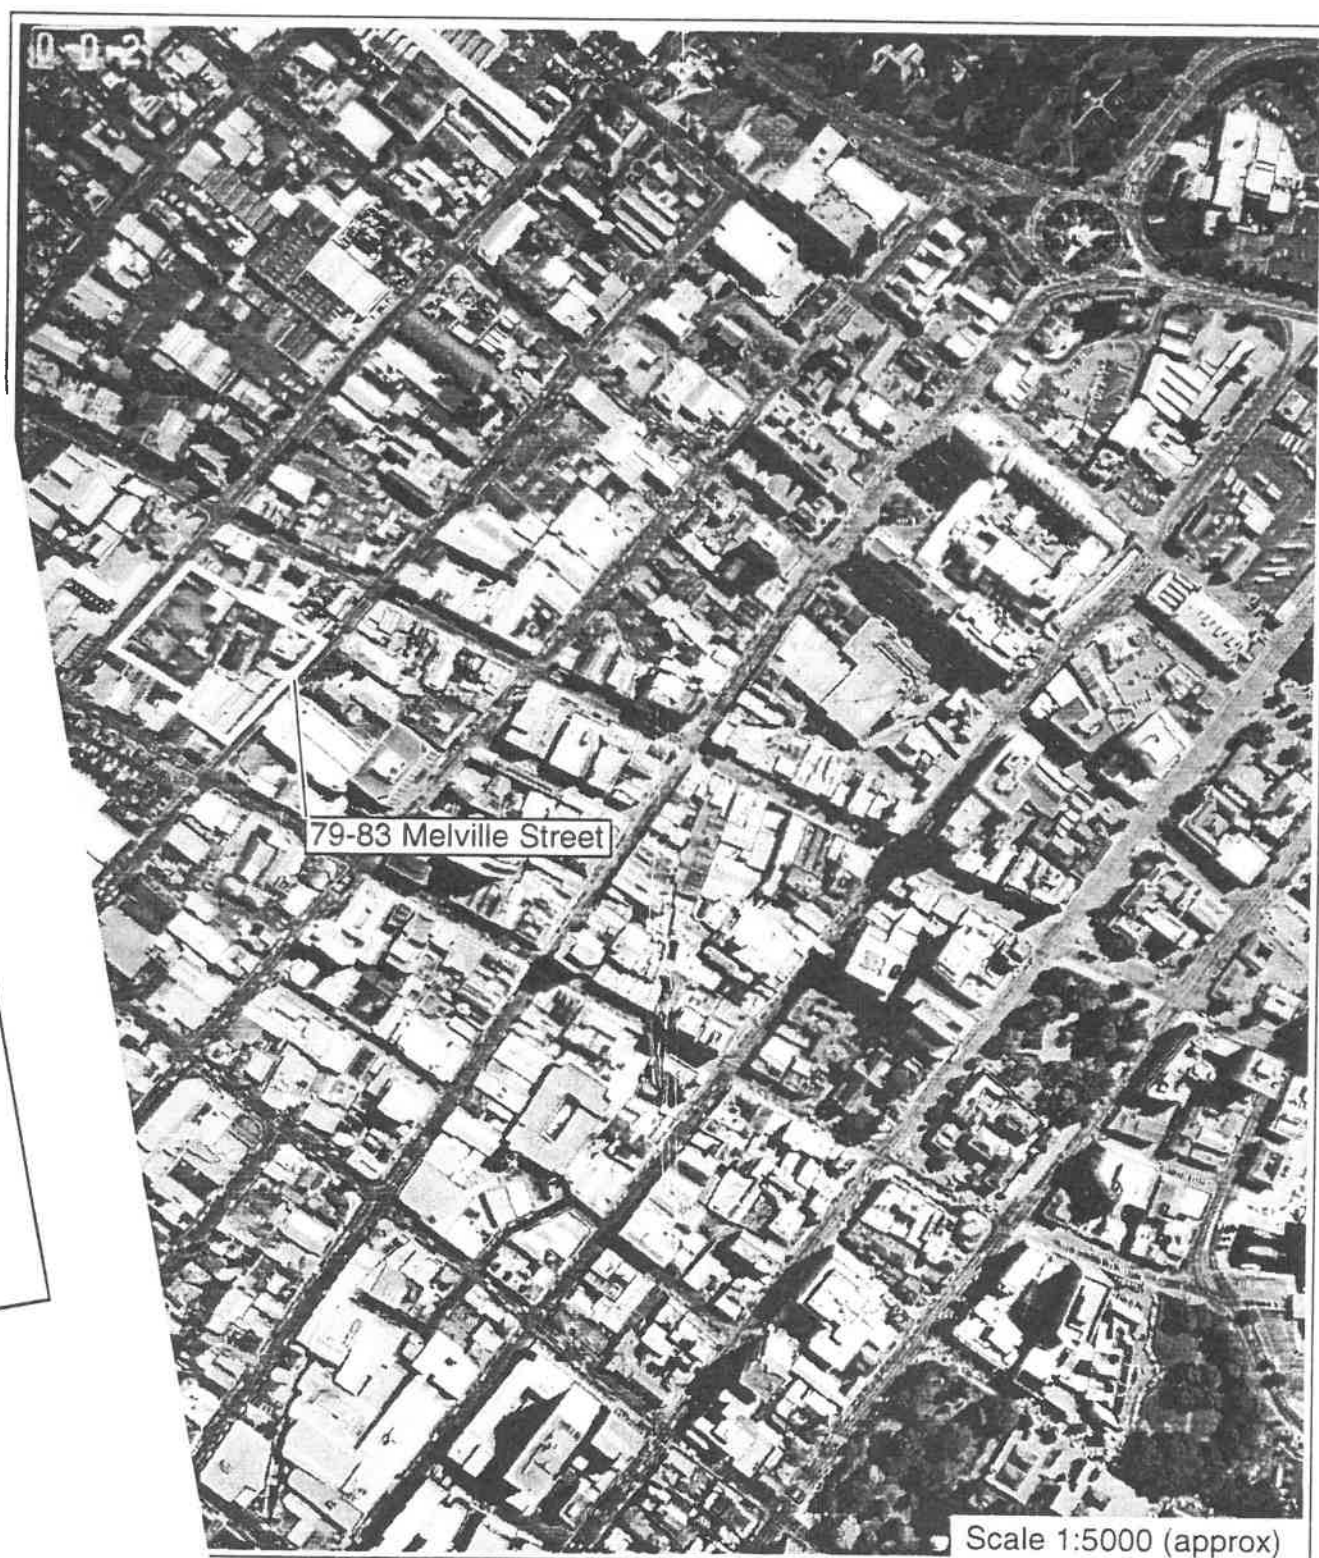
Aerial Photograph of Property and Vicinity (1994)

The property is located in an area of commercial and light industrial development in the Hobart "central business district" area. The site contains brick buildings currently used as offices, and large store areas constructed of brick and timber, with concrete floors. At the rear of the buildings are outdoor car parking areas on bitumen and graded gravel and soils. Some vehicles also park inside the store area immediately off Melville Street. Figure 2-2 is an aerial photograph of the site, showing existing development.

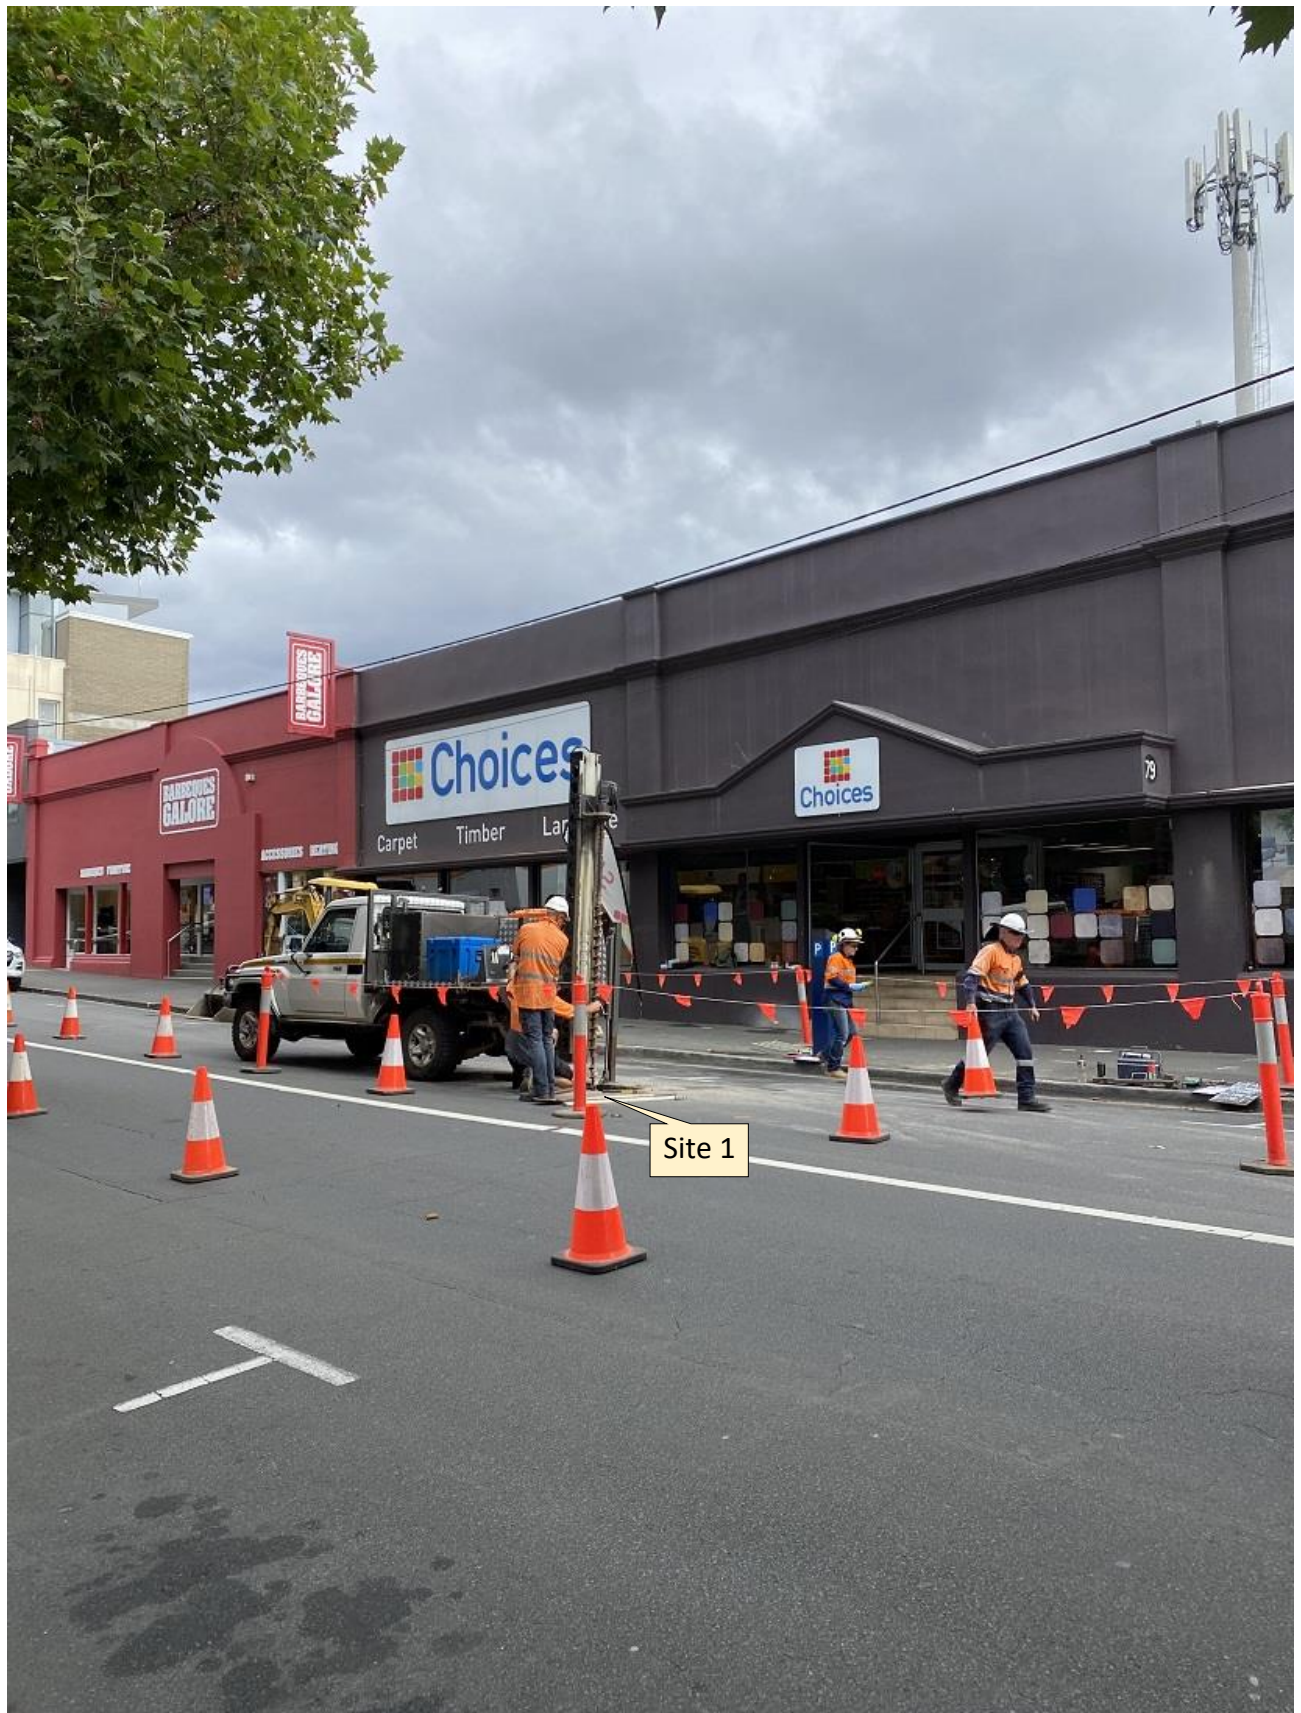
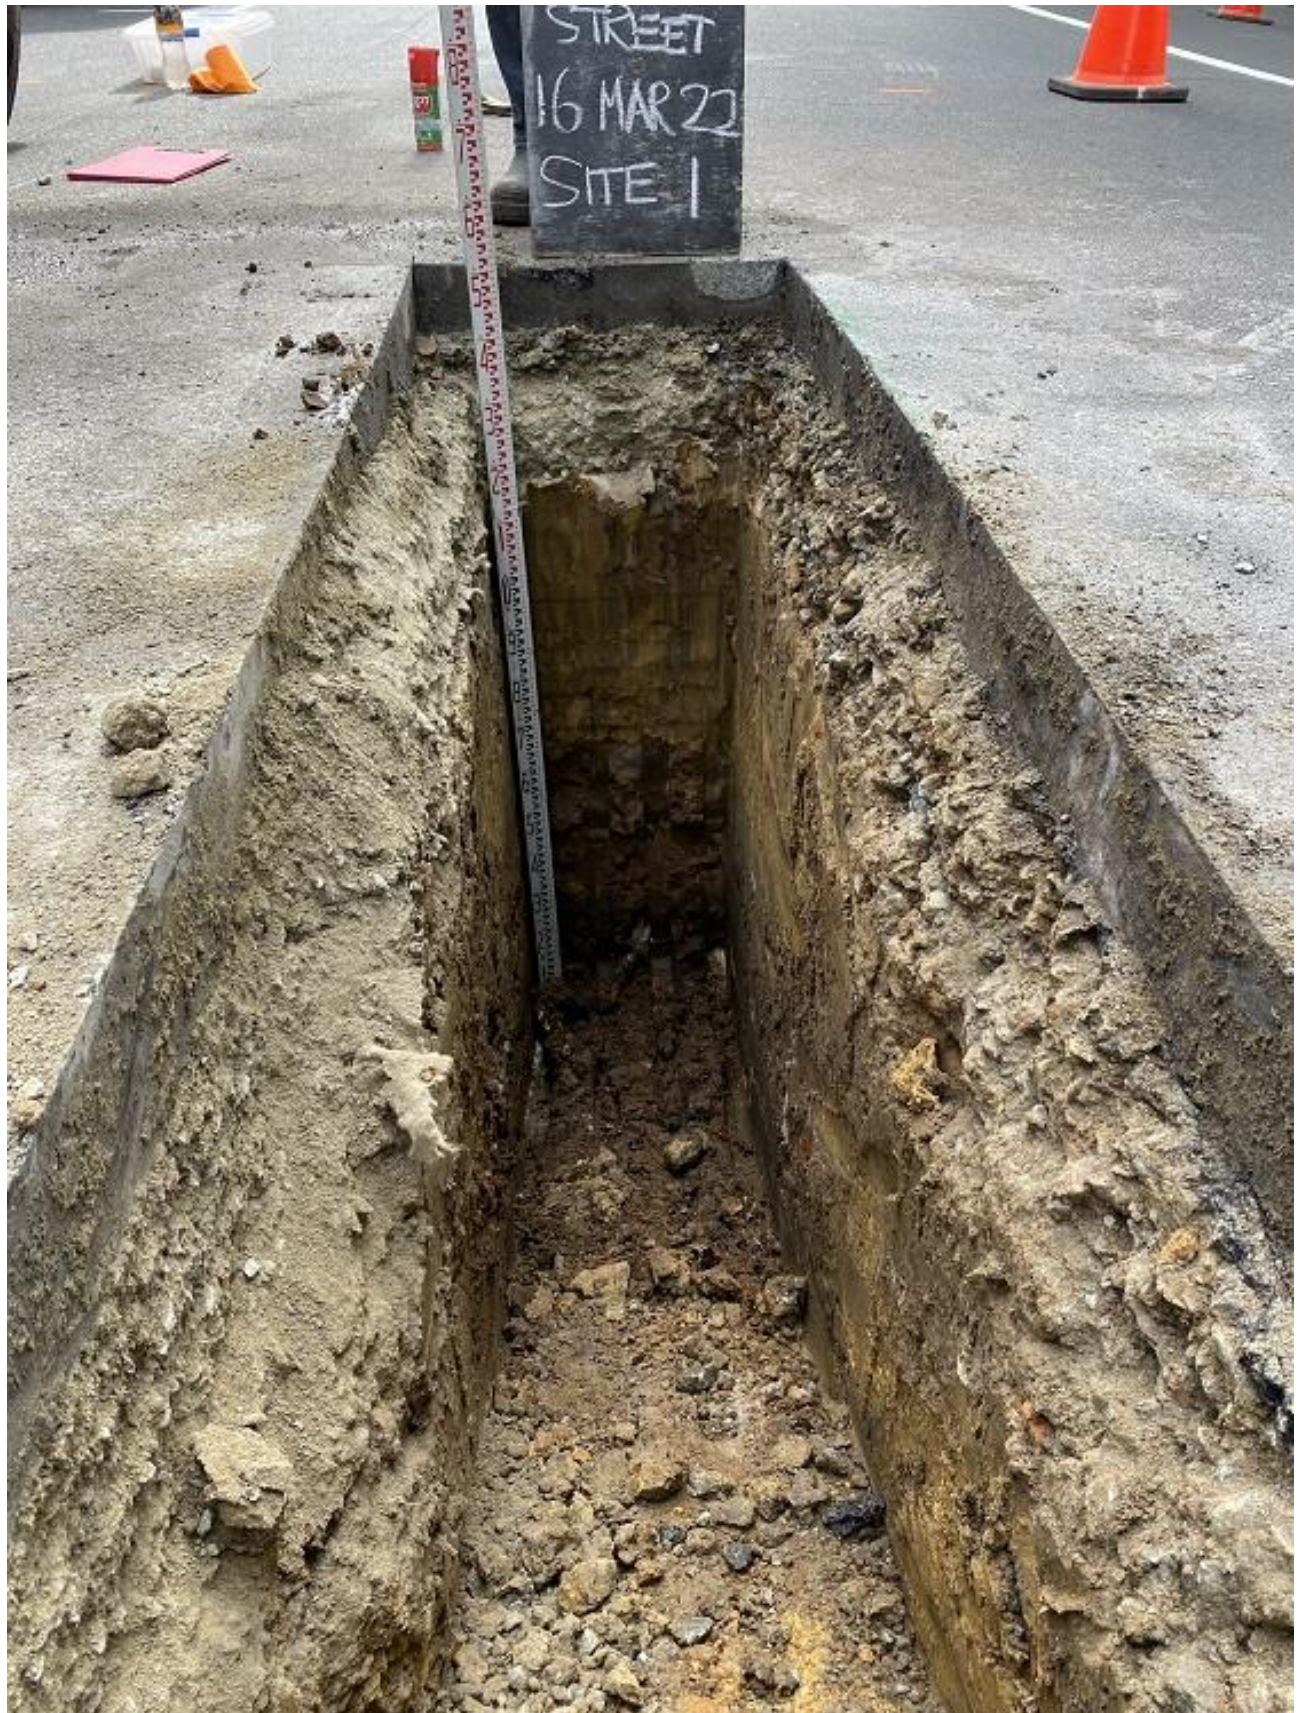
The staff/scale in these photos is graduated in red- and black numbered segments each one metre long.  
The larger numbers are decimetres and the smaller numbers are centimetres.

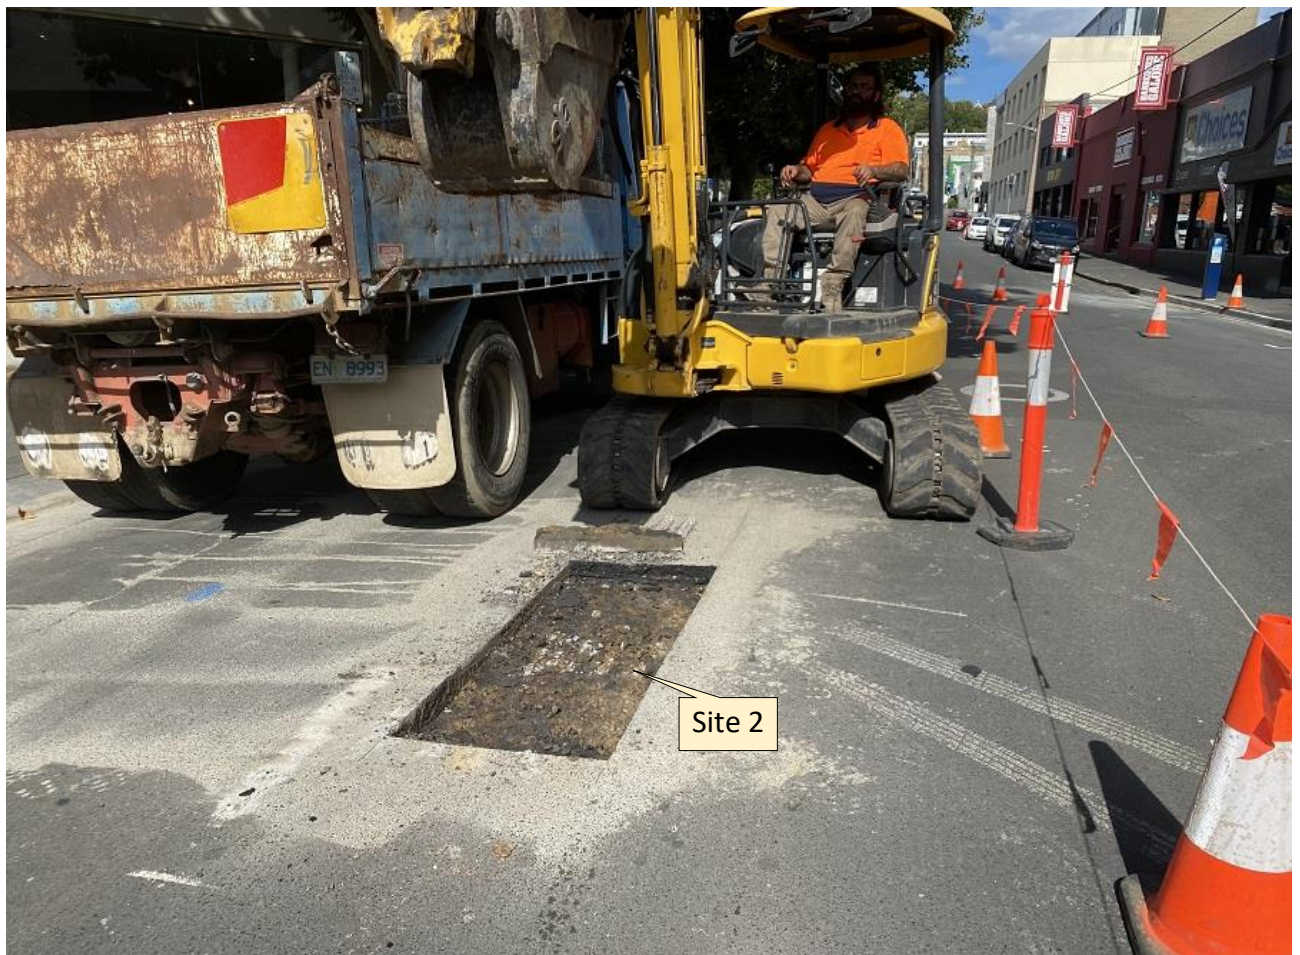
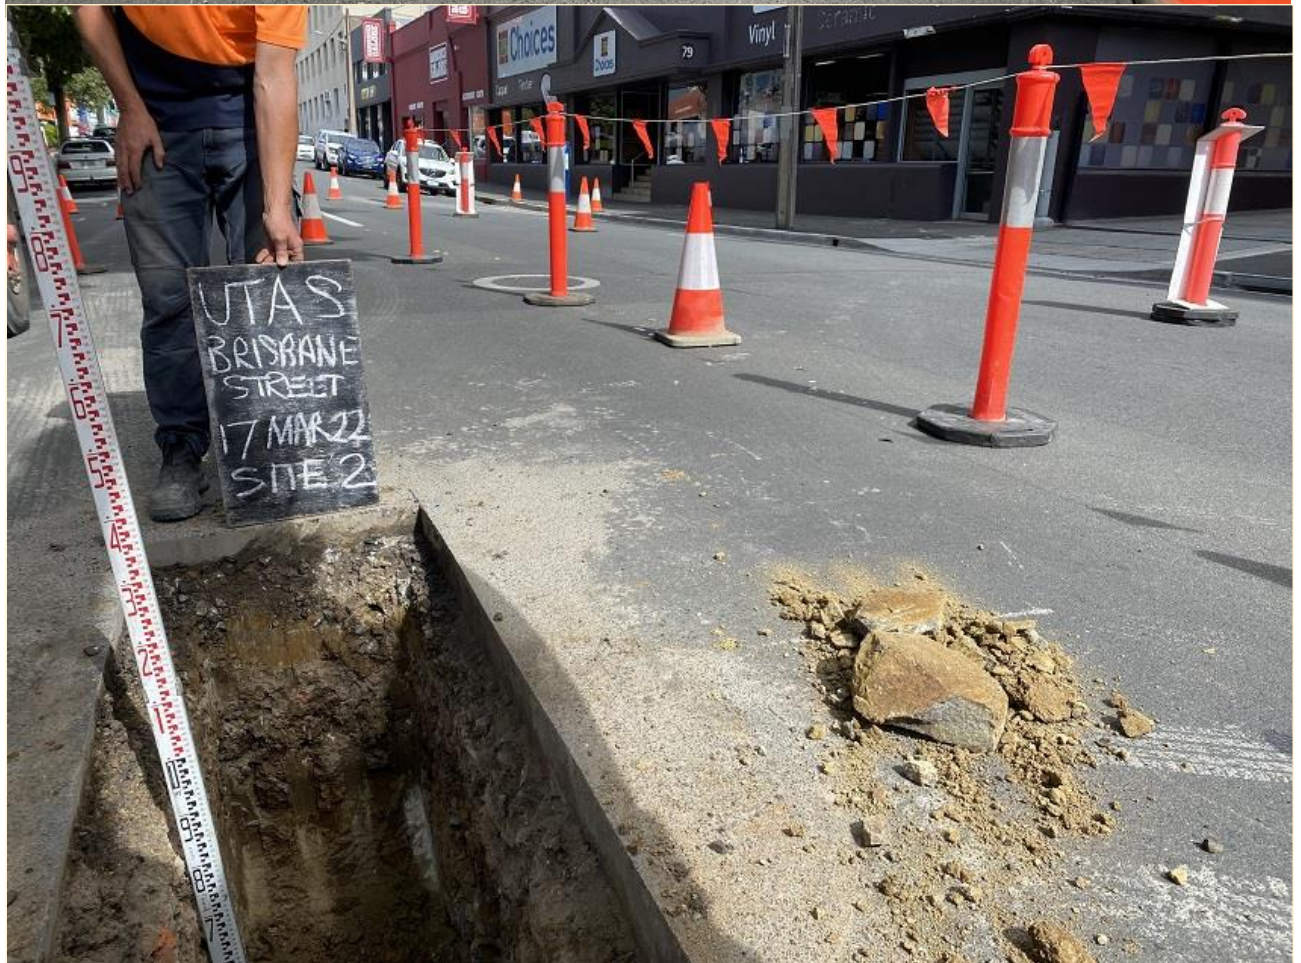
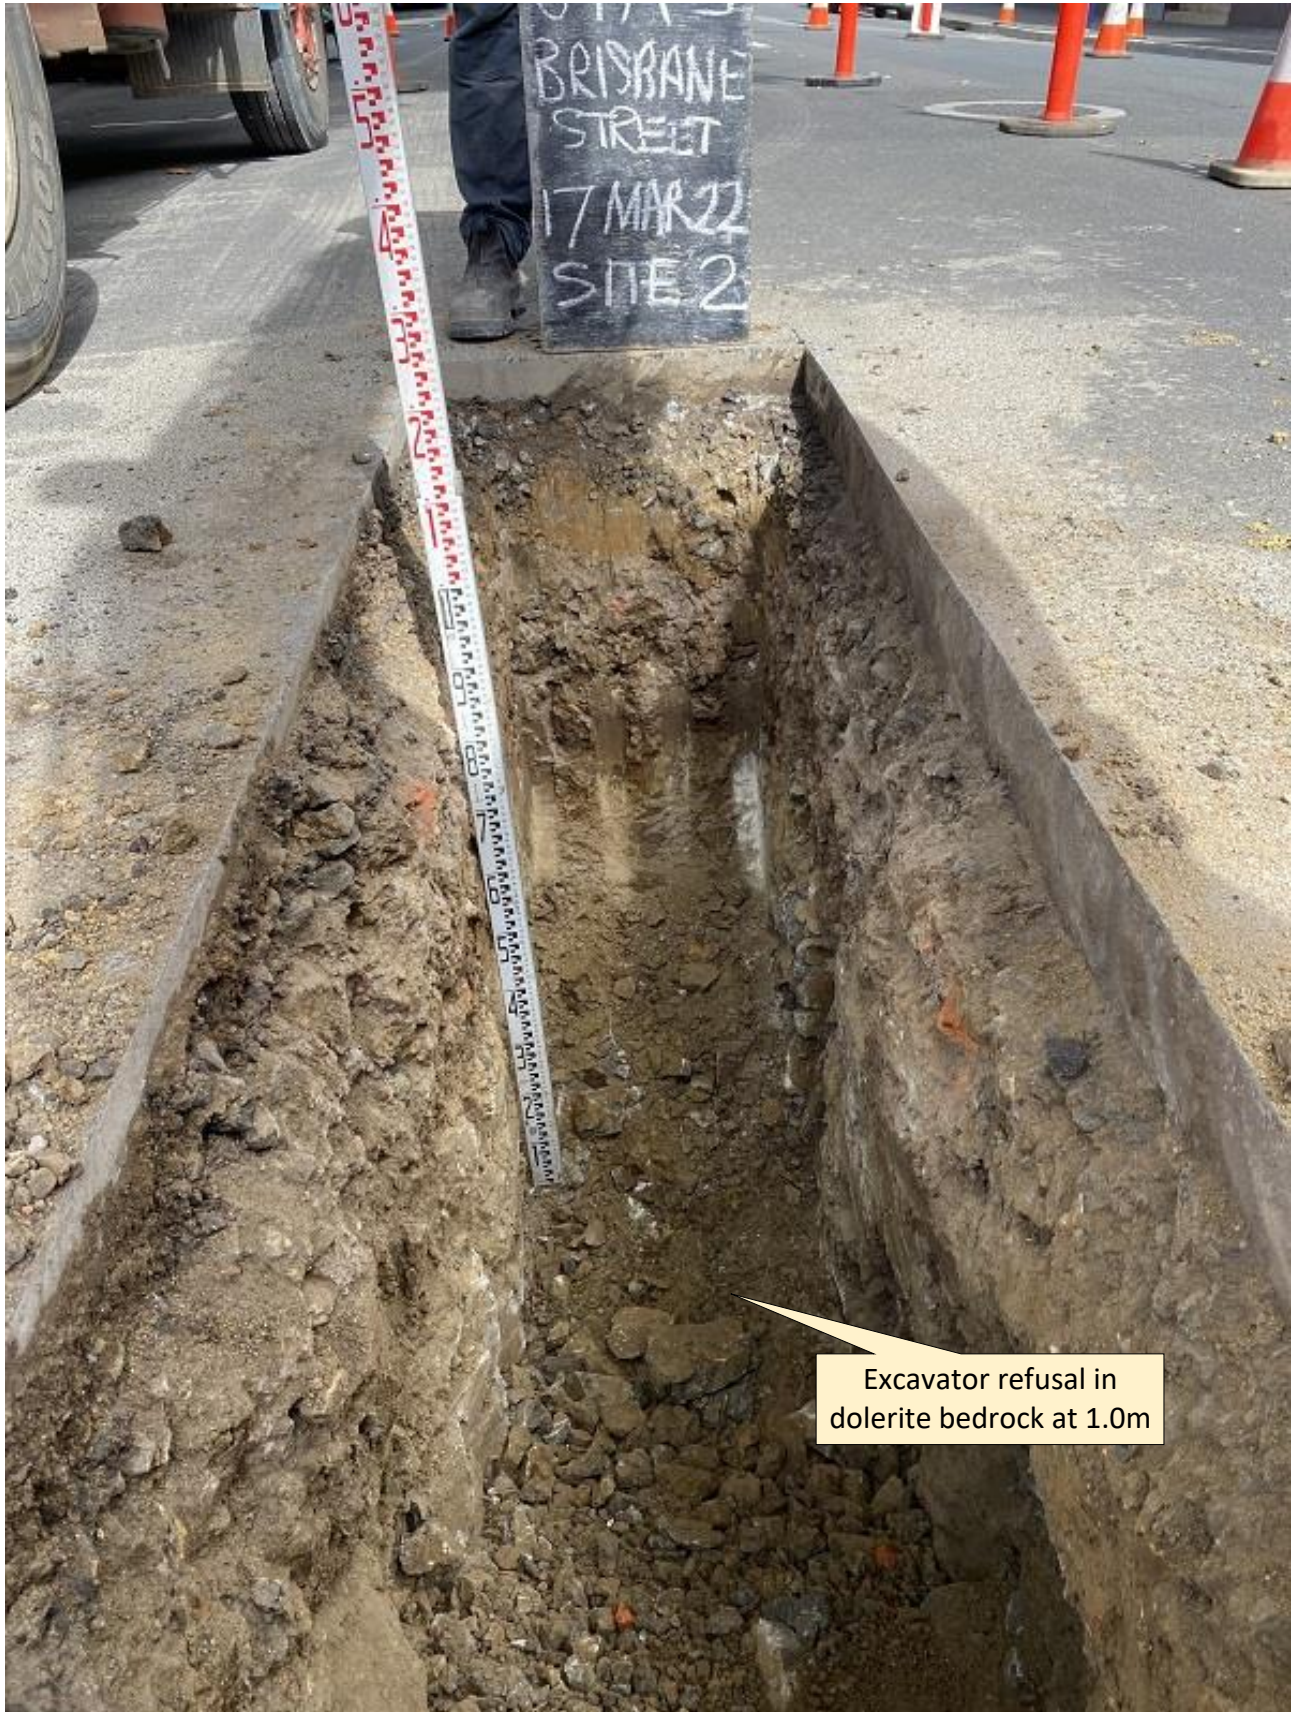
# Excavation log

Depth 1.0m Length 2.2m Width 0.6m										SOIL				ROCK																																																																																																																																																																																																																																																																																																																																																																																																																																																																																																																	
Penetration		Support	Notes Samples and tests (GHD site contamination samples)	metres	Graphic log	USCS	Materials  SOIL: Soil name, plasticity or particle characteristics, colour, secondary and minor components  ROCK: Rock name, grain size and type, colour, fabric, texture, inclusions or minor components, moisture content, durability, strength, weathering, defects	Moisture	Consistency	Density index	DCP (blows/100mm)	Shear Vane (kPa)	PID (ppm)	Weathering					Alteration				Strength			Reaction to 10% HCL	Defects (symbol)	Structure, geology, interpretation

1	2			3										RL (mAHD)	Depth	FR	SW	MW	HW	XW	RS	SA	MA	HA	XA				VL	L	M	H	VH	EH	None	Slow	Fast																																																																																																																																																																																																																																																																																																																																																																																																																																																																																										
		None	GHD(0.2m)	21.0		GW GC	Bitumen (80mm)	D	D-VD	No DCP			0.3
