PLANNING REF: PLN-22-790  
THC WORKS REF: 8058  
REGISTERED PLACE NO: 12028  
APPLICANT: University of Tasmania  
DATE: 25 January 2023

## NOTICE OF HERITAGE DECISION

Registered Place: Crisp & Gunn offices and workshop, and Forestry Tasmania dome, 79-83 Melville Street, 83 Melville Street and 80 Brisbane Street, Hobart.  
Proposed Works: New pedestrian bridge and landscaping work.

# University of Tasmania Forestry / Timber Yards Pedestrian Bridge Planning Report

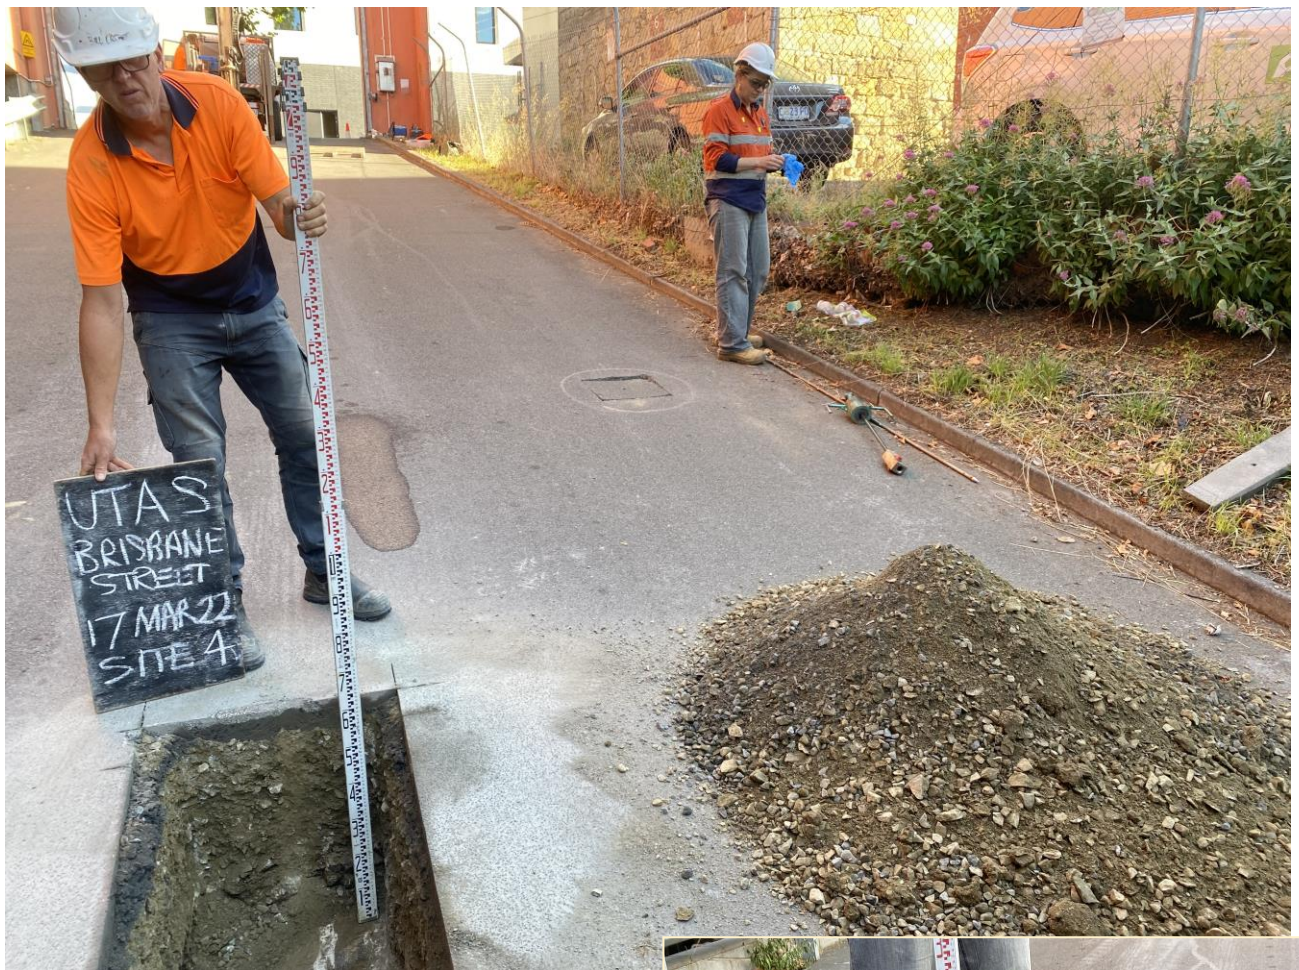
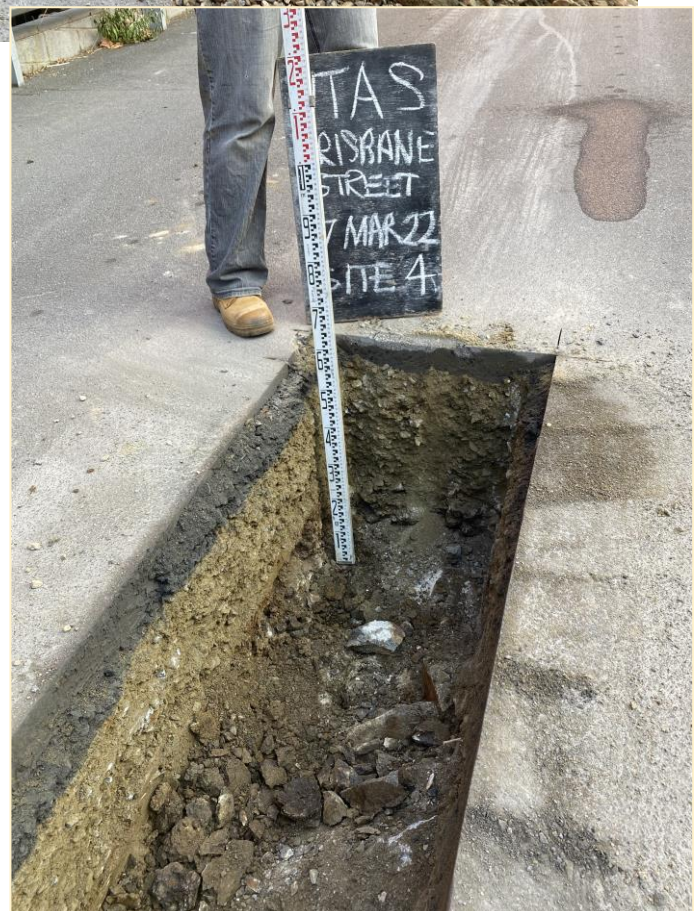
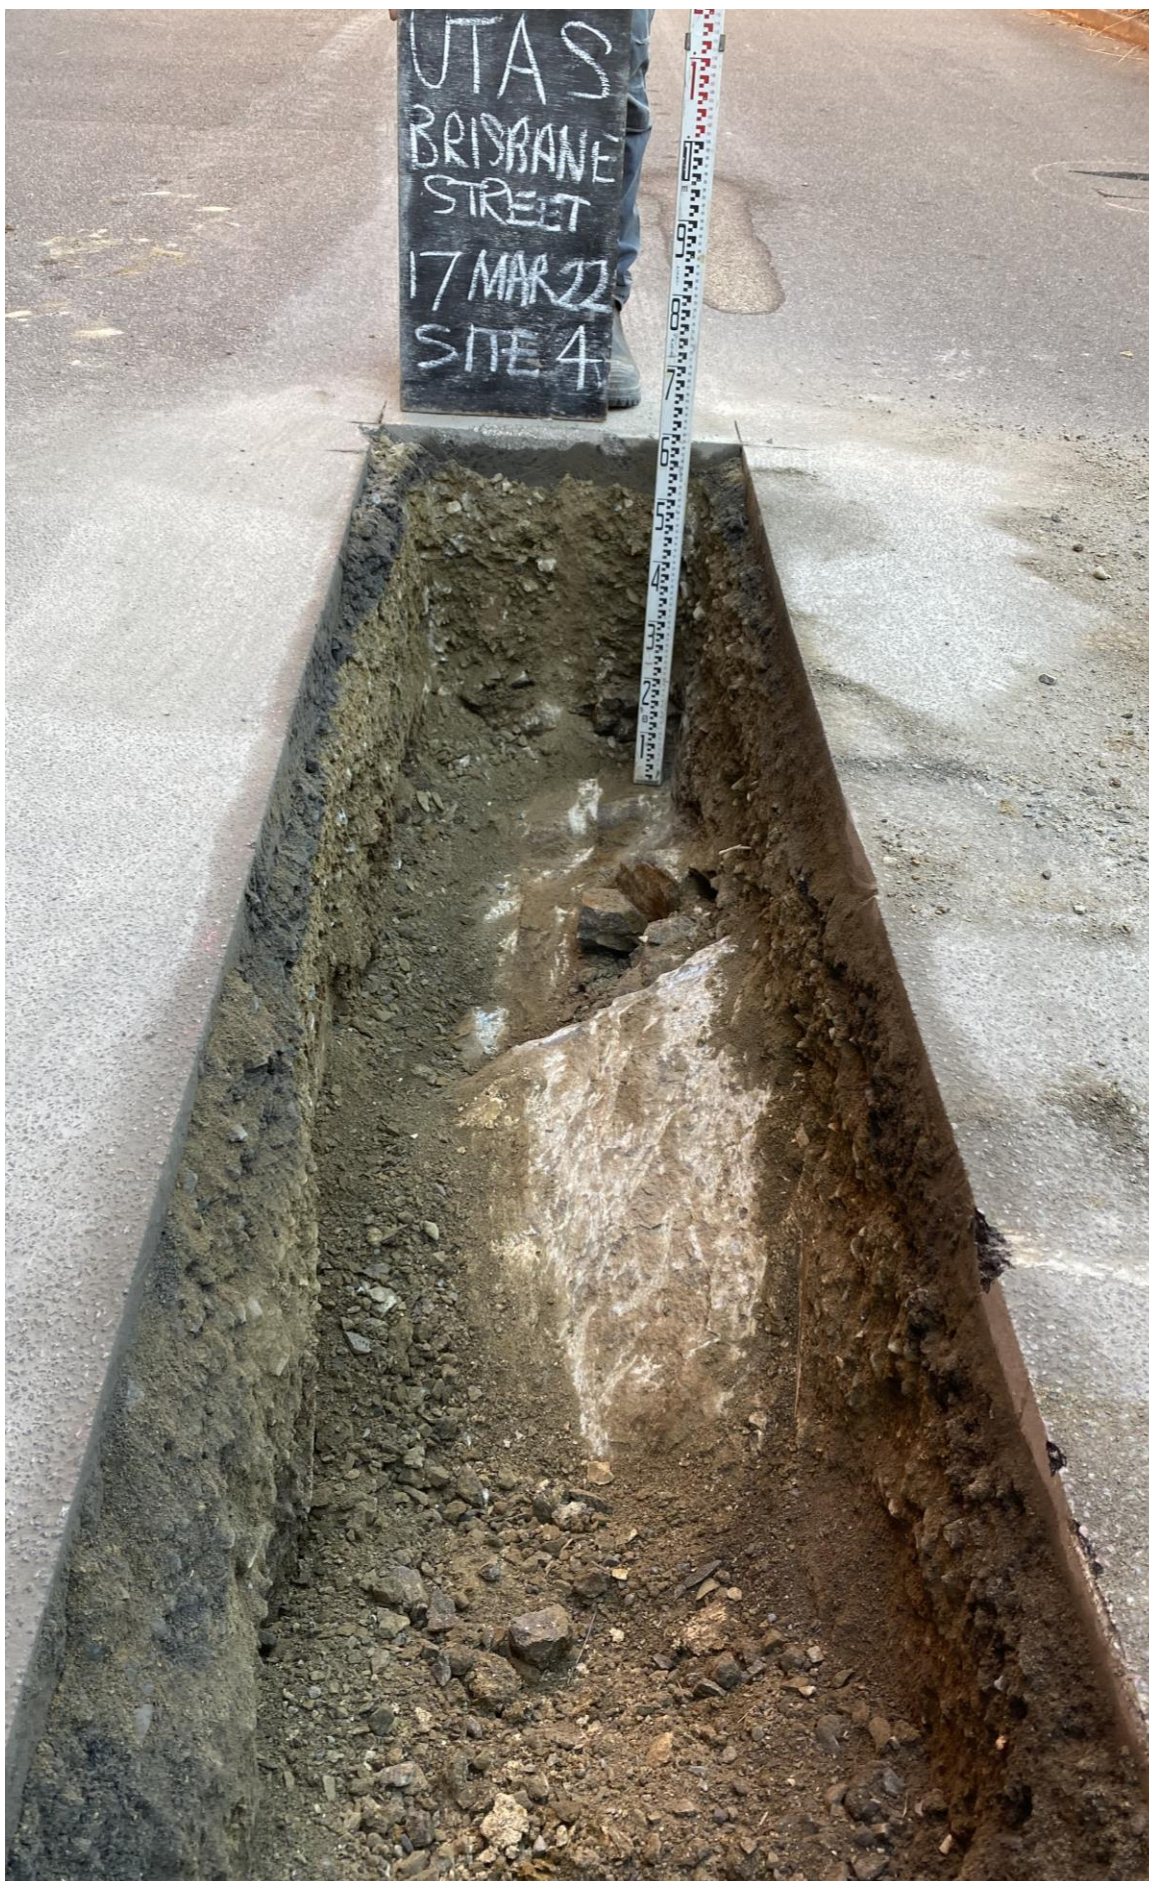
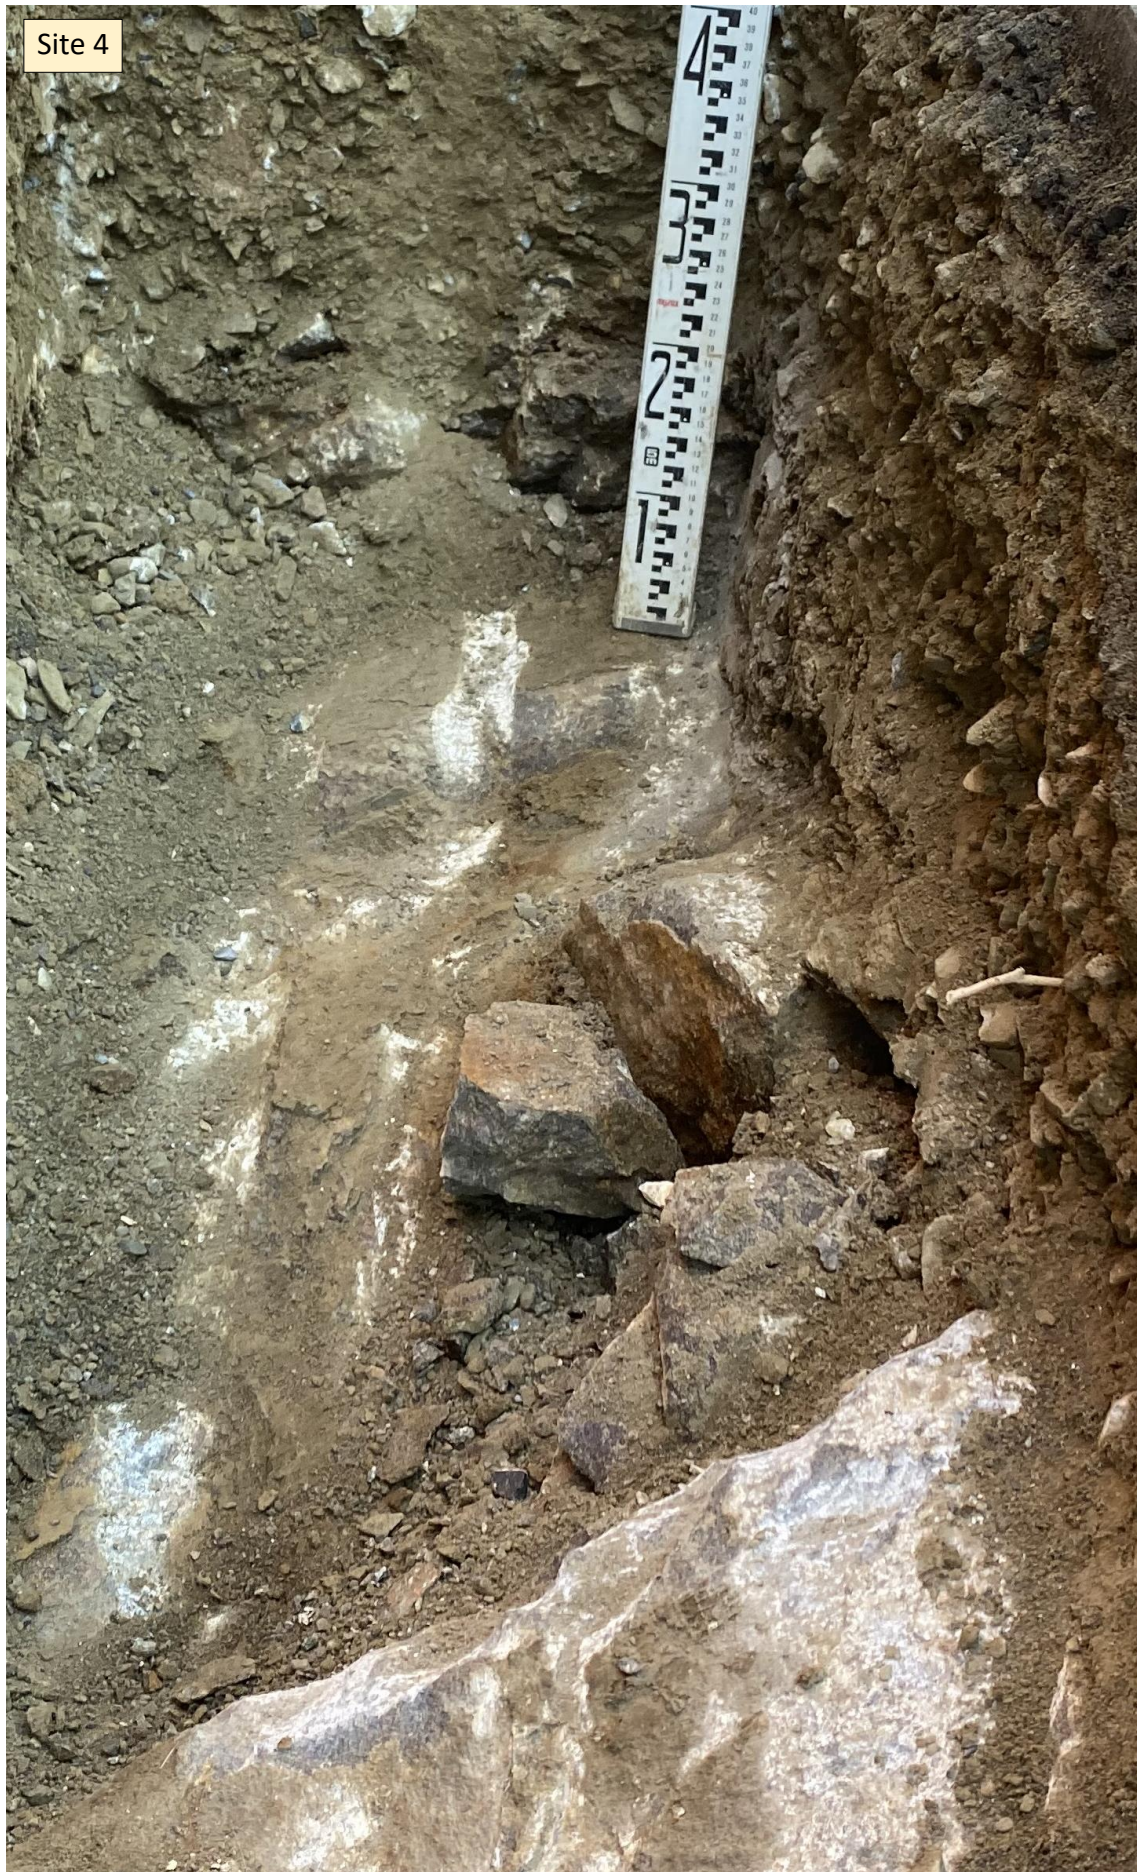
# Excavation log

Penetration						SOIL										ROCK									
Penetration		Support	Notes Samples and tests (GHD site contamination samples)	metres RL (mAHd) Depth	Graphic log	USCS	Materials SOIL: Soil name, plasticity or particle characteristics, colour, secondary and minor components ROCK: Rock name, grain size and type, colour, fabric, texture, inclusions or minor components, moisture content, durability, strength, weathering, defects	Moisture	Consistency	Density index	DCP (blows/100mm)	Shear Vane (kPa)	PID (ppm)	Weathering	Alteration	Strength	Reaction to 10% HCL	Defects (symbol)	Structure, geology, interpretation						
1	2																			3					
		None	GHD(0.1m)
