CITY OF HOBART

Planning Committee Meeting
Open Portion
Wednesday, 29 March 2023
at 5:00 pm
Council Chamber, Town Hall

| 6.1.1 220 Waterworks Road, Dynnryne - New Shared Track and Associated Works including Vegetation Rehabilitation | 7 |
| 6.1.2 171 Bathurst Street, Hobart - Partial Demolition, Alterations, and Extension | 346 |

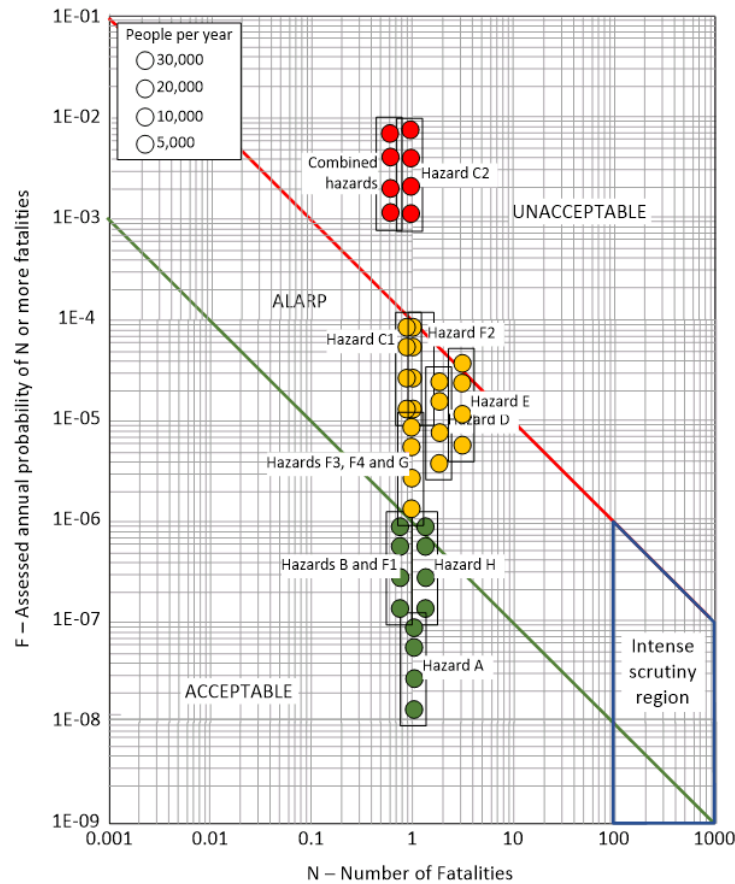
Figure 5. Societal risk graph for the new proposed track (a new development) for the F-N pairs estimated for individual mobile track users for each hazard (and the combined hazards) in Figure 3 and Table 9, for 5,000, 10,000, 20,000 and 30,000 track users per year. (N = 1 because the track users walk in single file so that only one fatality occurs. All hazards plot at N = 1 but some have been moved sideways for clarity.)

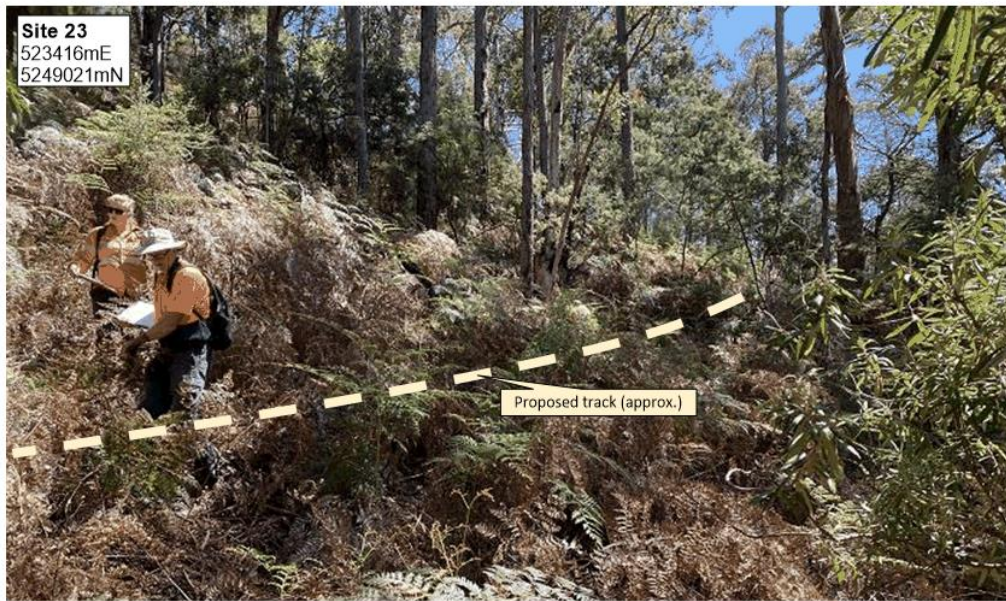
Plate 3 (above). View north across steep 30°+ slopes below the headscarp of the activity-unknown landslide depicted in Plate 4. The proposed track crosses this slope, and the slope angle presents challenges for track construction and maintenance. (There are other track sections just as steep or steeper, but Site 23 crosses a landslide and track relocation is relatively easily achieved.)

| | Hazard | Site # | GDA94 | | Description | Size, volume, velocity and run-out distance | Likelihood | | Consequences of impacts | |
|---|---|---|---|---|--|---|---|---|---|--|
| | C2 | Site 25 (Plate 4, Attach 4) | 523400 | 5249027 | Old landslide head about 20m wide. Some curves on mature tree trunks - see photos. Landslide joins up with gully below - all one feature. Main issue is reactivation of existing landslide, or development of new one on steep slopes (Plate 3, Attachment 4) in vicinity. | Small to Moderate size: 20m wide x 50m long x 1m deep; Slow to Rapid; run-out could extend to un-named creek | Possible | 0.005 | A walker faced by a slow-moderate moving landslide near this site would have sufficient time to avoid the hazard. | Crew members would be attending the failure and would be versed in safety measures. No adverse impacts expected. |

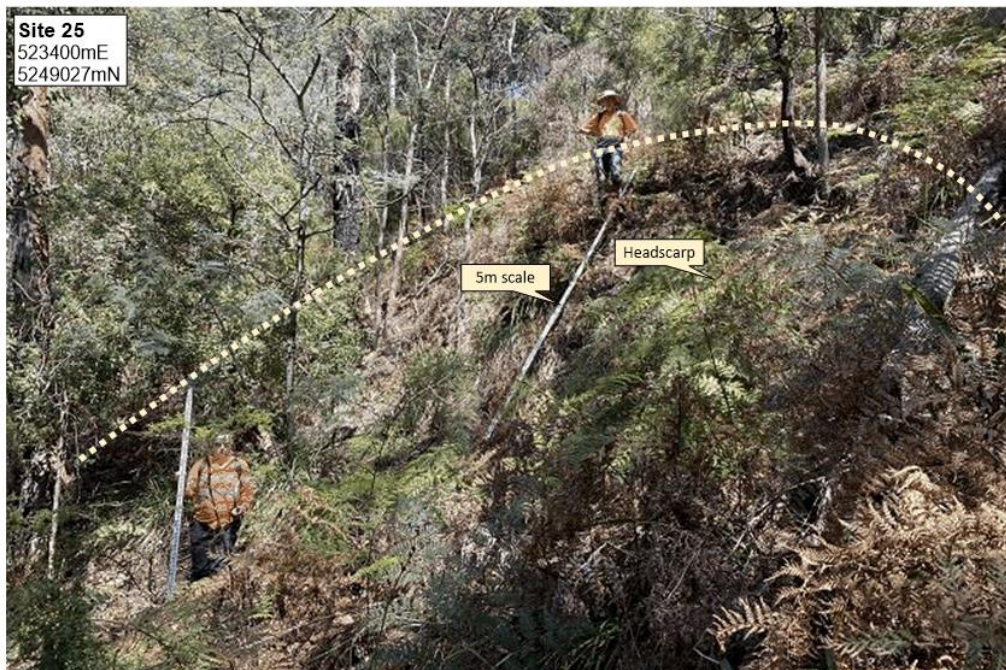
Plate 4 (below). View south across the 20m wide headscarp of the activity-unknown landslide at Site 25. The landslide extends downslope to the left, probably past the tunnel-eroded area at site 6 to the un-named creek. The proposed track crosses the landslide about 20m downslope to the left, shown in Plate 3.

creek. The second (with a headscarp near site 25; Plate 4 in Attachment 4) is a larger translational feature, also in colluvium, which has a subdued headscarp about 20m wide and which extends at least 75m downslope. It probably includes the tunnel eroded area near its toe and may reach the un-named creek.

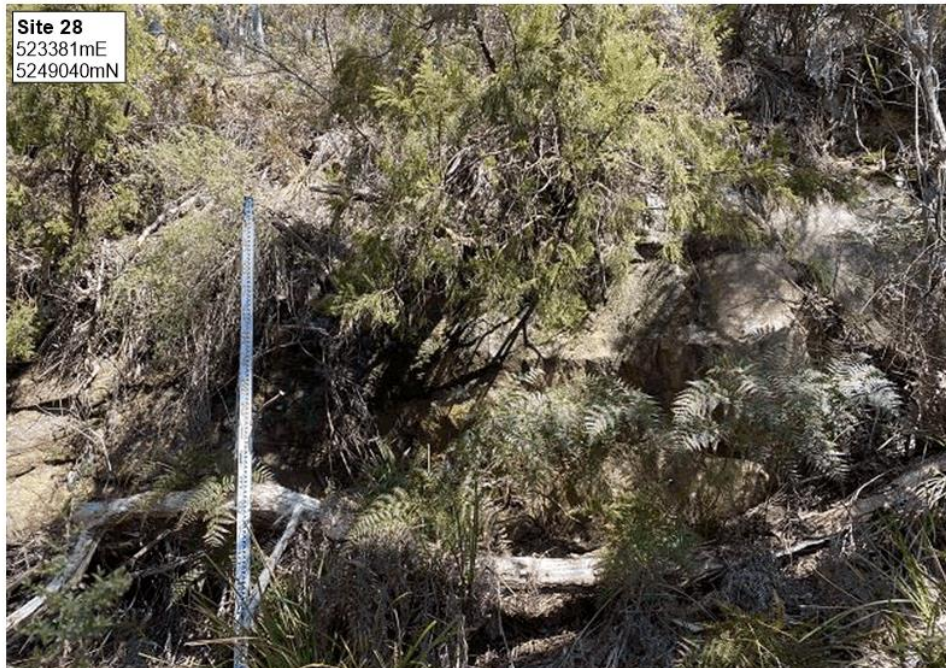
Plate 5 (above). View southeast towards a low sandstone cliff a few metres upslope from the proposed track (behind camera). Fallen sandstone blocks up to about 0.5m in size are common on the slope.

| | Hazard | Site # | GDA94 | | Description | Size, volume, velocity and run-out distance | Likelihood | | Consequences of impacts | |
|---|---|---|---|---|--|---|---|---|--|---|
| F | F1 | Site 28 (Plate 5 in Attach 4) | 523381 | 5249040 | Small sandstone cliff up to 2m high. Above Gentle Annie track and proposed new track. Some small boulders dislodged up to 0.5m diameter possibly from older track-making above. Local local outcrop? up to 1m high. | Outcrop is c. 10m long. Very small scale, rapid rockfall; probably involving individual boulders up to about 0.5m diam falling from outcrop; run-out likely restricted to 0-5m based on existing fallen boulders. | Possible | 0.001 | Boulder of these sizes with enough velocity to reach the track would impact one or perhaps two crew members in its path but may not cause death. | Boulder of these sizes with enough velocity to reach the track would impact a walker in its path but may not cause death. |

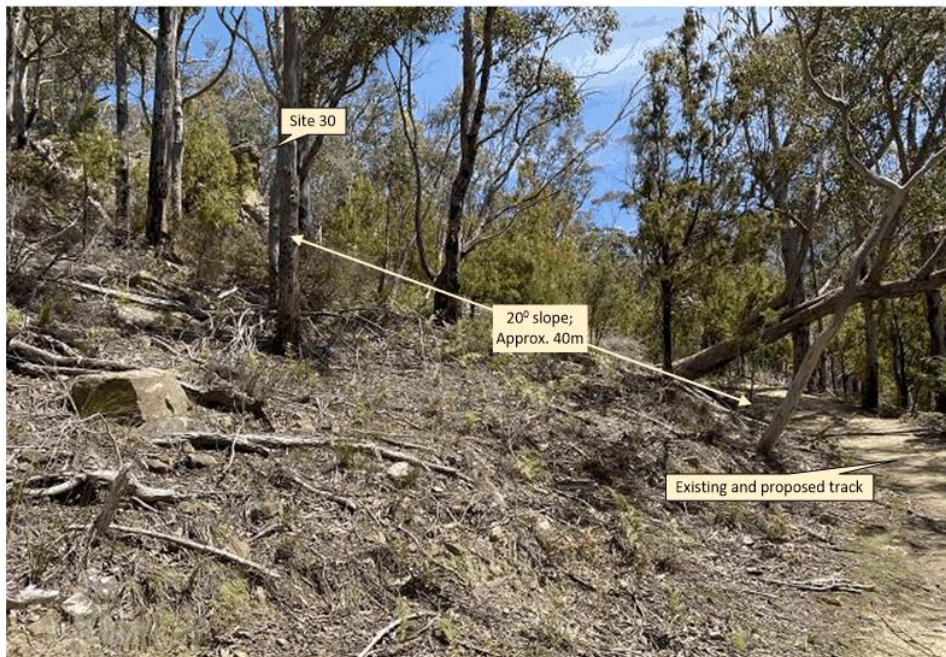
Plate 6 (below). View west along the existing track (the new track follows this route here). Site 30 at upper left is a relatively prominent 5m wide x 7m high section of low sandstone cliff. Rock fall is "Almost Certain"; boulders would fall onto a c.20° slope 40m upslope from the track.

Perhaps the most precarious potential rockfall is at site 30 (Plates 6 and 7 in Attachment 4).

| | Hazard | Site # | GDA94 | | Description | Size, volume, velocity and run-out distance | Likelihood | | Consequences of impacts | |
|---|---|---|---|---|--|---|---|---|--|---|
| | F2 | Site 30 (Plates 6 and 7 in Attach 4) | 523294 | 5249078 | Sandstone cliff section 6m high. Sandstone mid-strength, cross bedded. Dips into slope. Orthogonal joint sets 0.5 to 1m apart - some recently open. Active sloughing of joint blocks. Some joint blocks overhanging c.1m. Large tree growing out of outcrop destabilises it. High likelihood of further falls. | Outcrop is c.5m wide. Potential rockfalls of angular fragments up to 1m ³ . Outcrop is c.40m upslope from track; Fallen boulders likely to break up on impact. Unlikely to reach track. | Almost Certain | 0.1 | Boulder of these sizes with enough velocity to reach the track would impact a walker in its path but may not cause death. | Boulder of these sizes with enough velocity to reach the track would impact a walker in its path but may not cause death. |

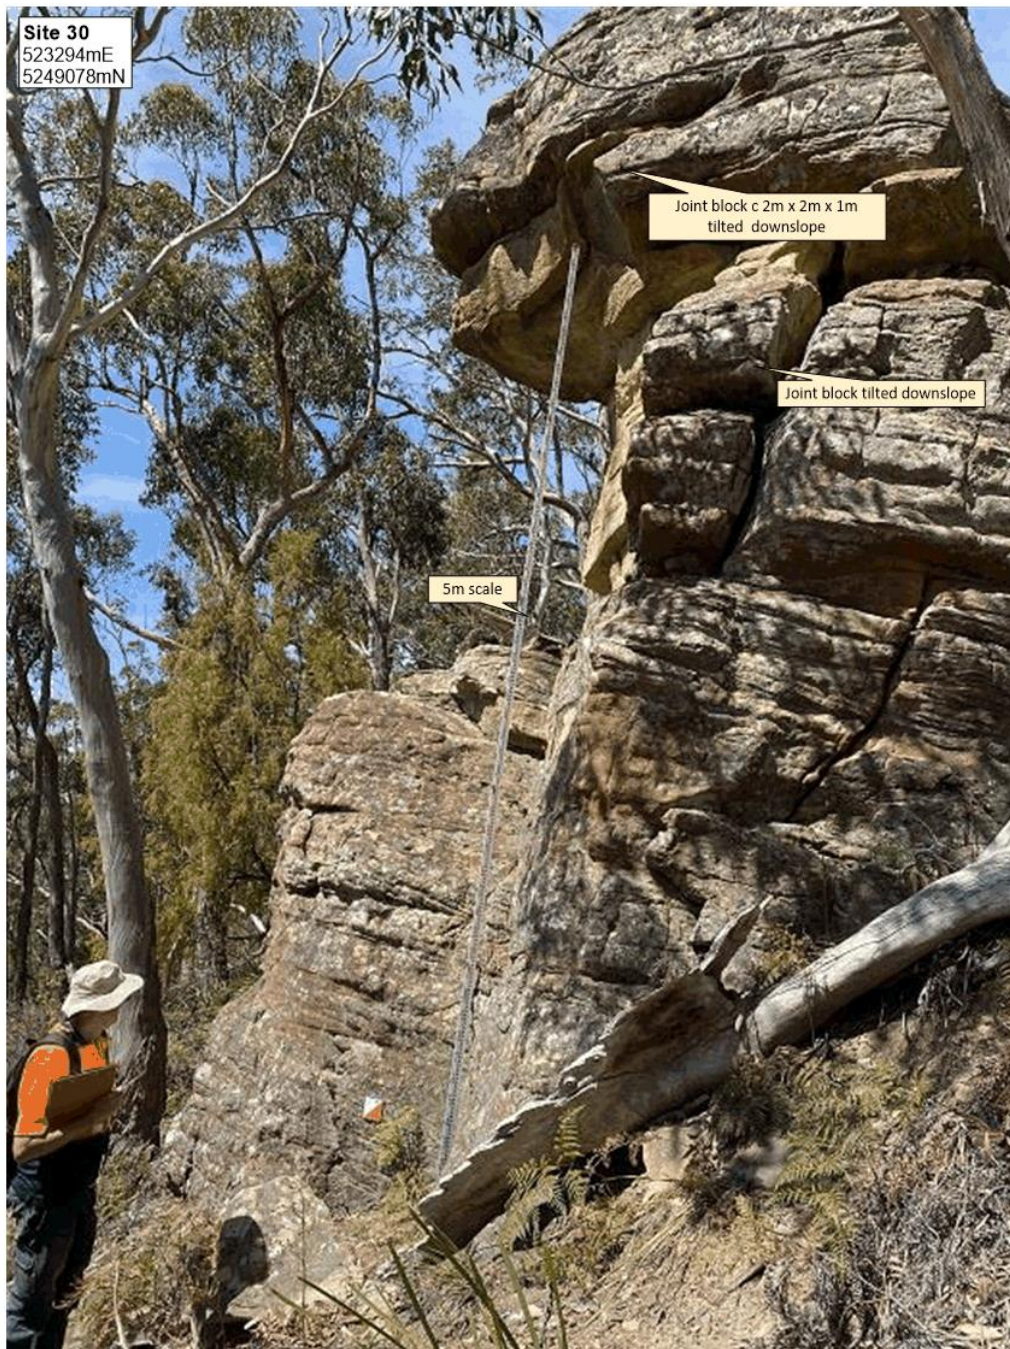
Plate 7. View east across the face of Site 30, a prominent 7m high short cliff section of cross-bedded, strongly-jointed, moderately-highly weathered Triassic sandstone bedrock dipping approx. 10° SSE. The site is about 40m upslope from the proposed track, which in this area follows the existing Pipeline Track. Some joint blocks are overhanging and rotated downslope, and there are several examples of relatively recent rockfalls (up to c.0.5m diameter) at its base and on the slope down to the track.

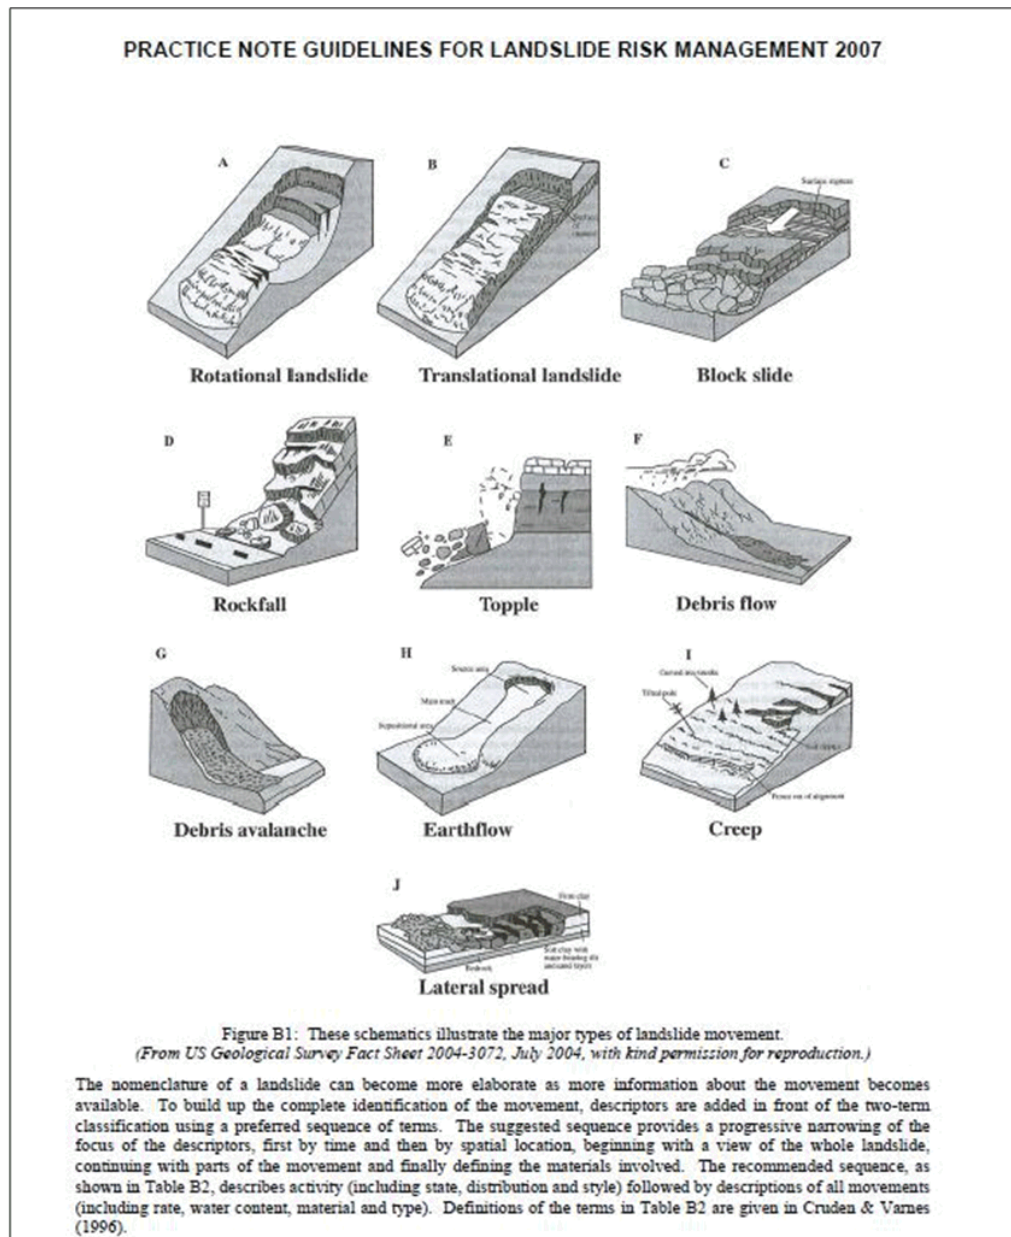
Figure 5.2

Main types of landslide movement

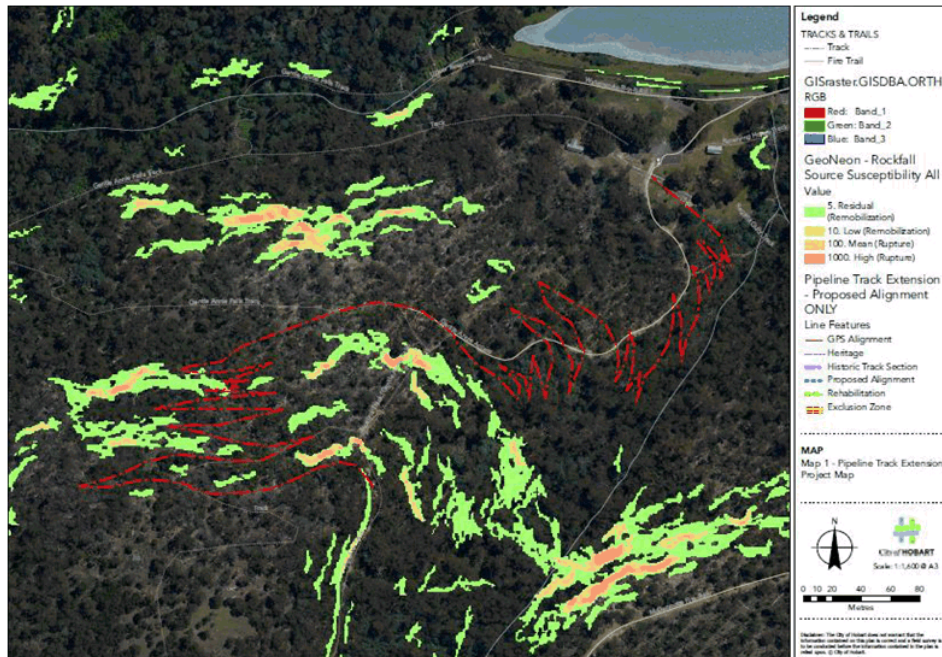
Map 1. Proposed alignment of the Gentle Annie Falls re-route (red) showing, residual rupture susceptibility areas (green).

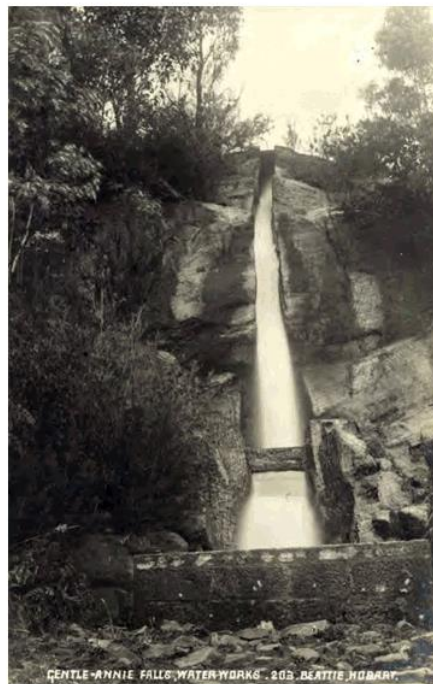
Figure 3.2: Lower section of falls and second intake basin. Beattie, Hobart

The falls was an artificial cascade comprising a cut sandstone channel directing the flow over an upper sandstone ledge into a small intake basin excavated out of the rock at the foot of the ledge. Water exited the basin into the open masonry channel flowing downslope to a second ledge where it was funnelled via a cut channel down the rock face through a sandstone grille to a second intake basin which was enlarged with sandstone blocks to create a well. From here the water was directed into an open channel that continued downslope to the Receiving House (Figure 3.1, Figure 3.2)

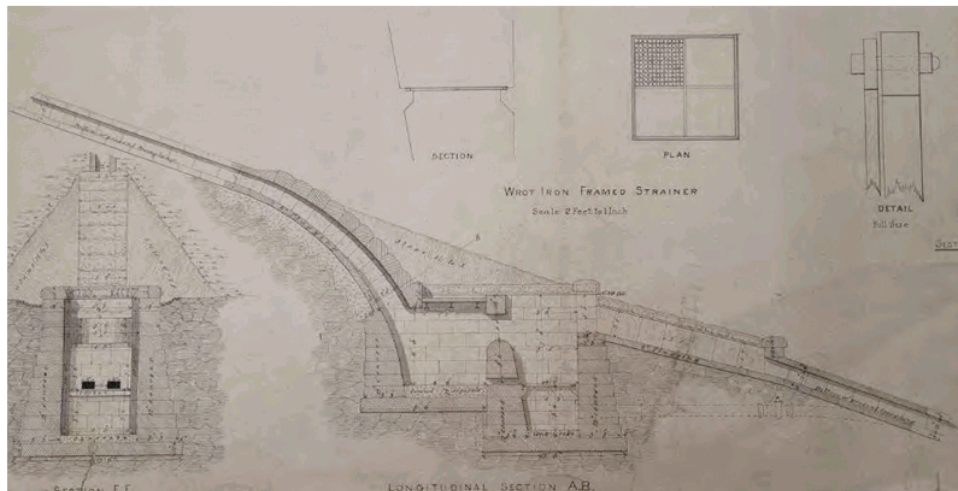
Figure 3.3: Excerpt from undated (c. 1883) plan for Pipe Head Well TMAG 18800/148 HCC -563-00

A new pipe head well was subsequently constructed in 1883 midway along the troughing below the lower intake basin. The well comprised two chambers, uphill and downhill separated by a baffle wall containing two rectangular apertures. Water flowed from the uphill well through the apertures and a metal screen into the base of the downhill well into a 10 inch cast iron pipe leading past to the Receiving House to the town main. Excess water flowed over the baffle, supplementing the water into the pipe or discharging back onto the masonry troughing where it continued to the Receiving House (Figure 3.3). A smaller 4" pipe was added feeding water directly to a fountain installed in the Upper Reservoir completed in 1888.

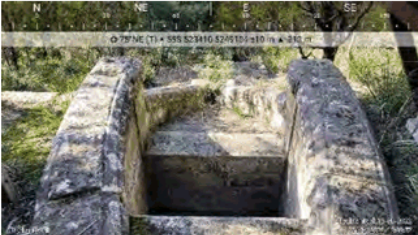
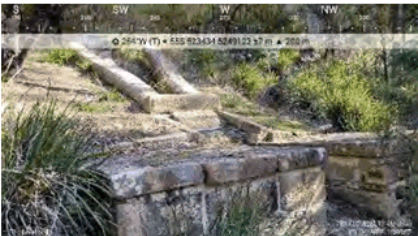
| Feature | Description | Significance | Images |
|--|--|--|---|
| Feature 2 Pipe Head Well | The Pipe Head Well is an interception device installed on the 1860s troughing in 1883 to divert water into a 10" steel pipeline bypassing the receiving House. Built from squared dress sandstone blocks with stepped and curved training walls topped with rock faced capstones with pitched margins. Low flows are directed through or over a ported baffle into a grated pit containing the outlet pipe/s. High flows formerly continued into the stone lined trough to the Receiving House for settling. The original design has been modified by the addition of raised flat-topped masonry platforms at the downstream end. Each contains an aperture which probably connect to valves for the 10" main and 4" fountain pipes below. More recent timber picket fencing and a steel viewing platform have been erected at the upslope end of the well. The viewing platform is assessed as having an intrusive impact on heritage values (Murray & Nieberler 1994: 19) | 5 - High cultural/scientific significance (Murray & Nieberler 1994) High/State (McConnell <i>et al</i> 1998) Covered by and referred to within current THR listing. | Pipe Head Well pipe intake Masonry platforms added at the downstream end of the main overflow |

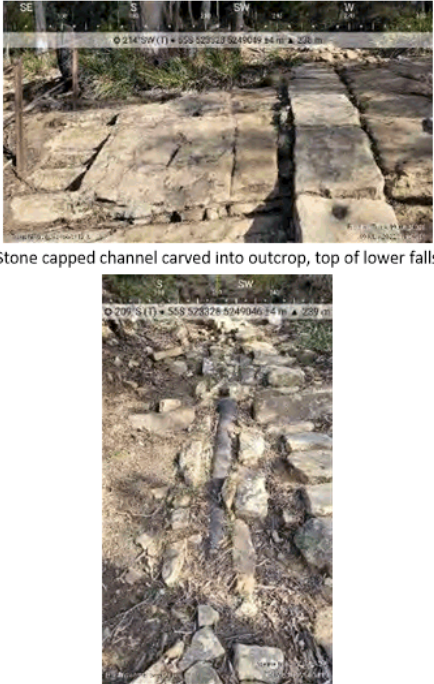
| <p>Feature 3 Sandstone troughing between the Falls and Receiving House</p> | <p>Relict stone troughing expresses between the upper falls and Pipe Head Well, although many of the caps between the upper and lower basins have been reordered to form rough stone steps for pedestrian access. The troughing between the Pipe Head Well and Receiving House is largely indistinct and appears to have been broken up, but the alignment can be followed along a 3m wide x 0.5m high inclined earth ramp that formerly connected the lower basin and Receiving House and has been recently fenced off and rehabilitated.</p> | <p>5 - High cultural/scientific significance (Murray & Nieberler 1994) High/State (McConnell <i>et al</i> 1998) Covered by and referred to within current THR listing. t.</p> | <p>Stone capped channel carved into outcrop, top of lower falls</p> <p>Stone troughing with later 10" main between upper and Lower falls</p> |

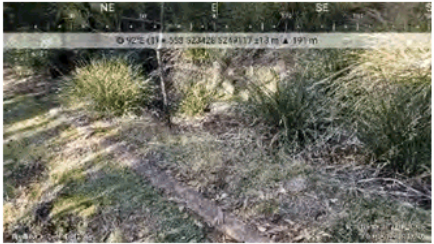
| <p>Feature 4 Cast iron pipes between Gentle Annie Falls and Receiving House</p> | <p>10" cast iron water mains have been installed variously within and beside the original stone troughing between the upper basin and Receiving House. At least one 9' section of iron main below the upper basin has been replaced with shorter-length concrete pipes, and much of the remaining iron piping to the lower falls appears to run within the stone troughing. From the lower falls to the Pipe Head Well the steel pipeline runs along the south side of the inclined formation beside the former trough, re-entering it near the well-head. Below the Pipe Head Well the 10" water main is periodically exposed in a ditch running along the south side of the inclined formation, while the 10" overflow pipe runs down the centre of the incline and appears to</p> | <p>2 - Slight heritage value (Murray & Nieberler 1994) High/State (McConnell <i>et al</i> 1998) Covered by and referred to within current THR listing. Potentially eligible under HCHA inclusion factors A4, C5 in their own right</p> | |

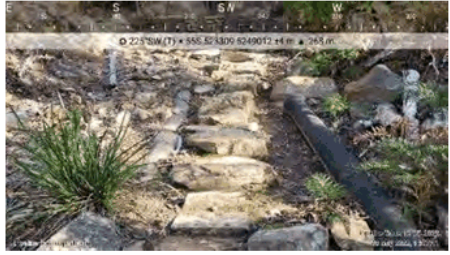
| | overprint the troughing, broken fragments of which have been dumped along the side of the incline. | | <p>Overflow pipe (centre of image) and water main (exposed in ditch along right hand side).</p> <p>Concrete pipes and displaced section of 10" main below upper basin</p> |

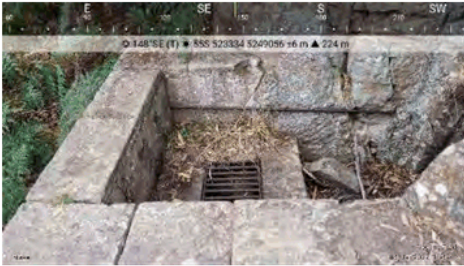
| Feature 6 Lower catchment basin | <p>Comprises a slot cut in the base of the sandstone outcrop at the base of the water channel, 1.5m maximum width tapering to 0.55m at the channel and 3.2m from front to back. The north edge of the cut is framed with two courses of dressed sandstone blocks, 0.83m high and 2.42m external width, forming a well collar. The north face is of the collar is braced by a horizontal flat bar pinned into the sandstone outcrop. At the base of the well is a 1.5m x 1.3m intake structure comprising a baffled chamber fed by a 500mm x 25mm slot in the southern side with a 600mm x 500mm grated aperture in the top for overflow.</p> <p>There is a simple trashrack consisting of two horizontal sandstone bars mortared into slots on a ledge spanning the water channel approximately 2m above the basin.</p> | <p>5 - High cultural/scientific significance (Murray & Nieberler 1994)</p> <p>High/State (McConnell <i>et al</i> 1998)</p> <p>Covered by and referred to within current THR listing.</p> | <p style="text-align: center;">Lower catchment basin and intake</p> |

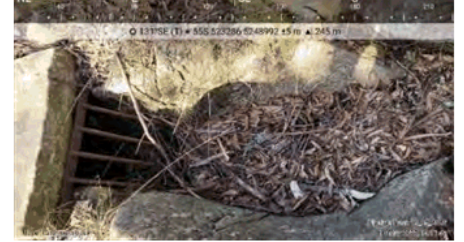
| Feature 7 Upper catchment basin | <p>The upper basin comprises a section of the lower water channel that has been widened 1.5m from the back of the cut into an oval-shaped bowl 95cm wide x 90cm deep diverting water into a section of stone-lined trough 45cm wide x 60cm deep. A 20" C. welded steel grate has been fitted to the intake. A 10" concrete pipe has been laid in the trough 1.2m from the intake and continuing beneath a low drystone wall and continuing downhill towards the lower falls (Refer Feature 4).</p> | <p>5 - High cultural/scientific significance (Murray & Nieberler 1994)</p> <p>High/State (McConnell <i>et al</i> 1998)</p> <p>Covered by and referred to within current THR listing.</p> | <p style="text-align: center;">Upper catchment basin and pipe intake</p> |

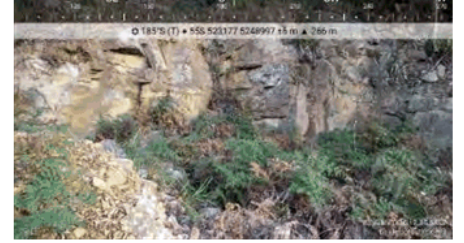
| Feature 8B (Q2) | <p>Moderate sized quarry 12m wide x 10m deep with 4m maximum face height. The uppermost units comprise laminated sandstone and with lowermost 1.5m being more massively bedded. The main face has a saw-toothed profile reflecting the two main joint sets (210-230 @ 78° dip to southeast and 130-140 @ 75-80° dip to east). No drill holes were observed and it appears that the face has primarily been worked by leveraging the joints. There is a narrow (2-4m wide) working floor backed by mounds of stacked rubble which are bounded on the north side by the access track which widens to form a turning area. A large spoil heap extends for 12m downslope below the track.</p> | <p>5 - High cultural/scientific significance (Murray & Nieberler 1994)</p> <p>High/State (McConnell <i>et al</i> 1998)</p> <p>The Gentle Annie Falls quarries contribute to the State-level significance of the mountain water supply system. Outside current THR listed area but potentially eligible for THR listing under C5.</p> | <p style="text-align: center;">View south to jointed main face</p> |

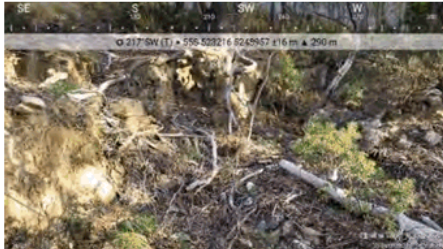
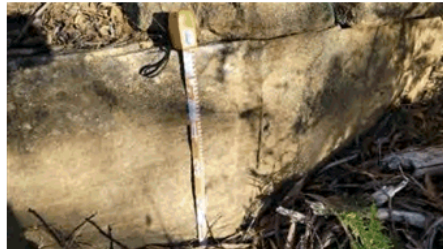
| Feature 8C (Q3) | <p>Elongate pit 12m long x 4m wide x 3m maximum height, the topmost 1m being regolith. The exposed stone features 30-40cm bed joints with subordinate vertical jointing resulting in irregular blocks that are suitable for caps and bases but not cheek stones. A large spoil spur extends downslope on the north side, that would account for most of the excavated volume, indicating low production</p> <p>A separate 1m high ledge of sandstone is situated above the pit extending towards Q3 and bearing evidence of hand drilling.</p> | <p>5 - High cultural/scientific significance (Murray & Nieberler 1994)</p> <p>High/State (McConnell <i>et al</i> 1998)</p> <p>The Gentle Annie Falls quarries contribute to the State-level significance of the mountain water supply system. Outside current THR listed area but potentially eligible for THR listing under C5.</p> | <p>View southwest from mouth of pit to rear</p> <p>Drill hole in sandstone ledge between Q3 and Q4</p> |

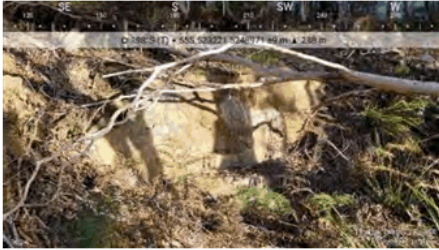
| Feature 8D (Q4) | <p>Small pit excavated into hill face, 5m wide at mouth, 3.5m deep with 2.5m high back wall comprising 1.5m high ledge and 1m overburden. Spoil extends along both side of the pit and downslope to the track to Q2. A small amount of production is indicated.</p> | <p>5 - High cultural/scientific significance (Murray & Nieberler 1994) High/State (McConnell <i>et al</i> 1998) The Gentle Annie Falls quarries contribute to the State-level significance of the mountain water supply system. Outside current THR listed area but potentially eligible for THR listing under C5.</p> | <p>View southwest from mouth of pit to ledge</p> |

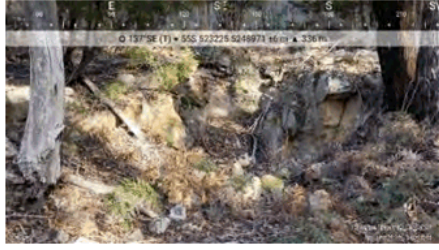
| Feature 8E (Q5) | <p>Small test pit on a low sandstone outcrop on the top side of the track to Q2. The topmost 1m of overburden is heavily weathered/rotted with the lower 1.5m of harder stone being heavily jointed and breaking into small irregular blocks. Unsuitable for dimension stone. The small working measures 3.3m wide at the mouth x 5m deep with a maximum face height of 2.5m. Spoil extends around both sides and downslope of the pit. No evidence of production</p> | <p>5 – High cultural/scientific significance (Murray & Nieberler 1994) High/State (McConnell <i>et al</i> 1998) The Gentle Annie Falls quarries contribute to the State-level significance of the mountain water supply system. Outside current THR listed area but potentially eligible for THR listing under C5.</p> | <p>View south from mouth to rear of pit</p> |

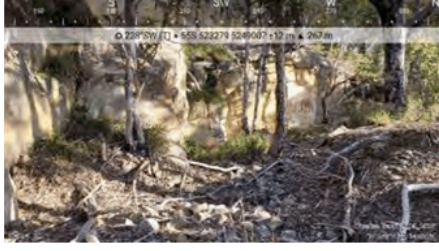
| Feature 8F (Q6) | <p>Large quarry with near vertical faces up to 7m high on a saw-tooth configuration reflecting sub-vertical primary jointing. Fairly massive stone with little discernible bedding structure. Has been worked by blasting and splitting debris on quarry floor. The working floor is up to 6m wide littered with irregular blocky debris and bordered by a large spoil heap that extends c. 20m down the hill face. Several drill holes are visible in the faces and occasionally seen on floor debris. There is relict graffiti in tar-based black paint and brown paint at the east and west sides of the workings.</p> | <p>5 - High cultural/scientific significance (Murray & Nieberler 1994) High/State (McConnell <i>et al</i> 1998) The Gentle Annie Falls quarries contribute to the State-level significance of the mountain water supply system. Partly contained within current THR listed area with area outside eligible for THR listing under C5.</p> | <p>View west from mouth of quarry</p> |

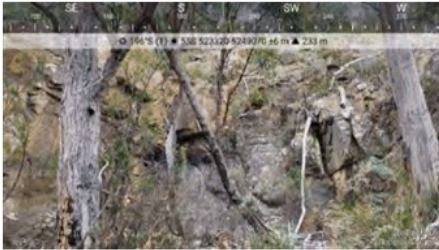
| Feature 8J (Q10) | <p>Sandstone quarry situated immediately west of the lower catchment basin. The pit is 10m wide x 12m deep x 8m high with relatively vertical faces. Two drill holes were recorded in 1988. A large spoil heap extends 15m downslope and a 2m wide benched access track runs below the toe of the spoil heap to connect with Quarry 8H.</p> | <p>5 - High cultural/scientific significance (Murray & Nieberler 1994) High/State (McConnell <i>et al</i> 1998) The Gentle Annie Falls quarries contribute to the State-level significance of the mountain water supply system. Contained within current THR listed area.</p> | <p>Working face from spoil heap</p> |

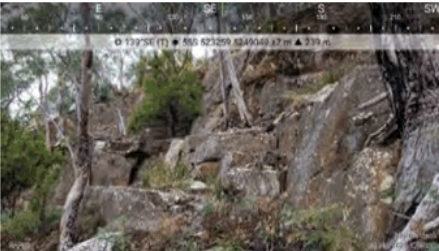
| Feature 8K (Q11) | <p>Irregular worked sandstone outcrop, 24m long x 10m x c. 4m high. Principally worked on two levels with opportunistic removals on a third. Contains evidence of working by wedging bed joints within more massive sandstone units. A steel wedge was found on the spoil heap at the east corner of the working. A large spoil heap measuring 30m east-west x 10m north-south extends downslope.</p> | <p>5 - High cultural/scientific significance (Murray & Nieberler 1994) High/State (McConnell <i>et al</i> 1998) The Gentle Annie Falls quarries contribute to the State-level significance of the mountain water supply system. Outside current THR listed area but potentially eligible for THR listing under C4, C5.</p> | <p>Irregular face with blocks split from three levels.</p> |

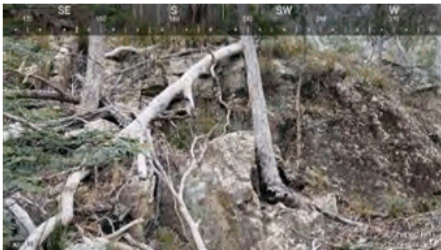
| Feature 8M (Q13) | Small working approximately 4m wide x 3m deep x 2.5m high on north face of natural sandstone outcrop, accessed via a 3m benched track. The irregular working face is defined by horizontal and sub-vertical jointing resulting in a stepped appearance. One drill hole is visible. Spoil extends for 6m downslope of the working. | <p>5 - High cultural/scientific significance (Murray & Nieberler 1994)</p> <p>High/State (McConnell <i>et al</i> 1998)</p> <p>The Gentle Annie Falls quarries contribute to the State-level significance of the mountain water supply system. Outside current THR listed area but potentially eligible for THR listing under C4, C5.</p> | <p>View south from track to worked face</p> |

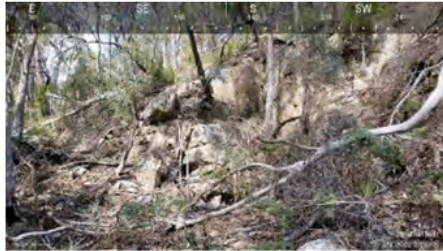
| Feature 8N (Q14) | <p>Small working approximately 9m wide x max. 6m deep x 3m high on north face of natural sandstone outcrop, above and accessed via a 3m benched track. The irregular working face is defined by horizontal and sub-vertical jointing. Spoil extends for 5m downslope to the access track.</p> | <p>5 - High cultural/scientific significance (Murray & Nieberler 1994) High/State (McConnell <i>et al</i> 1998) The Gentle Annie Falls quarries contribute to the State-level significance of the mountain water supply system. Mostly outside current THR listed area and HIPS Heritage Place but potentially eligible for THR listing under C4, C5.</p> | <p>View southeast to main worked face</p> |

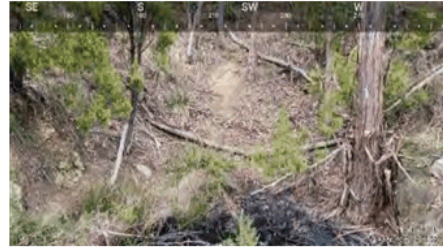
| Feature 8O (Q15) | <p>Elongate pit 20m long x <10m wide and <3m high sunk into the moderately sloping hill face with no surface outcrop. The southeast and southwest sidewalls slope in exposing heavily weathered stone in the lower portion. Hard-rock working is evident on an 8m face in the northwest corner. The pit is accessed by a narrow channel/drain at the southeast corner. An overburden dump runs around the north-west side of the pit while the main spoil heap extends for 18m on the northeast side.</p> | <p>5 - High cultural/scientific significance (Murray & Nieberler 1994) High/State (McConnell <i>et al</i> 1998) The Gentle Annie Falls quarries contribute to the State-level significance of the mountain water supply system. Contained within current THR listed area.</p> | <p>View south from northwest corner</p> |

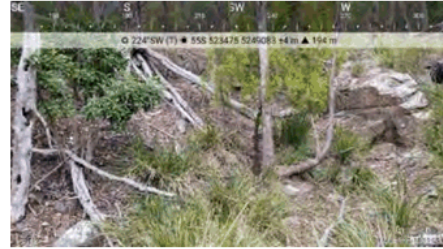
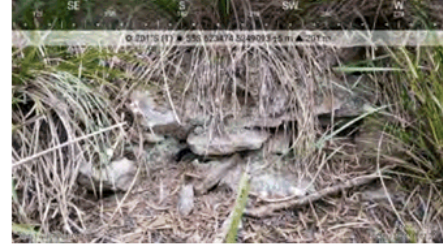
| Feature | Description | Significance | Images |
|---|---|--|--|
| Feature 8S (Q16) | Small excavation 10m wide x 9m deep with 2m high rear face, situated immediately north of the intersection between the Pipe Head Well track and fire trail. The hard rock working is small and mainly confined to the north side, much of the removal appears to be overburden/waste rock. Spoil heaps curve around the north and south side of the pit, with evidence of dry stacking (Welsh walling) in the northern heap. There is no evidence of a formal track access track and the pit may have only been a test pit with little actual production. | Not previously assessed. Contains evidence of contemporary spoil management techniques including Welsh walling. McConnell <i>et al</i> (1998) consider that the Gentle Annie Falls quarries contribute to the State-level significance of the mountain water supply system. Outside current THR listed area but potentially eligible for THR listing under HCHA inclusion factors C4, C5. | <p style="text-align: center;">View west from mouth of pit</p> <p style="text-align: center;">Dry-stacked rubble in north spoil heap</p> |

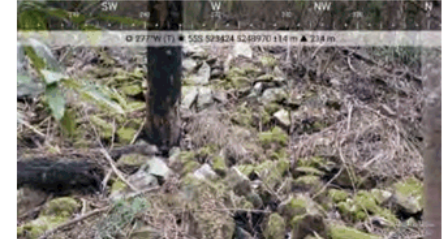
| Feature | Description | Significance | Images |
|---|---|--|--|
| Feature 8T (Q17) | Small sandstone quarry and test pit. The larger, northern, pit measures 17m long x 8m wide with faces up to 6m high, cut into the west side of the gully, approximately 100m south of the falls pipeline. Spoil spurs extend from the north and south ends either side of a lower central access area. The remains of a 3m wide benched access track can be traced for 50m from the northern spoil heap. A small excavation with separate spoil heap is situated c. 15m south of the main working. | Not previously assessed. Contains evidence of contemporary spoil management techniques. McConnell <i>et al</i> (1998) consider that the Gentle Annie Falls quarries contribute to the State-level significance of the mountain water supply system. Outside current THR listed area but potentially eligible for THR listing under HCHA inclusion factors C4, C5. | <p style="text-align: center;">Main working southern spoil heap</p> |

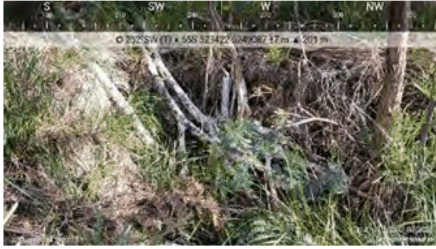
| Feature 8U (Q18) | <p>Small rectangular pit measuring 3.7m long x 2.7m wide x 1.5m deep 4m above the track leading from the fire trail to the Pipe Head Well. Likely test pit.</p> | <p>Not previously assessed.</p> <p>Likely expedient prospecting feature with low intrinsic value but some contributory significance.</p> <p>McConnell <i>et al</i> (1998) consider that the Gentle Annie Falls quarries contribute to the State-level significance of the mountain water supply system. Contained within current THR listed area.</p> | <p>Small pit beside Pipe Head Well access track</p> |

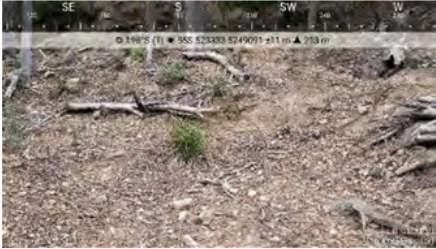
| Feature 8V (Q19) | <p>Small borrow pit 5m x 5, with <1m high face beside the main fire trail. A rough stone-edged shortcut track runs from the Gentle Annie Falls Track between quarry 8J and the borrow pit leading to the lower intake basin. Likely associated with fire train construction/maintenance.</p> | <p>Not previously assessed.</p> <p>Expedient feature likely associated with Fire Trail maintenance. Contained within THR listed area but unlikely to meet thresholds for State or Local listing based on HCHA exclusion factors XA1, XA2, XD3 and XD4.</p> | <p>Borrow pit beside fire trail below 8J</p> |

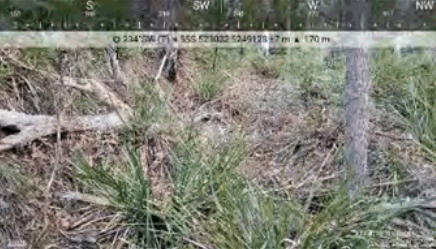
| RPH2 | <p>Benched track 3-4m wide with topside cutting up to 1m high running 45-60m upslope of Sandy Bay Rivulet. Traced for 500m from the west end of Upper Reservoir, the easternmost 300m has been overprinted and upgraded as part of the Falls Track. The original formation continues west of the point where the Falls Track turns southeast upslope and as a short (c. 20m) section between the Lower Track (RPH15) and new Falls Track section.</p> | <p>High/State (McConnell <i>et al</i> 1998, Vol 1: Table 2A)</p> <p>Outside current THR listed area but eligible (as Old Huon Road) for THR listing under HCHA inclusion factors A2 and D3.</p> | <p>View southwest along track west of Falls Track junction.</p> |

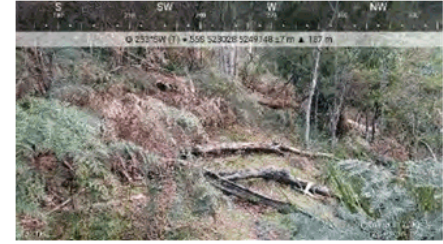
| RPH15 | 2.5m wide benched track taking off from RPH2 c. 365m west of Upper Reservoir. Function unknown, but McConnell <i>et al</i> (1998) suggest it may be part of the Old Huon Road. This alignment was not followed beyond the current study area but can be traced using LiDAR imagery for c. 200m southwest of the northern junction and c. 250m northeast of the southern junction near the Limekiln Track. There are suggestions that another branch may cross over Sandy Bay Rivulet to join a series of contour tracks on the north side of the rivulet running parallel to Turnip Fields Road. As such the northern segment of RP15 may have been a short cut between the original Huon Road and the Turnip Fields area. | Assessed in 1998 as High/State (McConnell <i>et al</i> 1998, Vol 1: Table 2A) on the basis of it being a possible early or late alignment of Old Huon Road. If only a local track it is unlikely to meet thresholds for State or Local listing based on HCHA exlusion factors XA1, XA2, XD3 and XD4 | View southwest along track west of Falls Track junction. |

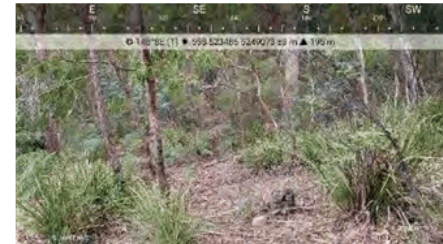
| Track 1 | Lower 3m wide benched track that takes off from Track 2 on the east side of Regans Gully to cross the creek and turn north upslope towards the east end of the Pipe Head Well Track (Track 12). Likely associated with the east gully quarries (not assessed) and possibly a lower switch/shortcut for communicating with the Pipe Head Well. | Not previously assessed. Outside the THR and HIPS Heritage Place boundaries. Has potential contributory significance relating to the construction and maintenance of the mountainwater supply system, but without further research is unlikely to meet thresholds for State or Local listing based on HCHA exlusion factors XA1, XA2, XC1, XD3 and XD4. | View south along Track 1, west side Regans Gully. |

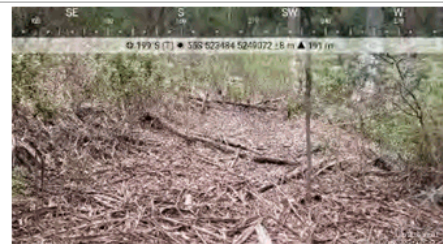
| Track 2 | 4m wide contour track running c. 15m east of Regans Gully. Likely associated with the east gully quarries (not assessed and possibly connected to Track 5 on the west bank although a creek crossing was not able to be detected. Possibly a longer and less steep route between the east gully quarries and Pipe Head Well. | Not previously assessed. Outside the THR and HIPS Heritage Place boundaries. Has potential contributory significance relating to the construction and maintenance of the mountainwater supply system, but without further research is unlikely to meet thresholds for State or Local listing based on HCHA exlusion factors XA1, XA2, XC1, XD3 and XD4. | View south along Track 2, east side Regans Gully. |

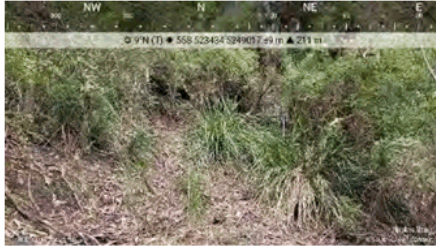
| Track 3 | Short section of benched track, 4m wide and c. 60m long, upslope of and parallel to Track 2. The east and west continuations were not traced. Likely associated with the east gully quarries (not assessed). | <p>Not previously assessed.</p> <p>Outside the THR and HIPS Heritage Place boundaries. Has potential contributory significance relating to the construction and maintenance of the mountainwater supply system, but without further research is unlikely to meet thresholds for State or Local listing based on HCHA exlusion factors XA1, XA2, XC1, XD3 and XD4.</p> | <p>View south along Track 3 (image compass incorrect)</p> |

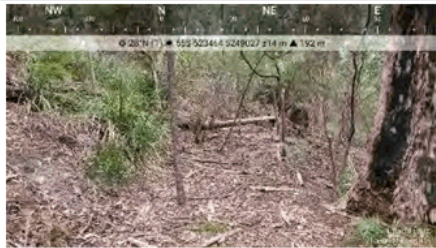
| Track 5 | 3m wide benched track formation heading north from Reagan's Gully to join Track 1 immediately south of the Falls Fire Trail and opposite the east end of the Pipe Head Well track. Possibly a continuation of Track 2. | <p>Not previously assessed.</p> <p>Outside the THR and HIPS Heritage Place boundaries. Has potential contributory significance relating to the construction and maintenance of the mountainwater supply system, but without further research is unlikely to meet thresholds for State or Local listing based on HCHA exlusion factors XA1, XA2, XC1, XD3 and XD4.</p> | <p>View north along track towards Fire Trail</p> |

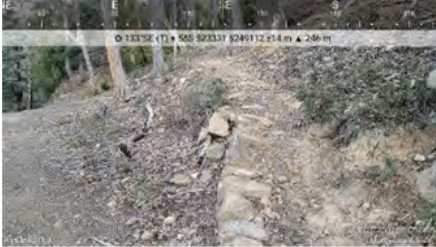
| Track 7 | <p>30m long narrow benched track edged with stone or formed as low steps connecting the Falls Track and lower catchment basin (Feature 6). 20th C feature.</p> | <p>Not previously assessed.</p> <p>Low intrinsic value but some contributory significance relating to the history of recreation in the Park. Unlikely to meet thresholds for State or Local listing based on HCHA exclusion factors XA1, XA2 and XD4</p> | <p>View east along shortcut track to Feature 6</p> |

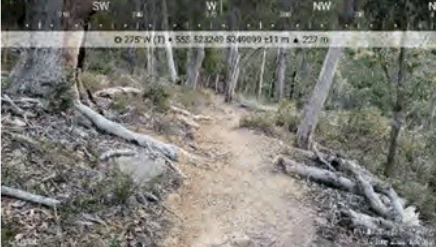
| Track 8 | <p>Falls Track. A downhill 2m wide walking track with stone steps and switchbacks on steeper sections continuing west from 8K/Q11 track to join RPH2/Old Huon Road c. 400m west of Upper Reservoir. The falls Track overprints RPH2 for 25m east of the junction before diverting upslope away from RPH2 for c. 50m before joining it again and overprinting it for the final 300m to Upper Reservoir.</p> | <p>Not previously assessed.</p> <p>Low intrinsic value but minor contributory significance relating to the history of recreation in the Park. Unlikely to meet thresholds for State or Local listing based on HCHA exclusion factors XA1, XA2 and XD4</p> | <p>View along Falls Track west of 8K/Q11 junction</p> |

| Feature | Intersection | Recommended mitigation |
|---|--|---|
| Track 8 | Intersected over c. 50m distance. No significant impacts associated with proposed upgrade. | No specific recommendations |

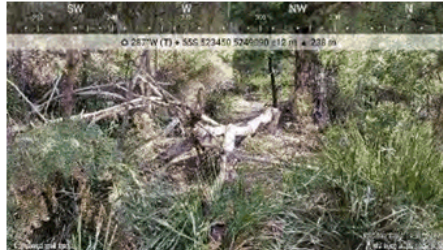
| Track 12 | 3m -wide benched level formation running for 90m from the Fire Trail to the top of the Pipe Head Well. Appears to be an early track, possibly continuous with Track 5, that has been overprinted for access to the current viewing platform. | High cultural/scientific significance (Murray & Nieberler 1994) High/State (McConnell <i>et al</i> 1998) The Pipe Head Well and associated infrastructure contribute to the State-level significance of the mountain water supply system. Partly outside current THR listed area but potentially eligible for THR listing under HCHA inclusion factors C4, C5. | View west along track from Fire Trail |

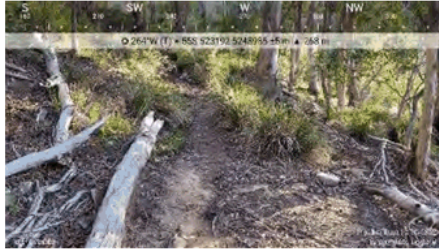
| 8A (Q1) Track | 3m wide benched formation taking off from the 8B/Q2 track in a south-westerly direction before switching back to head upslope towards quarry 8A/Q 1(not assessed). | <p>High cultural/scientific significance (Murray & Nieberler 1994)</p> <p>High/State (McConnell <i>et al</i> 1998)</p> <p>The Gentle Annie Falls quarries and associated infrastructure contribute to the State-level significance of the mountain water supply system. Partly outside current THR listed area but potentially eligible for THR listing under HCHA inclusion factors C4, C5.</p> | <p>Junction between 8A/*1 track and 8B/Q2 track</p> |

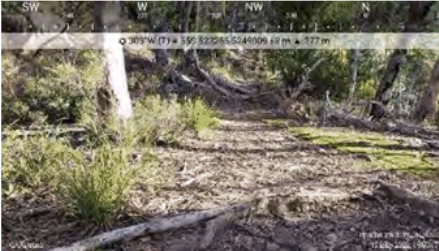
| 8B (Q2) Track | 3m wide benched formation running west from the upper basin in front of the 8F/Q6 workings to terminate at a turning area at 8B/Q2. | <p>High cultural/scientific significance (Murray & Nieberler 1994)</p> <p>High/State (McConnell <i>et al</i> 1998)</p> <p>The Gentle Annie Falls quarries and associated infrastructure contribute to the State-level significance of the mountain water supply system. Largely outside current THR listed area but potentially eligible for THR listing under HCHA inclusion factors C4, C5.</p> | <p>View west along quarry access track</p> |

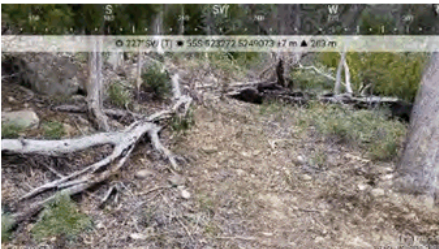
| 8K (Q11) Track | 3m wide benched formation running from the pipeline incline below the lower intake to quarry 8K/Q11, passing below the 8I/Q10 spoil heap. The easternmost 90m of the track has been overprinted/re-used as part of the Falls Fire Trail/Falls Track. | <p>High cultural/scientific significance (Murray & Nieberler 1994)</p> <p>High/State (McConnell <i>et al</i> 1998)</p> <p>The Gentle Annie Falls quarries and associated infrastructure contribute to the State-level significance of the mountain water supply system. Outside current THR listed area but potentially eligible for THR listing under HCHA inclusion factors C4, C5.</p> | <p>View southwest along quarry access track</p> |

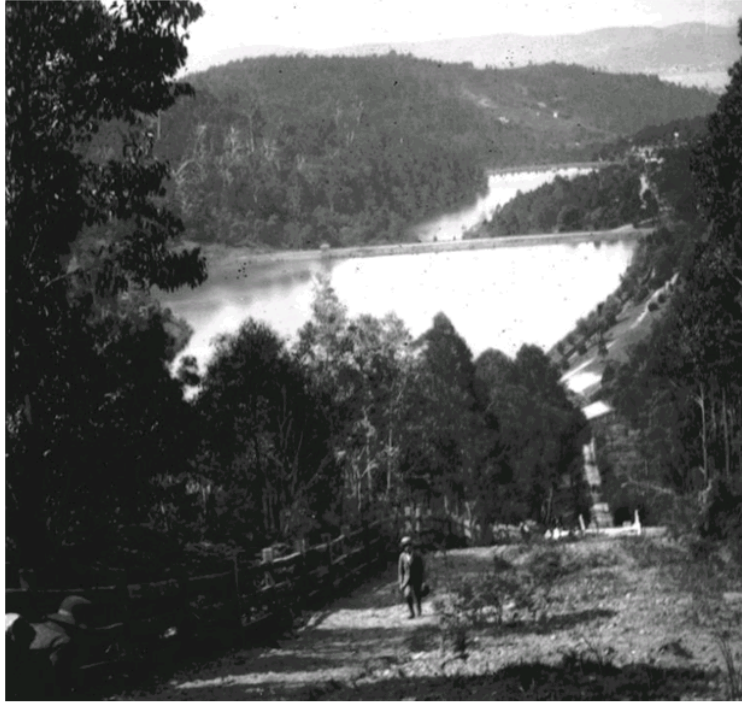
Figure 8.2: Walking track beside troughing/pipeline incline, c. 1920. TAHO NS479-1-159

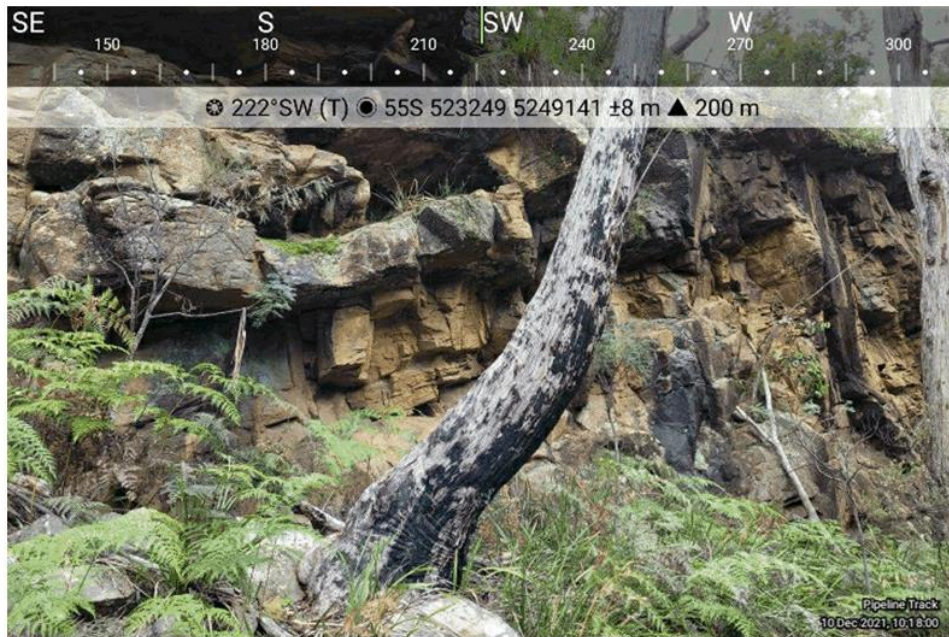
Figure 2.8: Sandstone cliffing on lower north spur face displaying typical blocky dissection

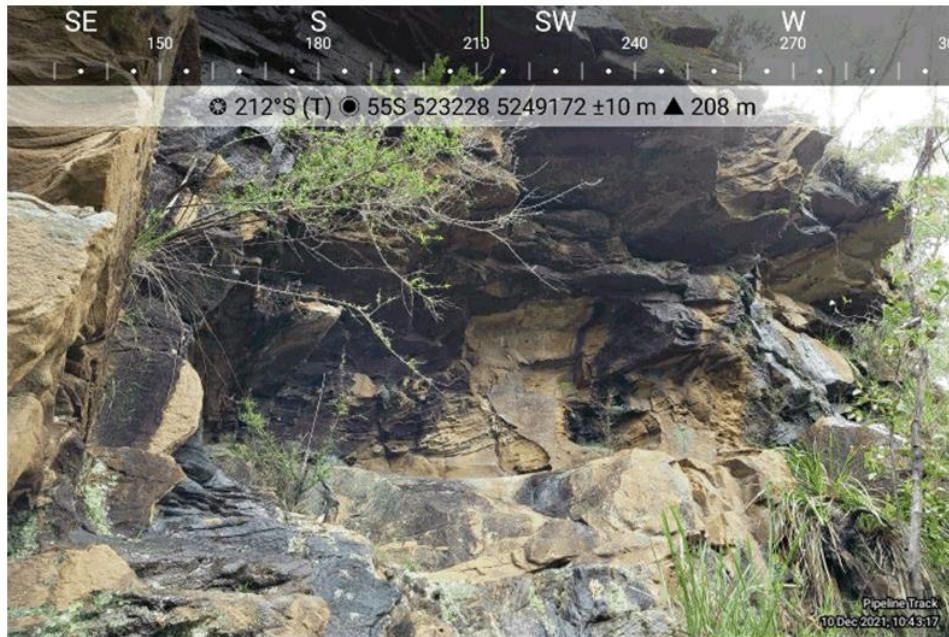
Figure 2.9: Shallow overhang with stone floors formed in lower north face cliff section
