CITY OF HOBART

Planning Committee Meeting
Open Portion
Wednesday, 29 March 2023
at 5:00 pm
Council Chamber, Town Hall

| 6.1.1 220 Waterworks Road, Dynnryne - New Shared Track and Associated Works including Vegetation Rehabilitation | 7 |
| 6.1.2 171 Bathurst Street, Hobart - Partial Demolition, Alterations, and Extension | 346 |

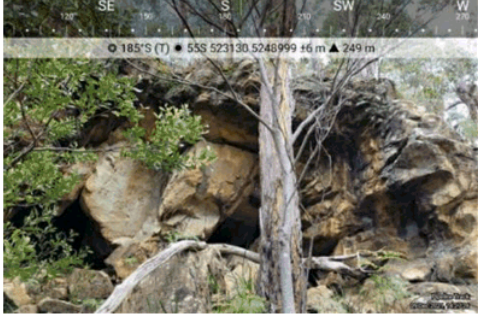
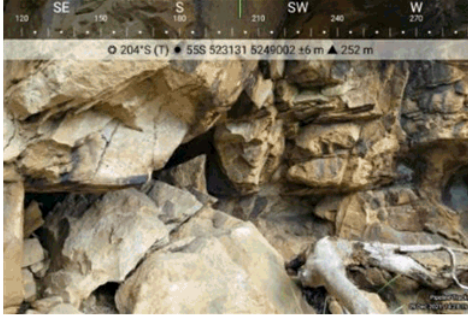
| Overhang | Coordinates (GDA94) | Description | Images |
|---|---|---|--|
| Overhang 1 | E 523128 N 5249003 | <p>Partially collapsed overhang in area of heavily jointed sandstone cliff line at 255m elevation, 220m from Sandy Bay Rivulet. Mouth 8m wide x 3m maximum height with roof dipping inwards. Contains two chambers c.4.5m deep from dripline x c2m wide separated by pillar. West chamber has 1m high back wall and ceiling collapse. East chamber has partial ceiling collapse and 2m high back wall on a major joint. Side walls in east chamber appear to have been excavated along the joint with debris accumulating at the chamber mouth. Appears deliberate chasing of shear zone but no chisel marks observed. Possible prospecting feature.</p> <p>No artefacts or evidence of use.</p> <p>Steep fall below entry ledge with minimal potential for cultural deposits.</p> <p>Very small floor area and not possible to stand up in chambers.</p> <p>Rock is very unstable and prone to collapse.</p> | <p>Overhang 1, view of dual chambers</p> <p>Overhang 1, heavily jointed ceiling with collapse</p> |

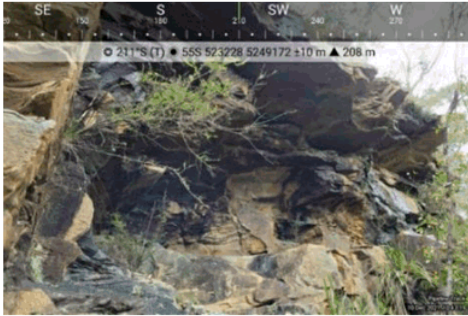
| Overhang | Coordinates (GDA94) | Description | Images |
|---|---|---|--|
| Overhang 2 | E 523230 N 5249154 | <p>Small, mid cliff overhang in heavily jointed low cliffline with staining and honeycombing. 190m elevation and 90m south of Sandy Bay Rivulet. Main overhang is 5m wide x 3m high at front of dripline x 1.5m deep. Steeply dipping roof due to collapse with 1m high back wall. Stone floor with dipping to north with no sediment deposits. Steep drop and fall of ground downhill with negligible potential for cultural deposits.</p> <p>No artefacts or evidence of use.</p> <p>Steep fall below entry with minimal potential for cultural deposits</p> <p>Very small floor area and only possible to stand up at entry.</p> | <p>Overhang 2, heavily jointed and stained</p> |

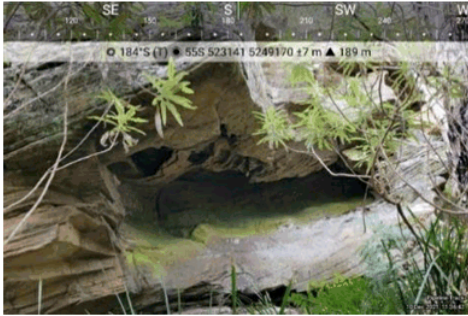
| Overhang 3 | E 523138 N 5249168 | <p>Small overhang, 6m north of existing Gentle Annie Falls track. 183m elevation and 40m south of sandy Bay Rivulet. Mouth 3m wide x 1m high x 1m deep with steeply north dipping sandstone floor and no sediment deposits.</p> <p>No artefacts or evidence of use.</p> <p>Small size precludes occupation.</p> | |

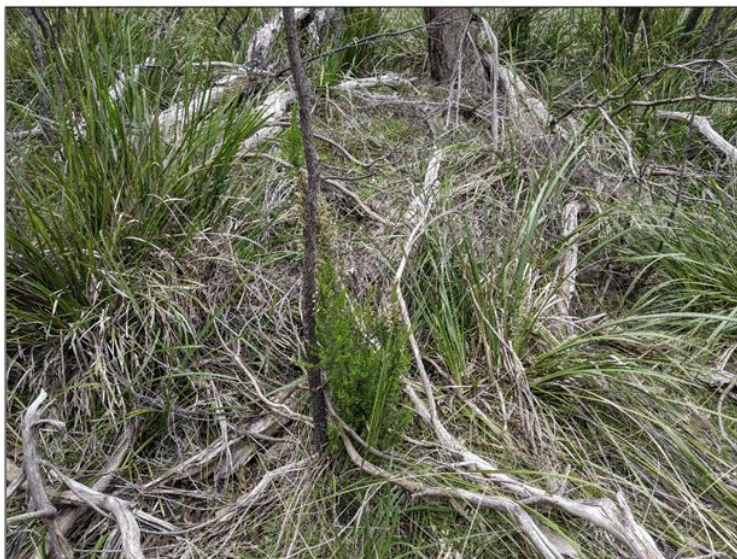
Figure 5 - Spanish heath plant growing amongst native understorey near existing gravel track.

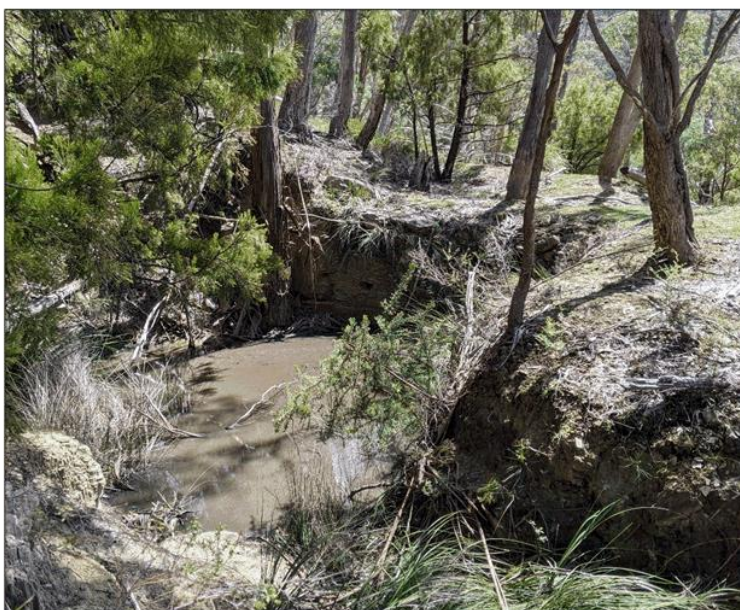
Figure 6 - Gorse growing on edge of small dam in DOB forest.

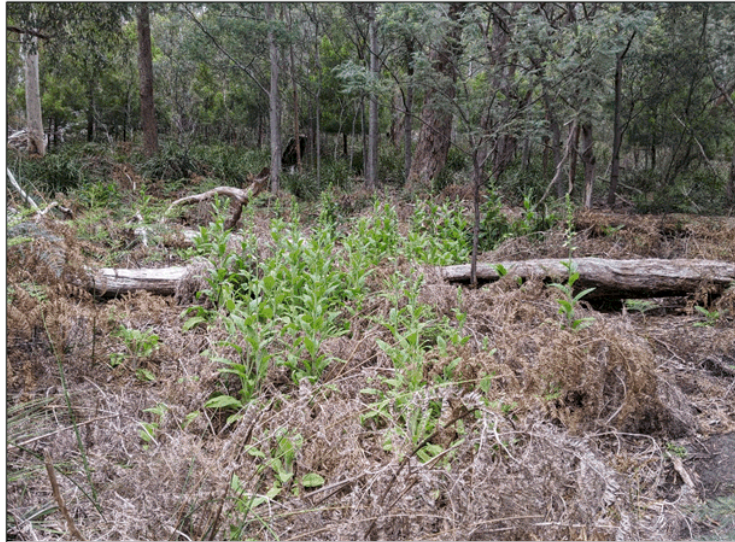
Figure 7 – Foxglove infestation in open area at edge of native forest.

Foxglove (*Digitalis purpurea*) is confined to a patch at the northern edge of the survey area, in native forest where the understorey has been disturbed (Figure 4). This herbaceous weed favours disturbed or bare soil such as along track edges. Most of the survey area is too dry for foxglove (e.g. the DTO forest) and the damper sites, such as the gully at the eastern edge of the survey area, are likely to be resilient to foxglove invasion in the absence of disturbance.

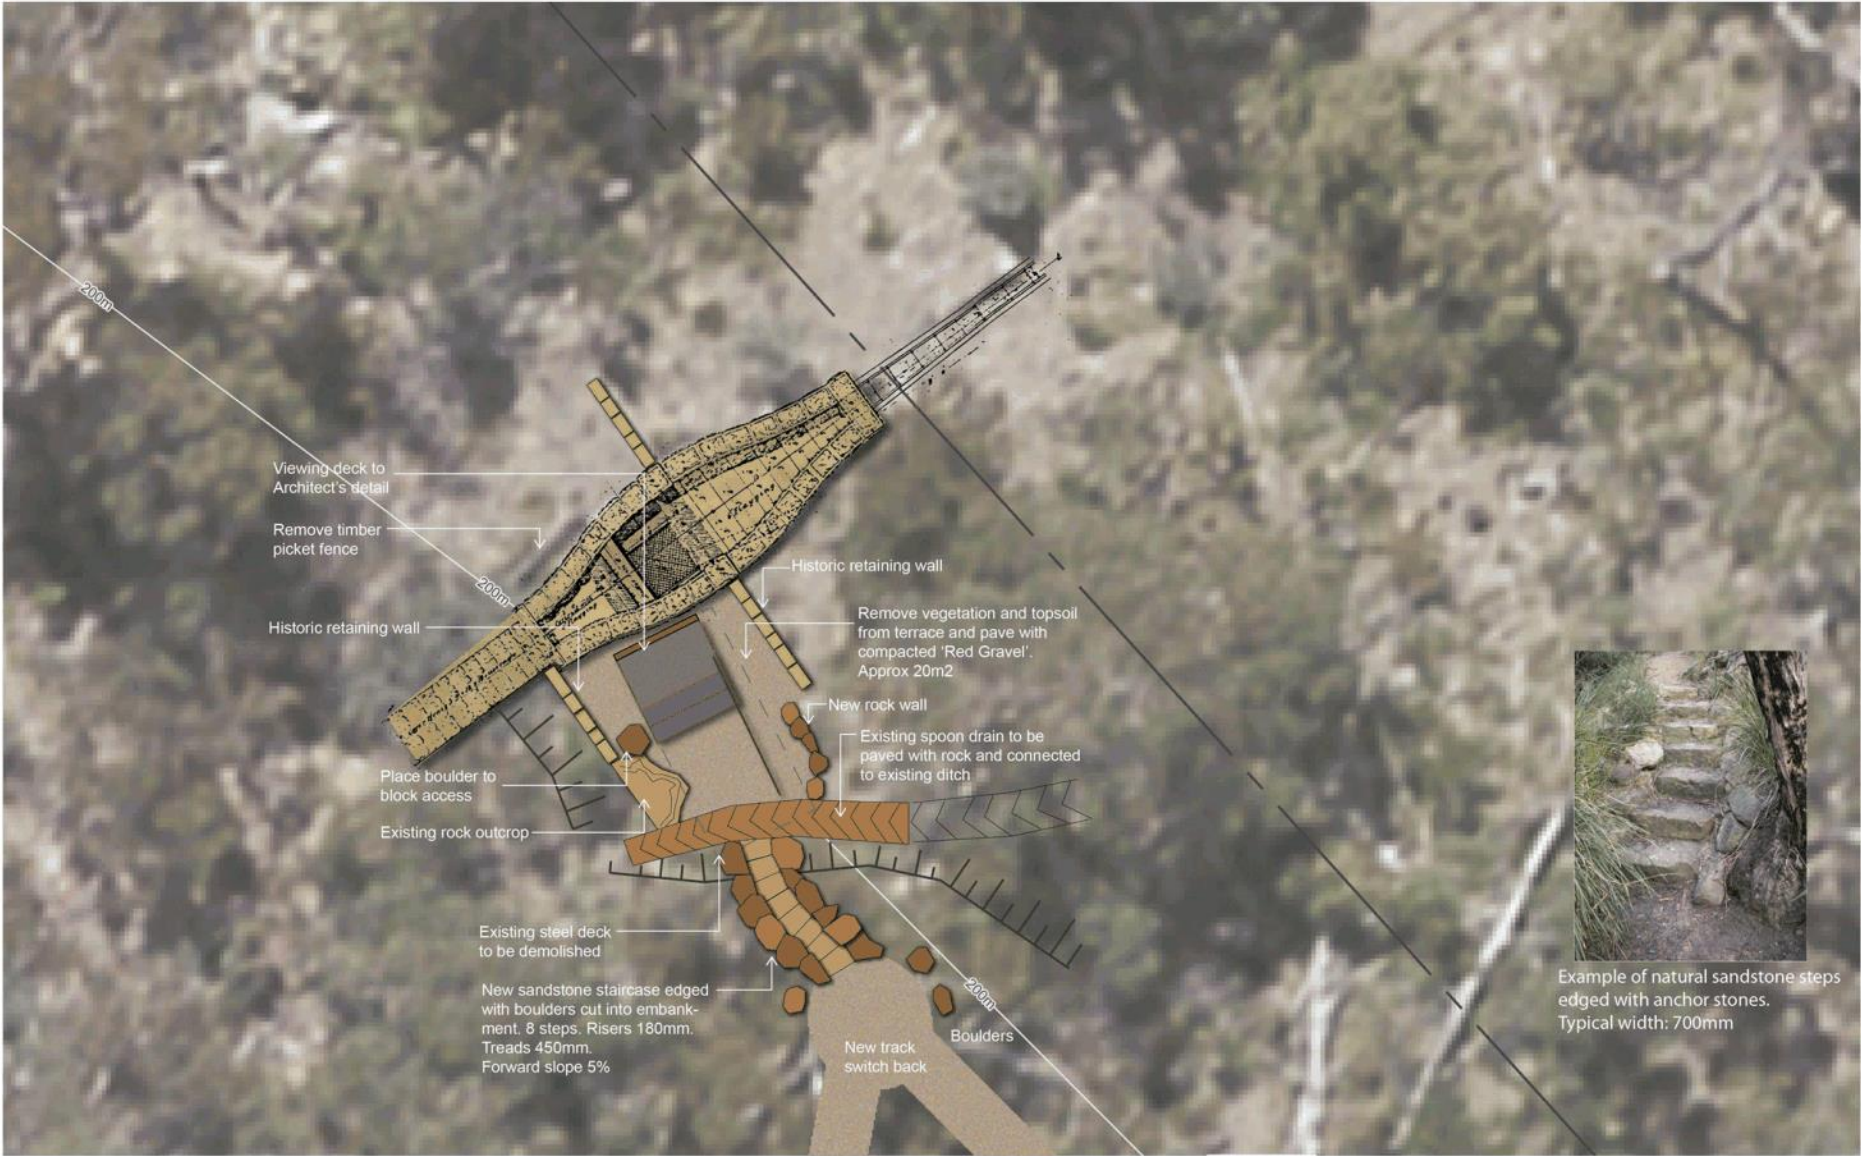
TRACK CONSTRUCTION NOTES**Track Surfacing**

Disturbed trackside areas are to be rehabilitated by transplanting, seeding and spreading of local organic matter.

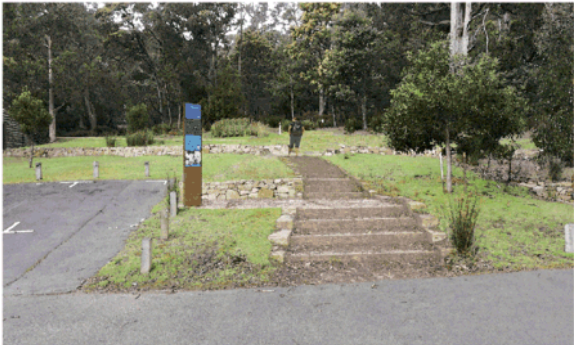
Montage showing steps from car park with terrace for gathering, sitting wall and interpretive signage (Provisional)

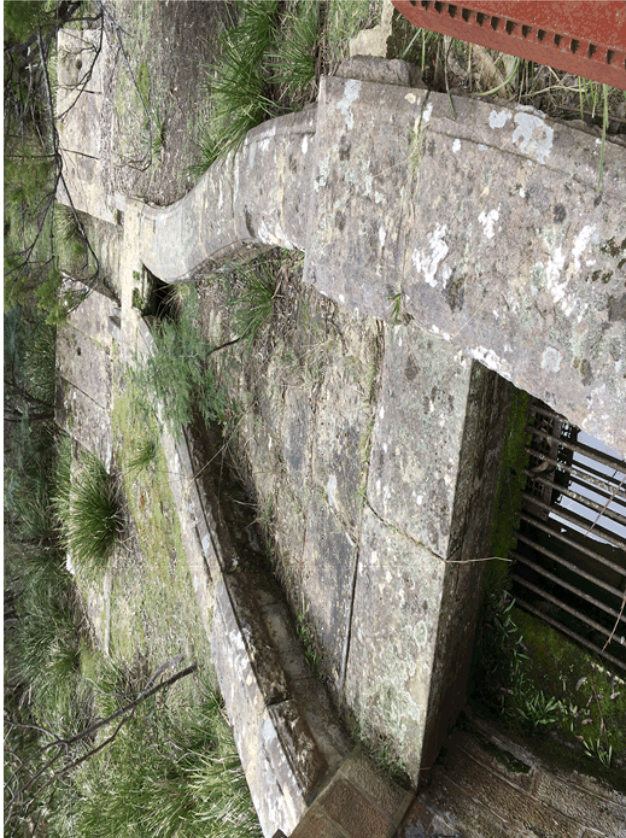
Pipe Well Head - the new track will intersect with this currently isolated feature with alterations to the abandoned viewing platform. Source: Council image.

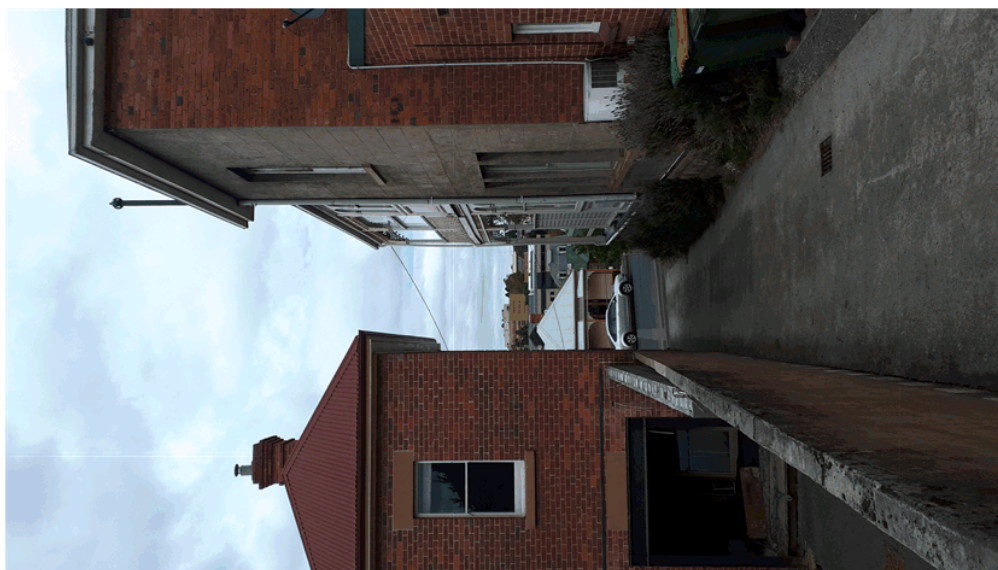
Figure 2: site photo - view to the south-east showing the rear of the dwelling on the subject property (left) and the dwelling on the adjoining property at unit 1, 173 Bathurst Street (right).

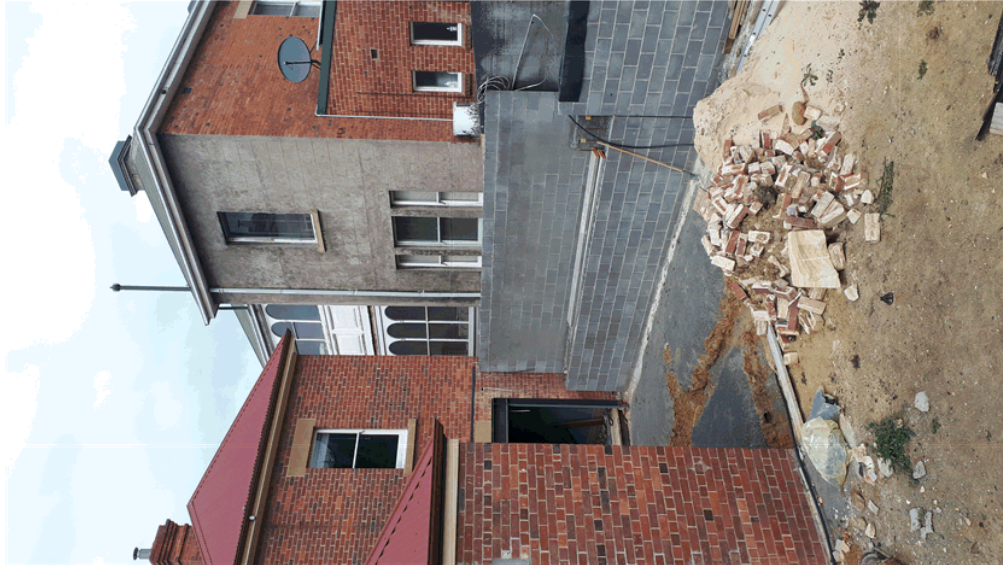
Figure 3: site photo - view to the south showing the rear of the dwelling on the subject property (left) and the dwelling on the adjoining property at unit 1, 173 Bathurst Street (right). The latter dwelling's living room window is at the centre of the photo.

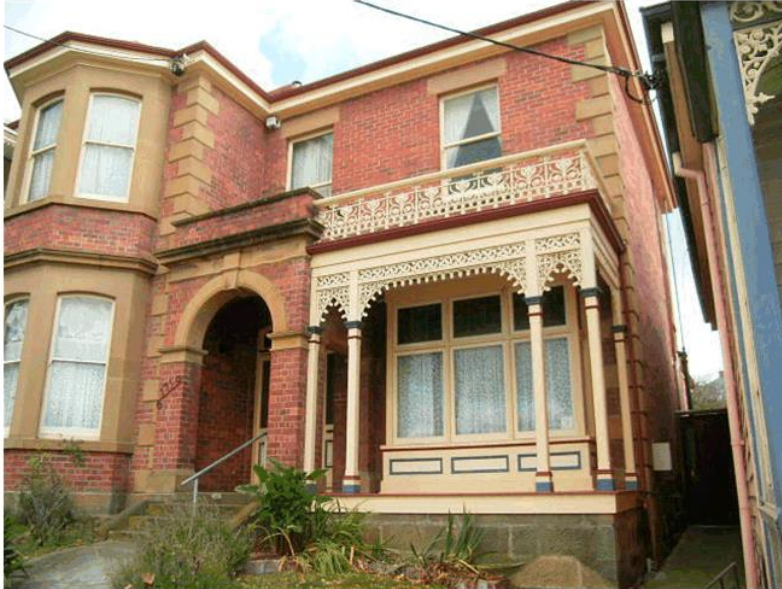
Photo 1 Front Elevation. Source: Council image

The subject property is a highly intact example of a red face brick townhouse, with asymmetrical front elevation containing two storey front bay window, distinctive arched and detailed porch, front verandah with highly decorated filigree ironwork and balustrade at first floor level along with sandstone detailing including quoins. To the rear, the building has a single storey half width wing with hipped roof. This partially encloses a rear 'courtyard' between the rear of the house and the garden typical of the traditional pattern associated with rear wings. This wing has been the subject of notable elements of demolition of external walls to facilitate the opening up of the space to larger windows and access to the courtyard. A lean-to open timber verandah that was previously attached to the wing has also been removed along with a large light weight infill addition with laserlite style roofing. At ground floor, the remaining rear elevation has also seen the removal of the original rear door and an original ground floor rear facing window, plus the removal of elements of the surrounding brick work to facilitate the opening up of the ground floor plan to the courtyard. Above this the rear elevation remains entirely unchanged and includes a timber sliding sash window serving a bedroom and a notable, highly decorated stain glass window that serves the principal staircase and landing.

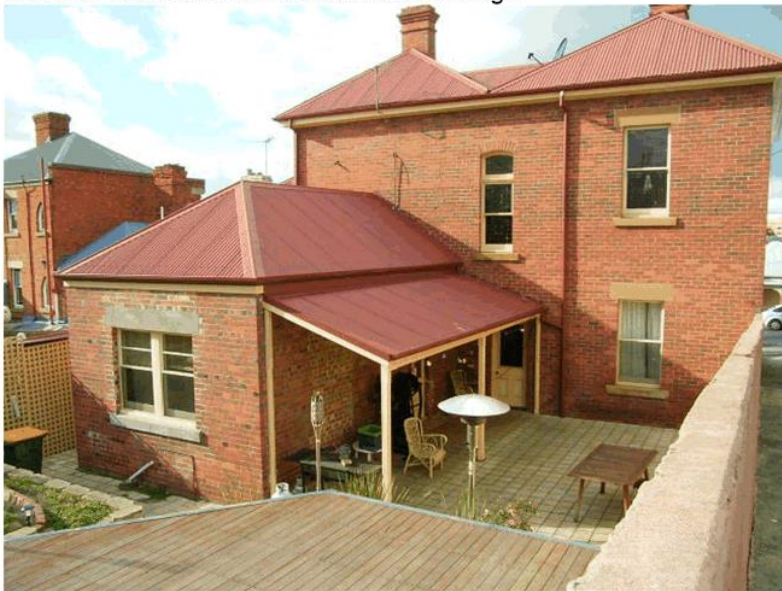
Photo 2 - Rear elevation prior to recent alterations and extension. Source: Council image (dated 2007)

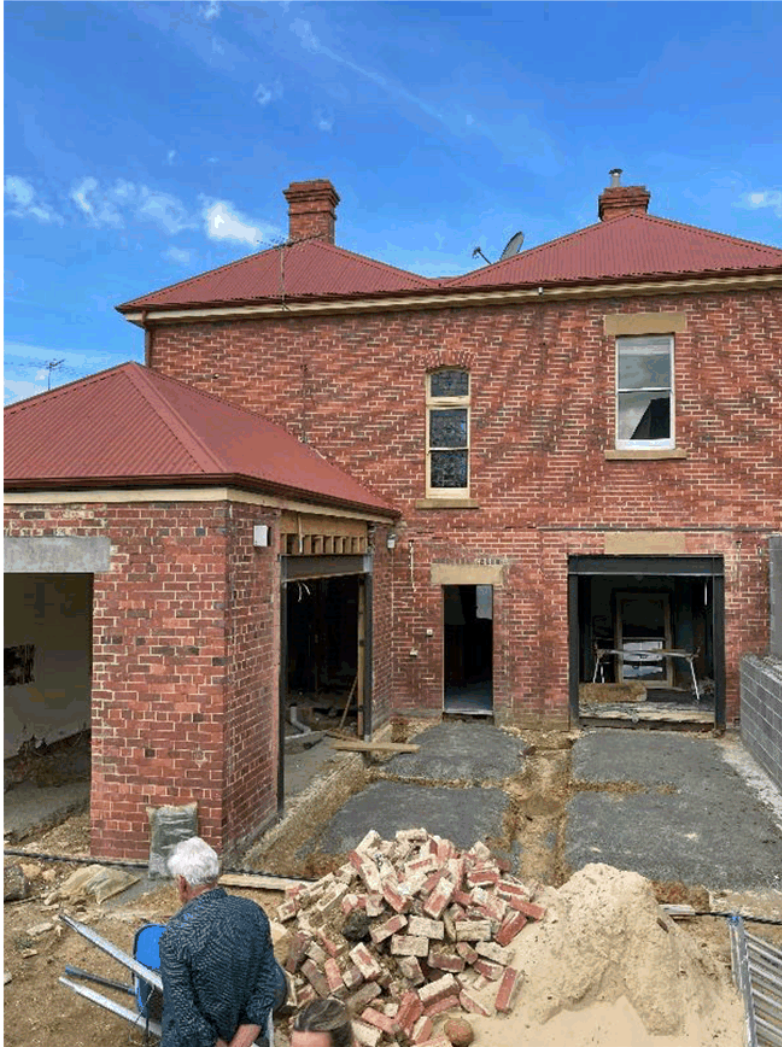
Photo 3 - Current rear elevation following approved demolition. Source: Council image (dated February 2023)

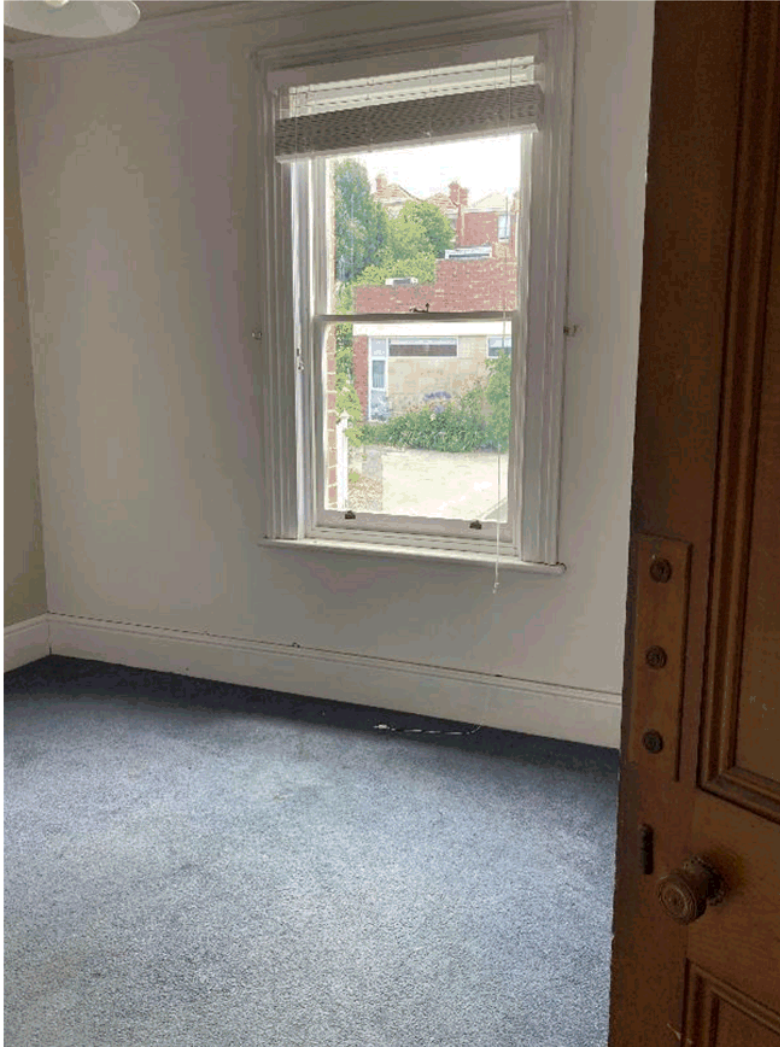
Photo 4 - Bedroom window proposed to be demolished. Source: Council image (dated February 2023)

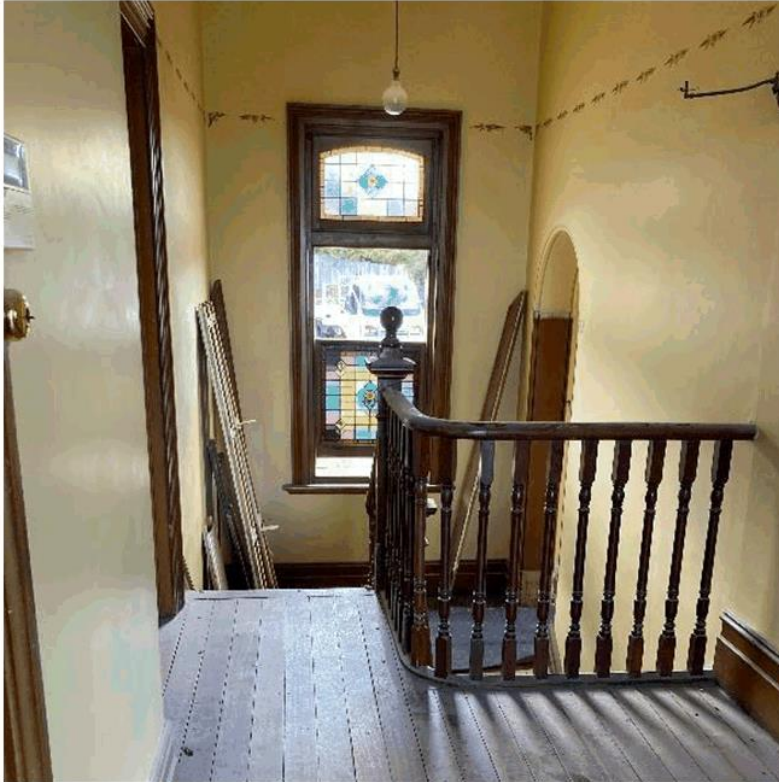
Photo 5 - Stain glass window serving stairs and landing. Source: Council image (February 2023)

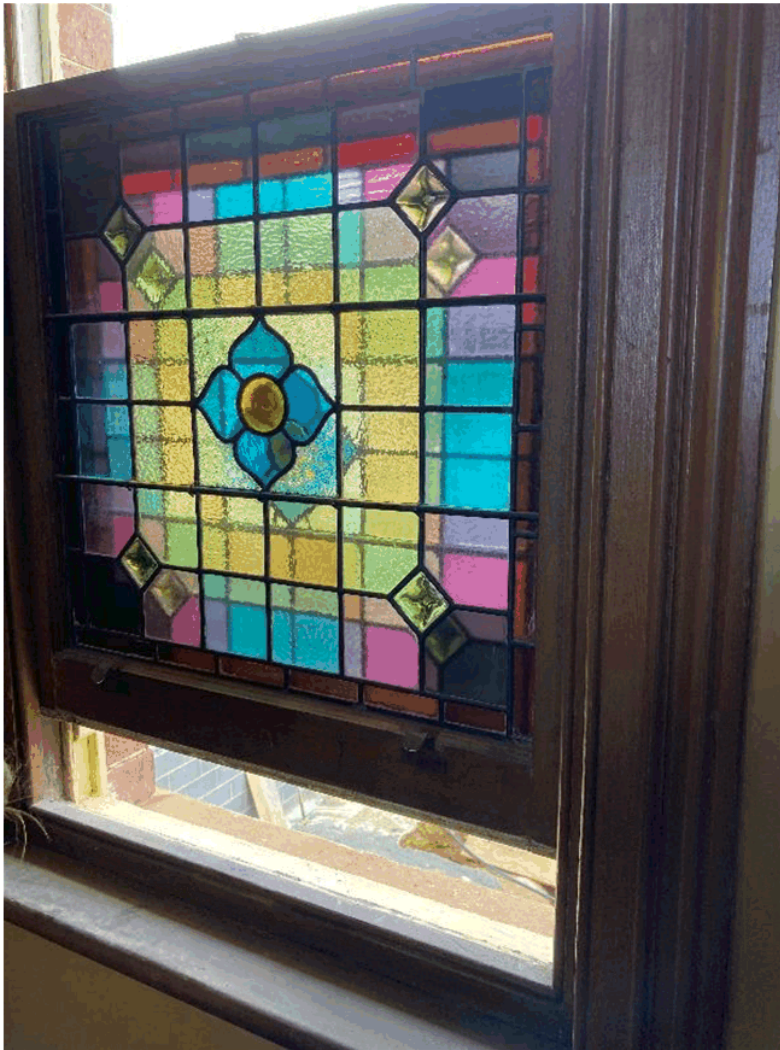
Photo 6 - Stain glass window detail. Source: Council image (February 2023)
Pertinent Pre-application Discussions
