CITY OF HOBART

**2.1.1 202 - 206 MACQUARIE STREET, HOBART AND ADJACENT ROAD
RESERVE - NEW BUILDING FOR 40 MULTIPLE DWELLINGS,
EDUCATIONAL AND OCCASIONAL CARE (CHILDCARE CENTRE),
AND GENERAL RETAIL AND HIRE, BUSINESS AND
PROFESSIONAL SERVICES AND FOOD SERVICES
PLN-20-104 - FILE REF: F20/107319**

Address:	202 – 206 Macquarie Street, Hobart and Adjacent Road Reserve
Proposal:	New Building for 40 Multiple Dwellings, Educational and Occasional Care (Childcare Centre), and General Retail and Hire, Business and Professional Services and Food Services
Expiry Date:	13 October 2020
Extension of Time:	Not applicable
Author:	Mark O'Brien

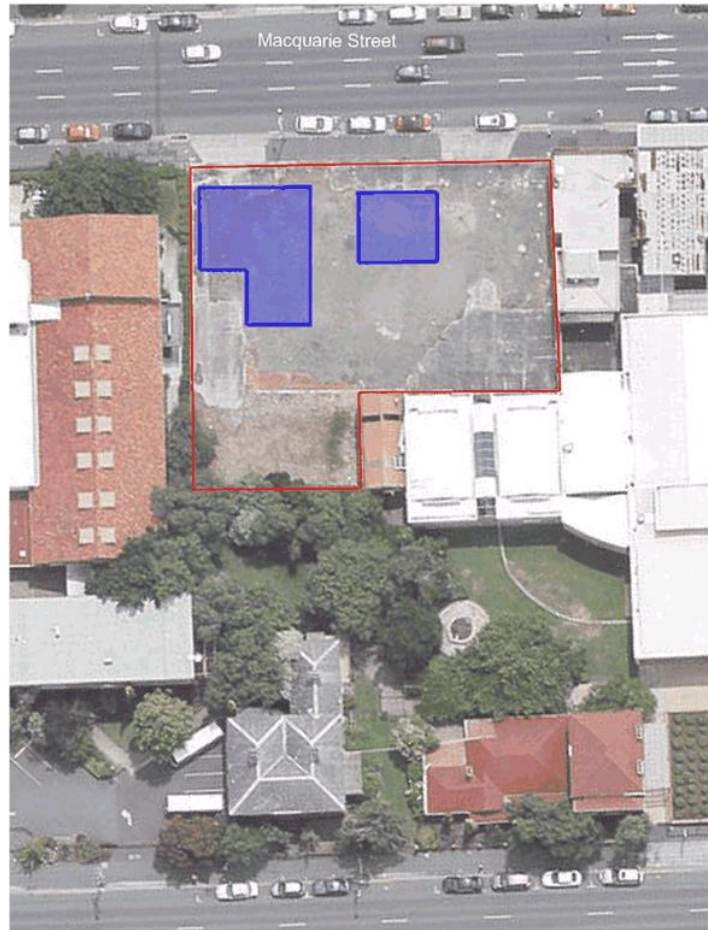
Figure 4.10 – Overlay of the of the c1832 depiction of the buildings on/near the subject site (blue). Note that the accuracy of this survey is known to be low – merely depicting the *presence* of buildings, rather than necessarily an accurate location.

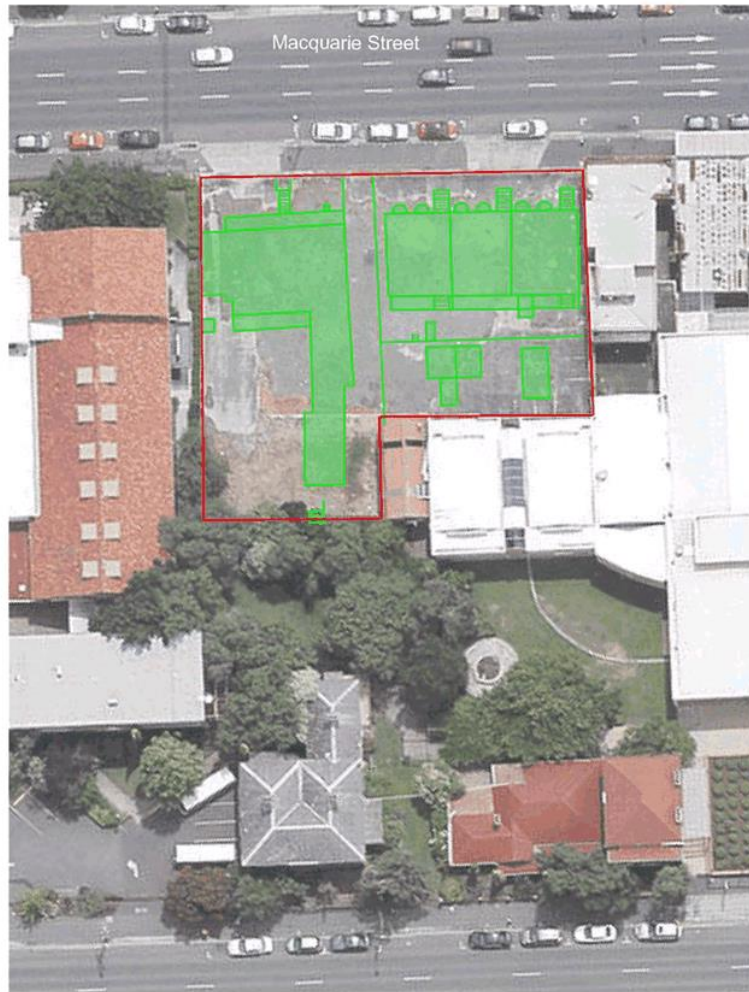
Figure 4.11 – Overlay of the of the c1850-c1950 depictions of the buildings on the subject site (green) in relation to the subject site (red). This is based on the 1907 Metropolitan Drainage Board survey and 1946 aerial photograph, both of which are known to have a very high accuracy.

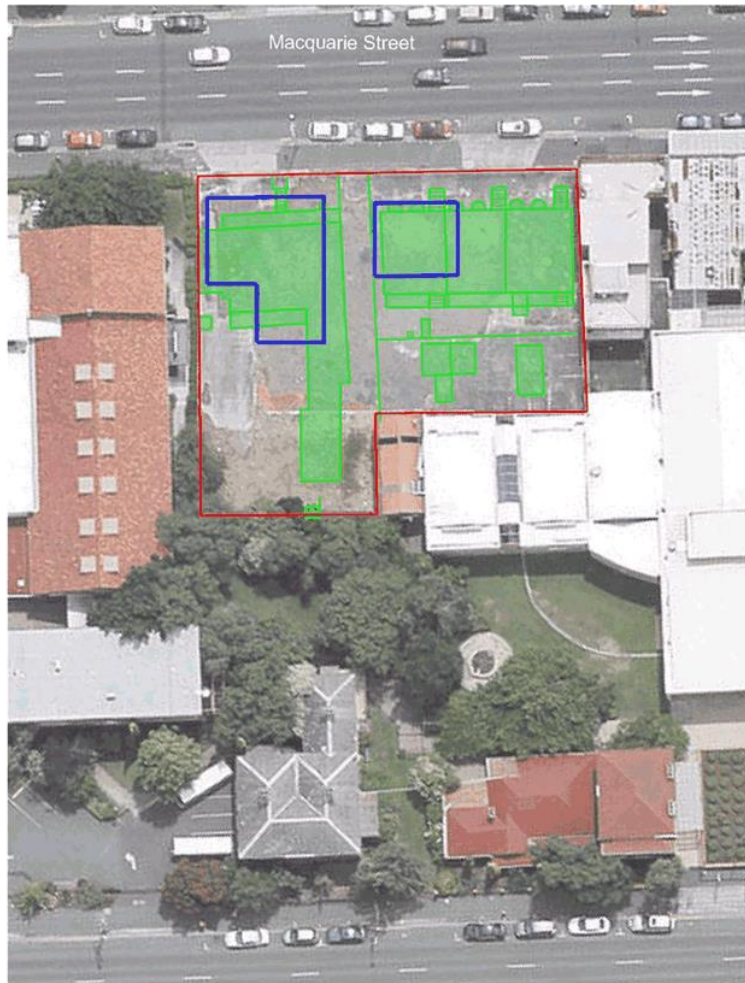
Figure 4.12 – Composite overlay of the footprint of all known pre-c1950 buildings and site features (colours as per coding above) in relation to the subject site (red).

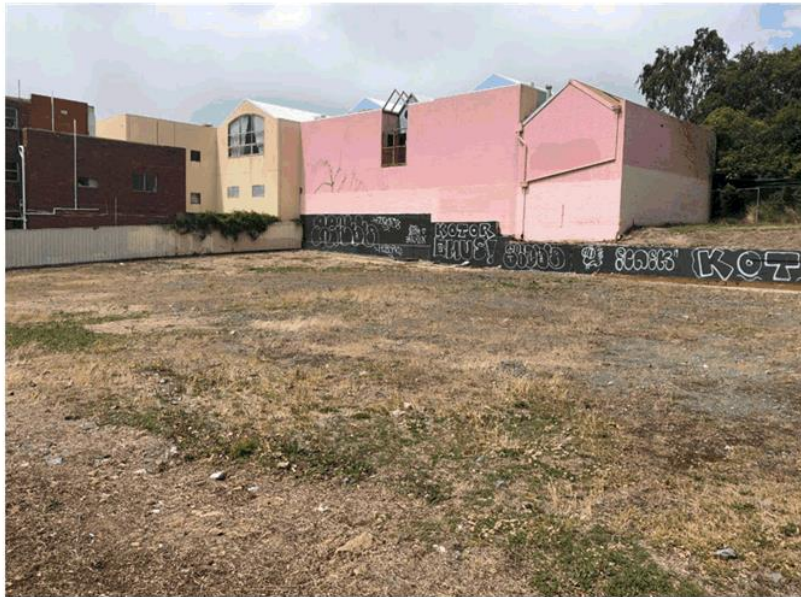
Figure 5.2 – View across the site to the rear corner (facing east).

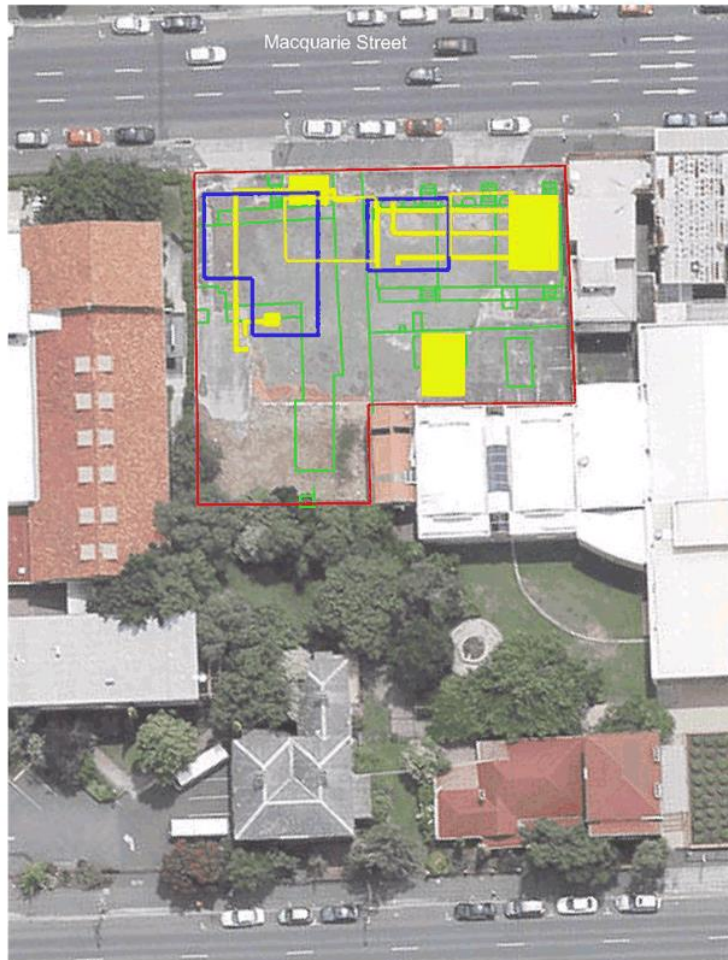
Figure 5.5 – Tank and fuel line locations (yellow) overlaid on historic building footprints (blue = c1832, green = c1850+). Adapted from www.thelist.tas.gov.au
